**Centennial Park Earthworks
Geotechnical Completion
Report**

Stage 1 Lots 1 to 16 and 19 to 28

Prepared for
Wallace Development Company Ltd.

Prepared by
Tonkin & Taylor Ltd

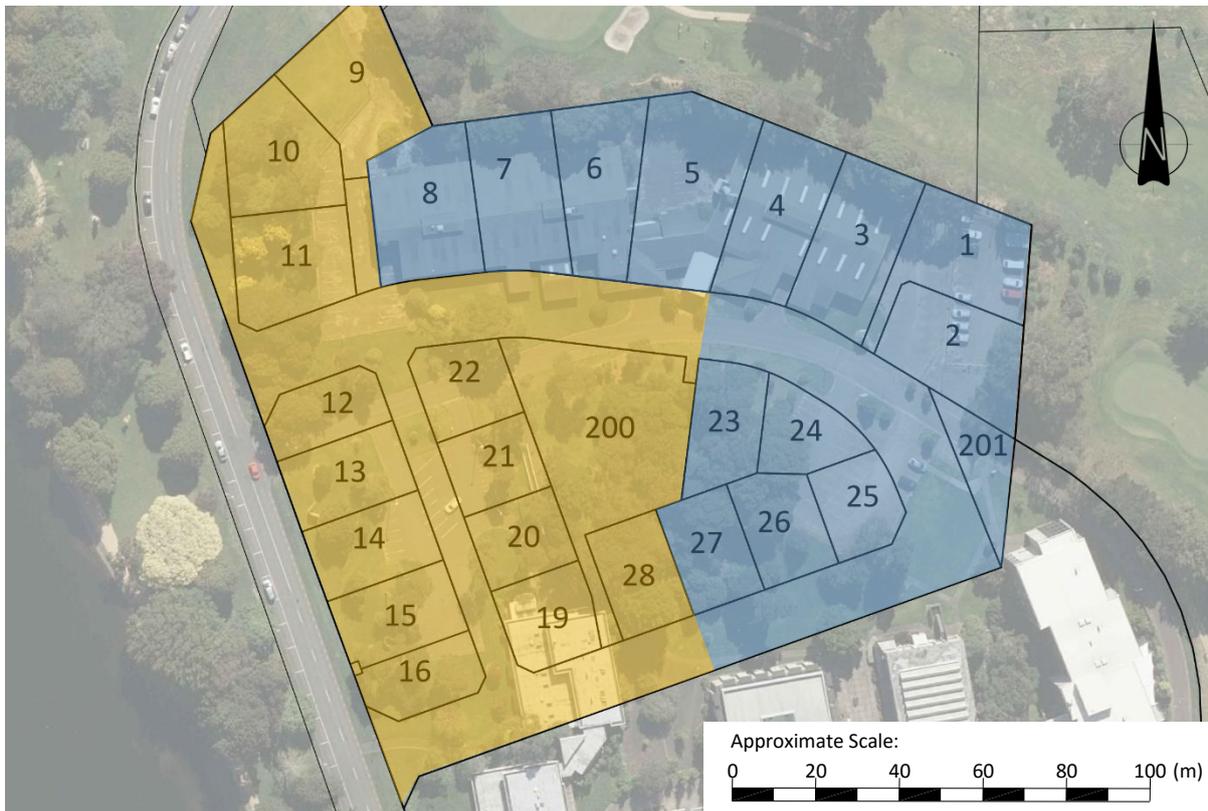
Figure 1.1: Layout of Centennial Park Stage 1 subdivision. Two portions of Stage 1 have been defined for the purposes of this geotechnical completion report: Stage 1-West shaded yellow, and Stage 1-East shaded blue. Subdivision layout is as per the GHD Drawings 51-37652 Sheets -C003 to -C008 dated 26 June 2020, provided in Appendix A

For the purposes of this geotechnical completion report Stage 1 has been divided into two portions as shown in Figure 1.1. These are referred to in this report as Stage 1-West and Stage 1-East.

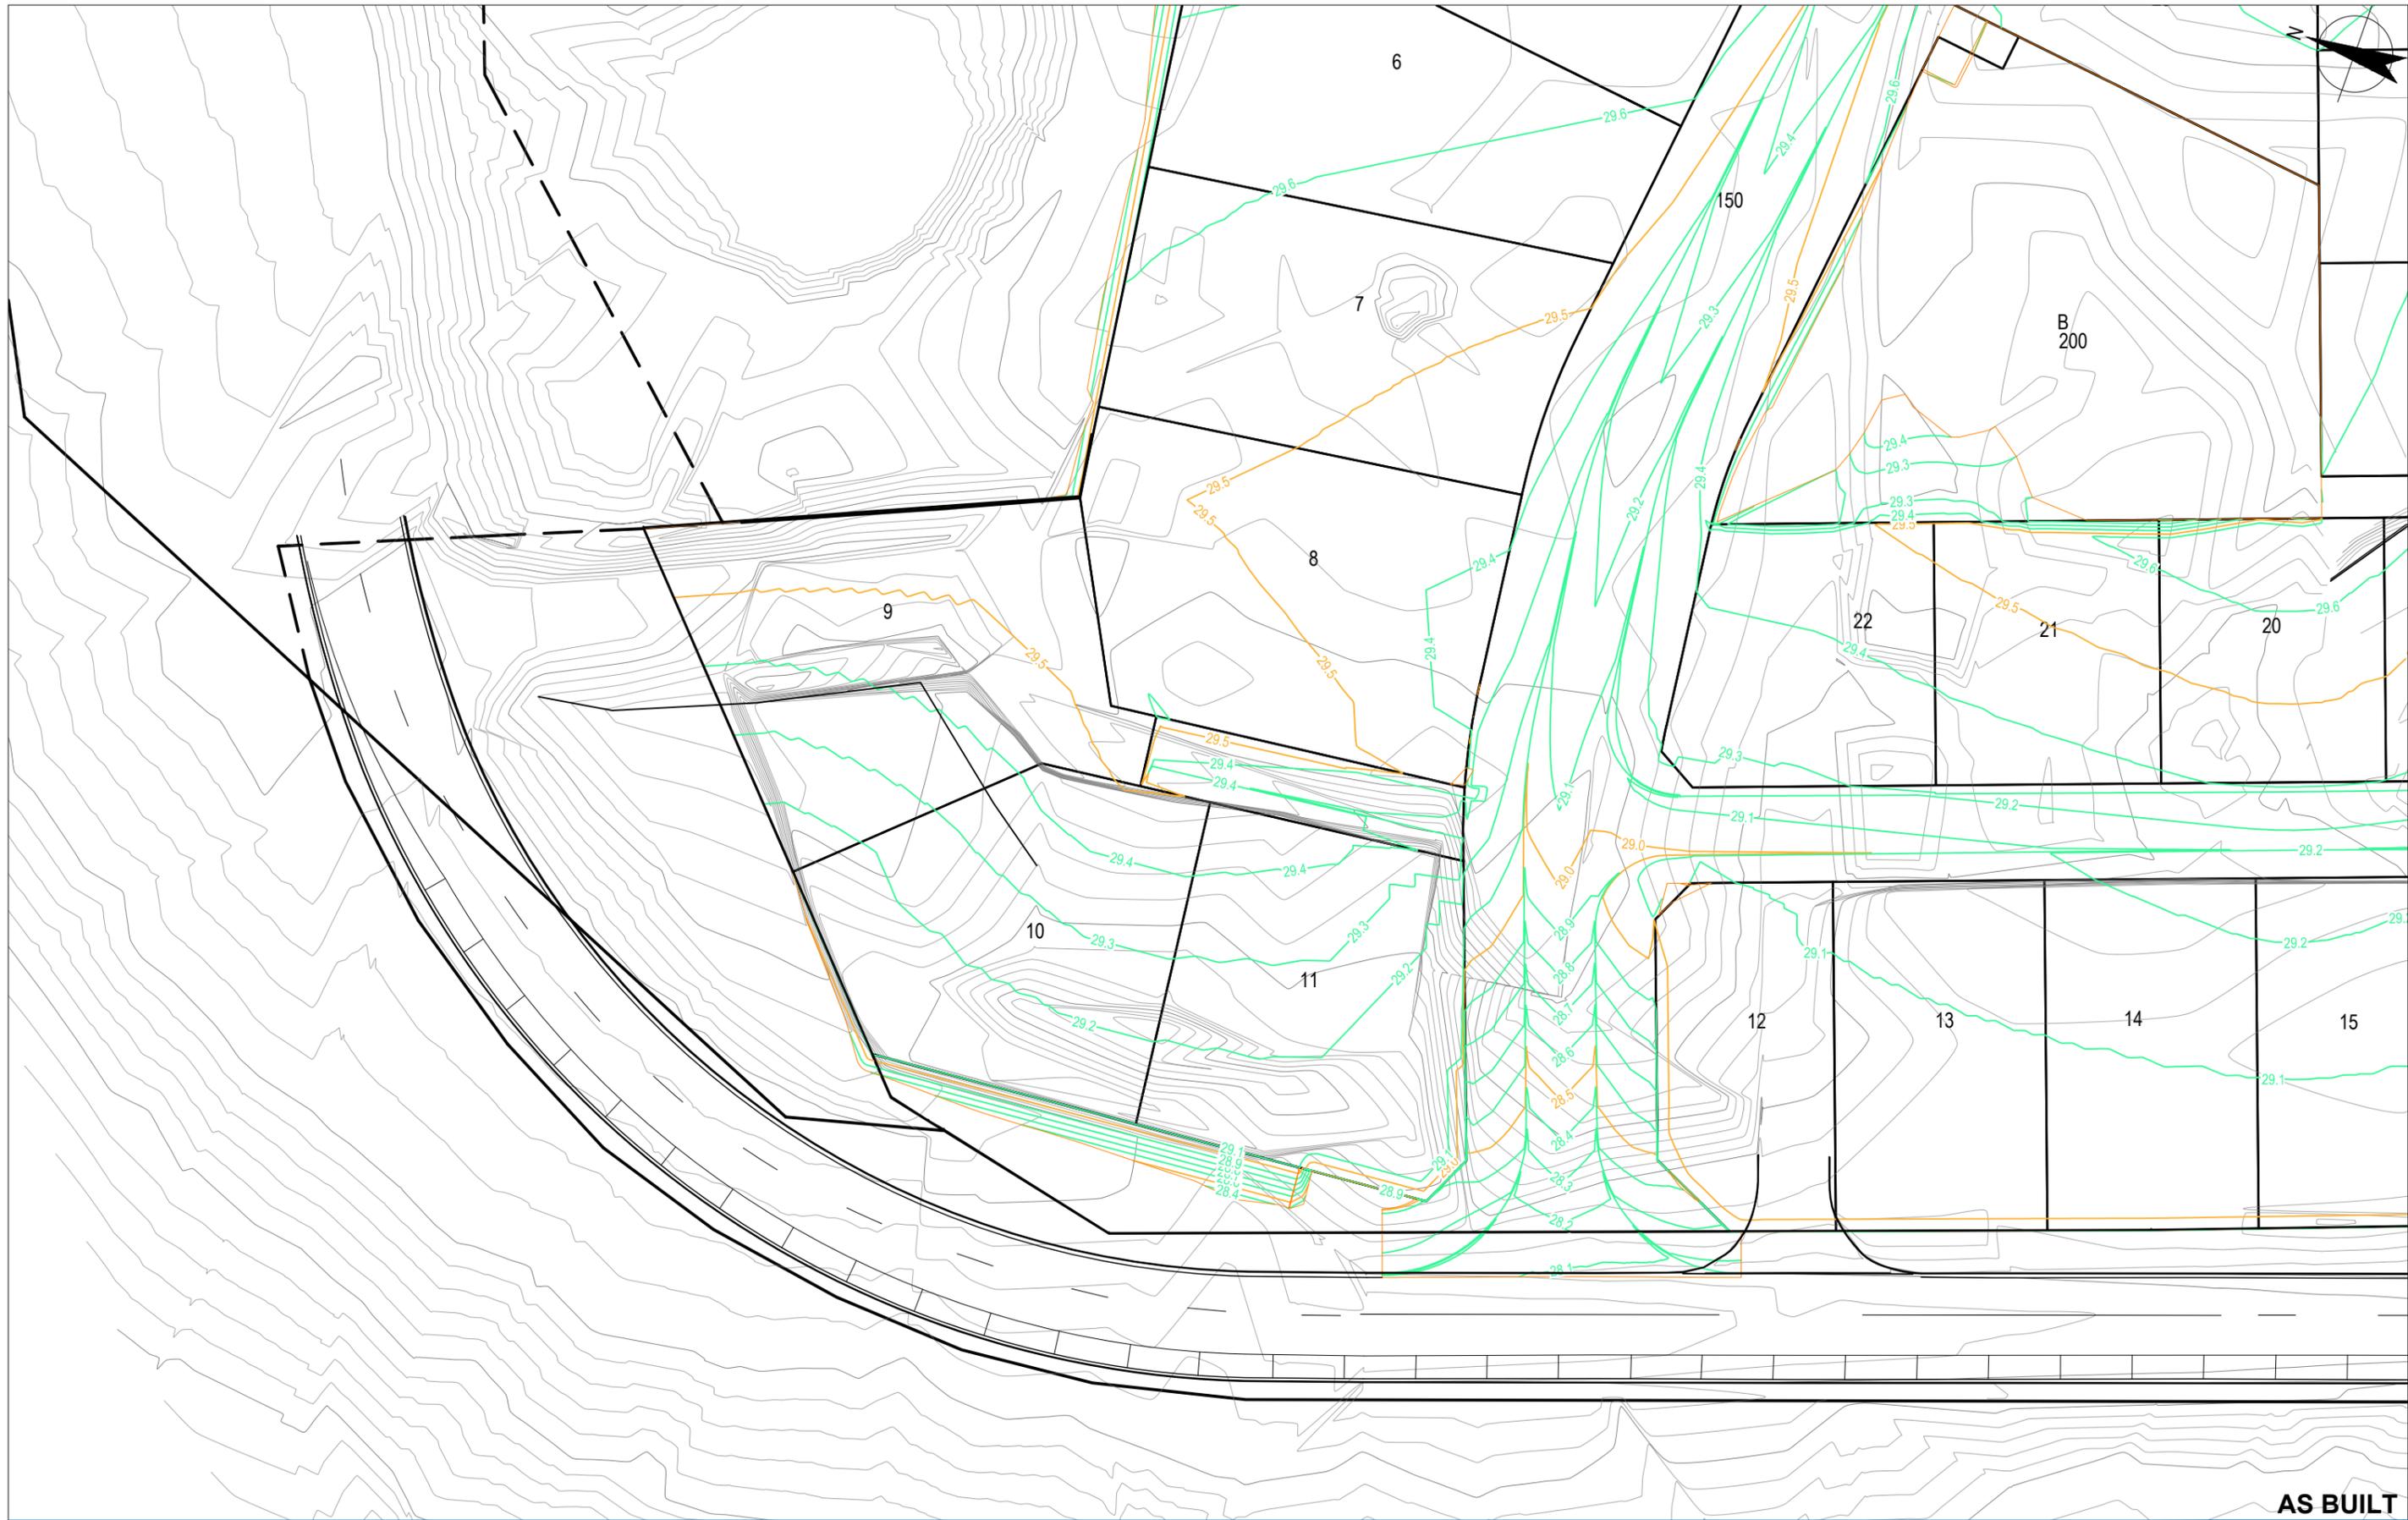
Client **WALLACE DEVELOPMENT COMPANY LTD**
 Project **CENTENNIAL PARK - STAGE 1**
 Title **EXISTING AND PROPOSED CONTOURS**
 Original Size **A1**
 Drawing No: **51-37652-C003**
 Rev: **AB**

AS BUILT

This report relates to earthworks areas associated with Lots 1 to 16 and 19 to 28 of the Stage 1 works of the Centennial Park Development in Palmerston North, undertaken between April 2019 and May 2020. The location and extents of the Stage 1 subdivision earthworks covered by this report are shown on the GHD Drawings 51-37652 Sheets -C003 to -C008 dated 26 June 2020, provided in Appendix A.

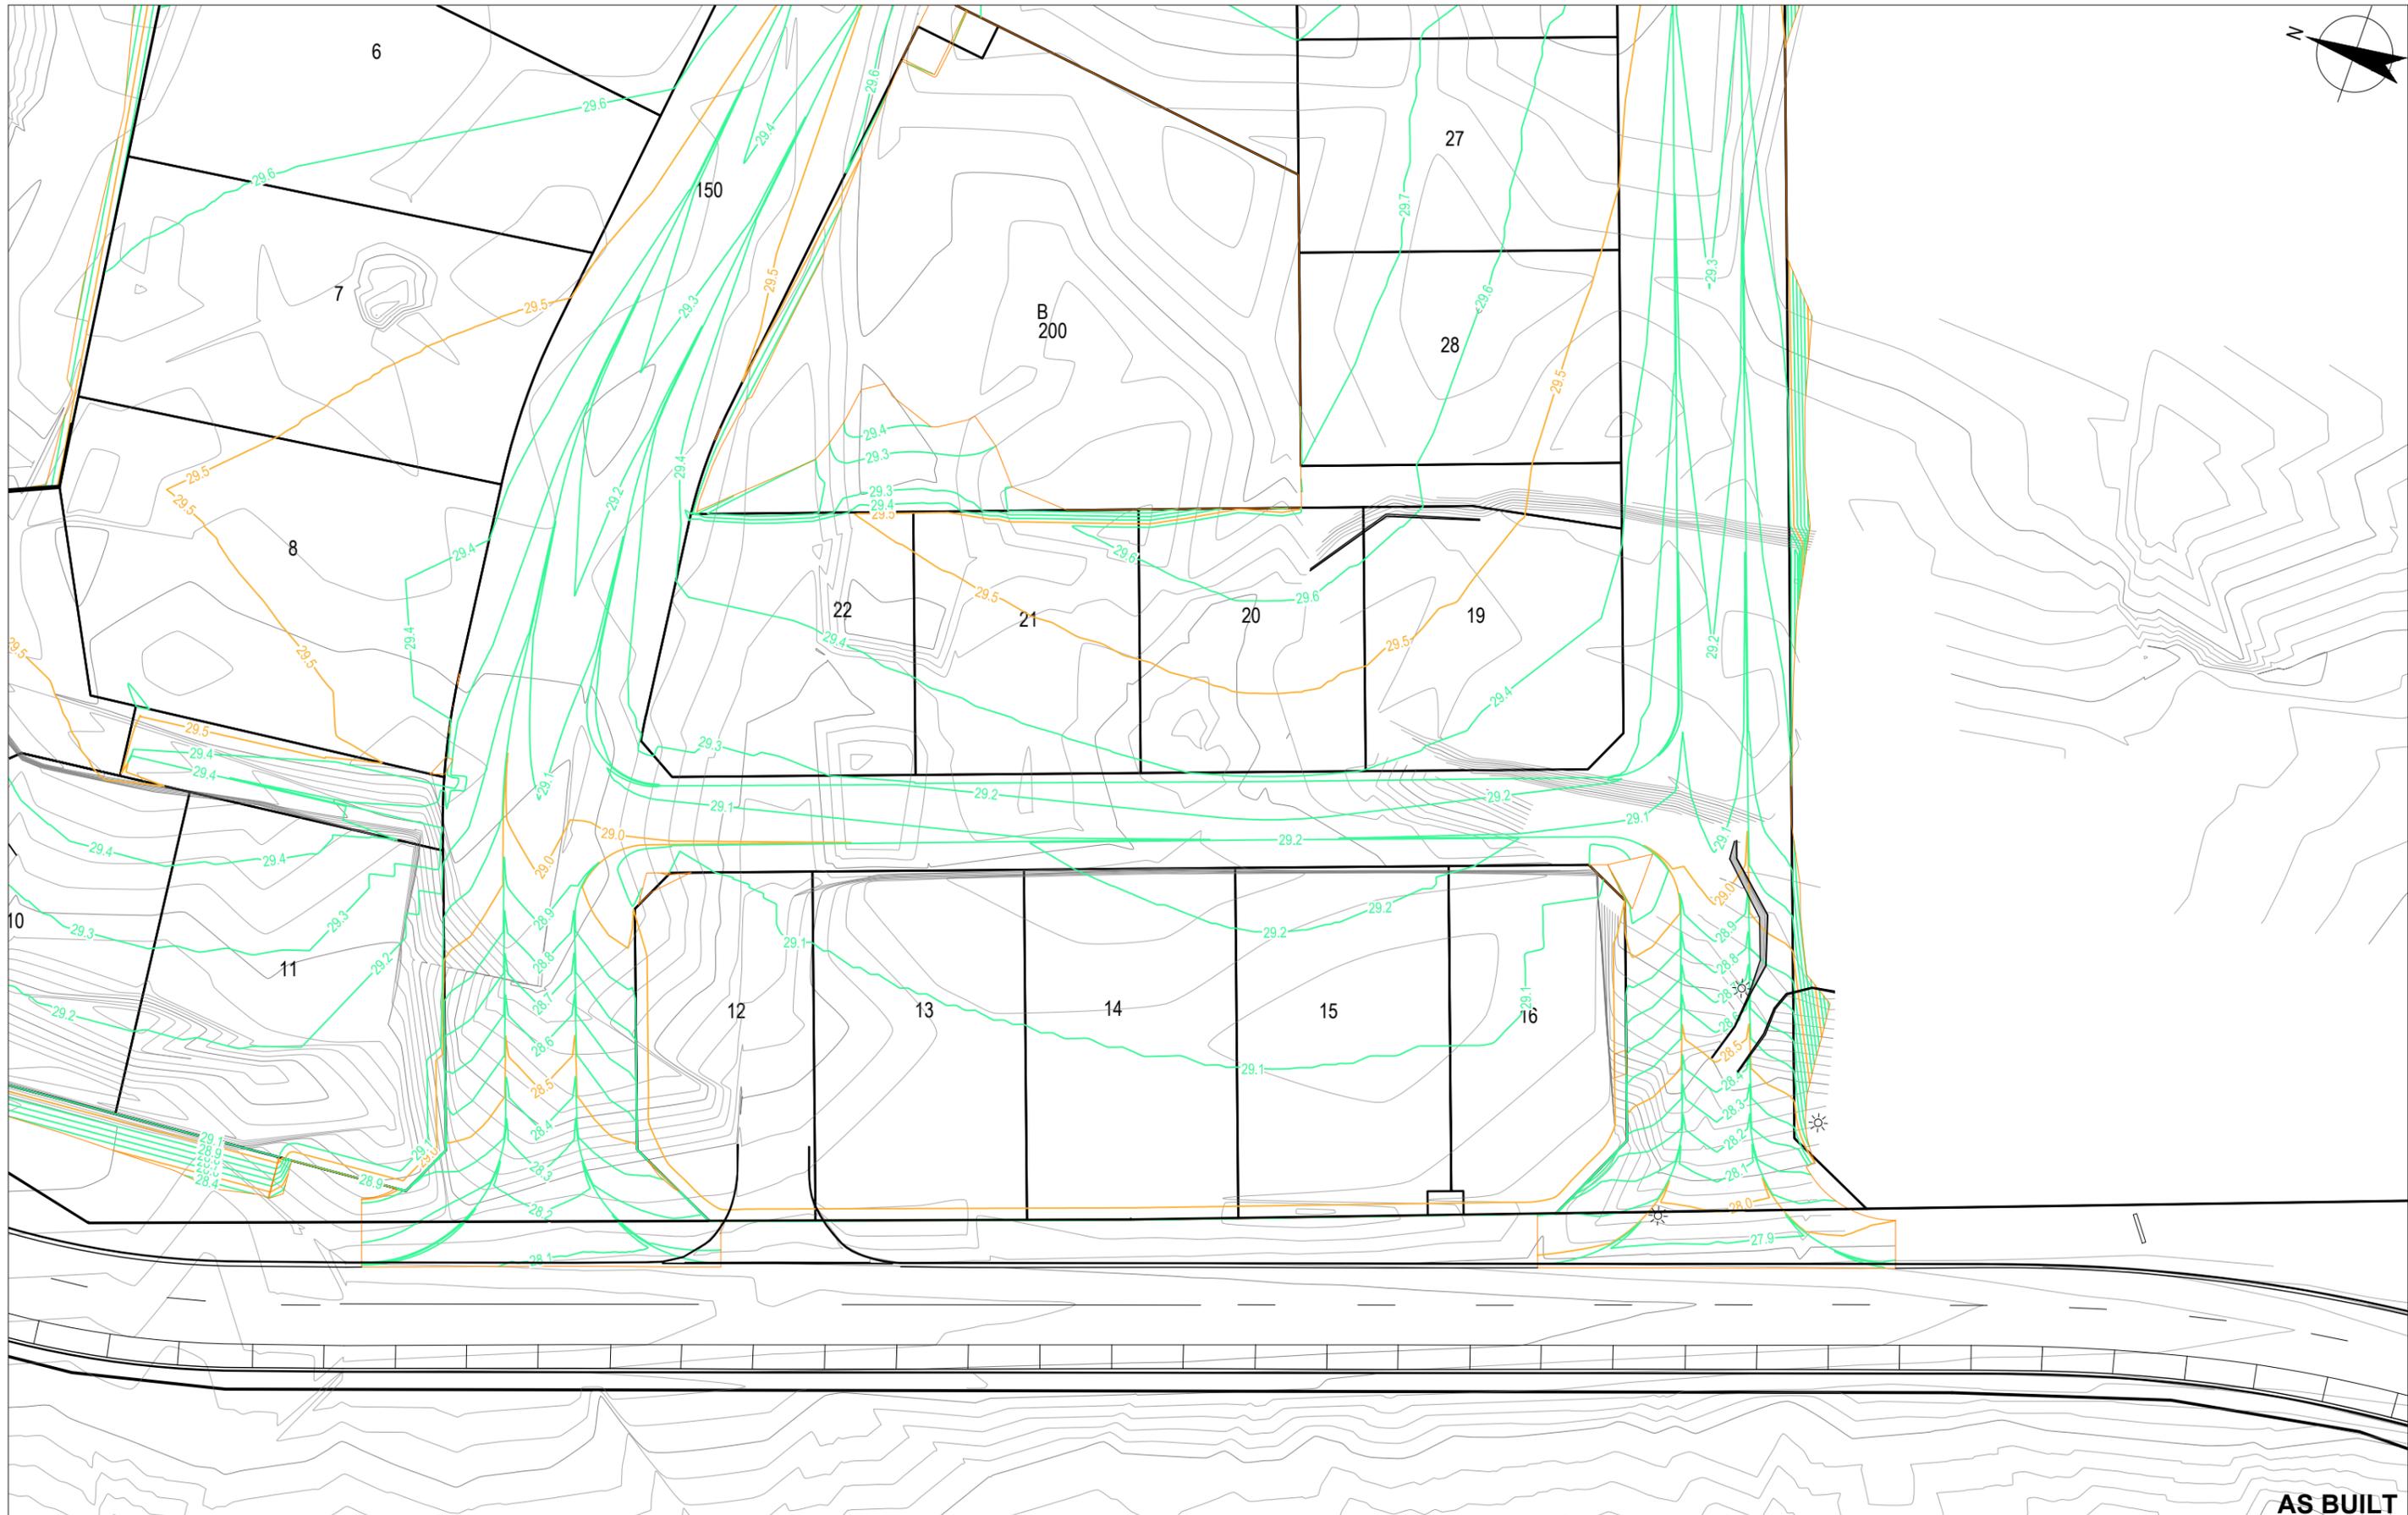
Original Size **A1**
Drawing No: **51-37652-C004**
Rev: **AB**

AS BUILT

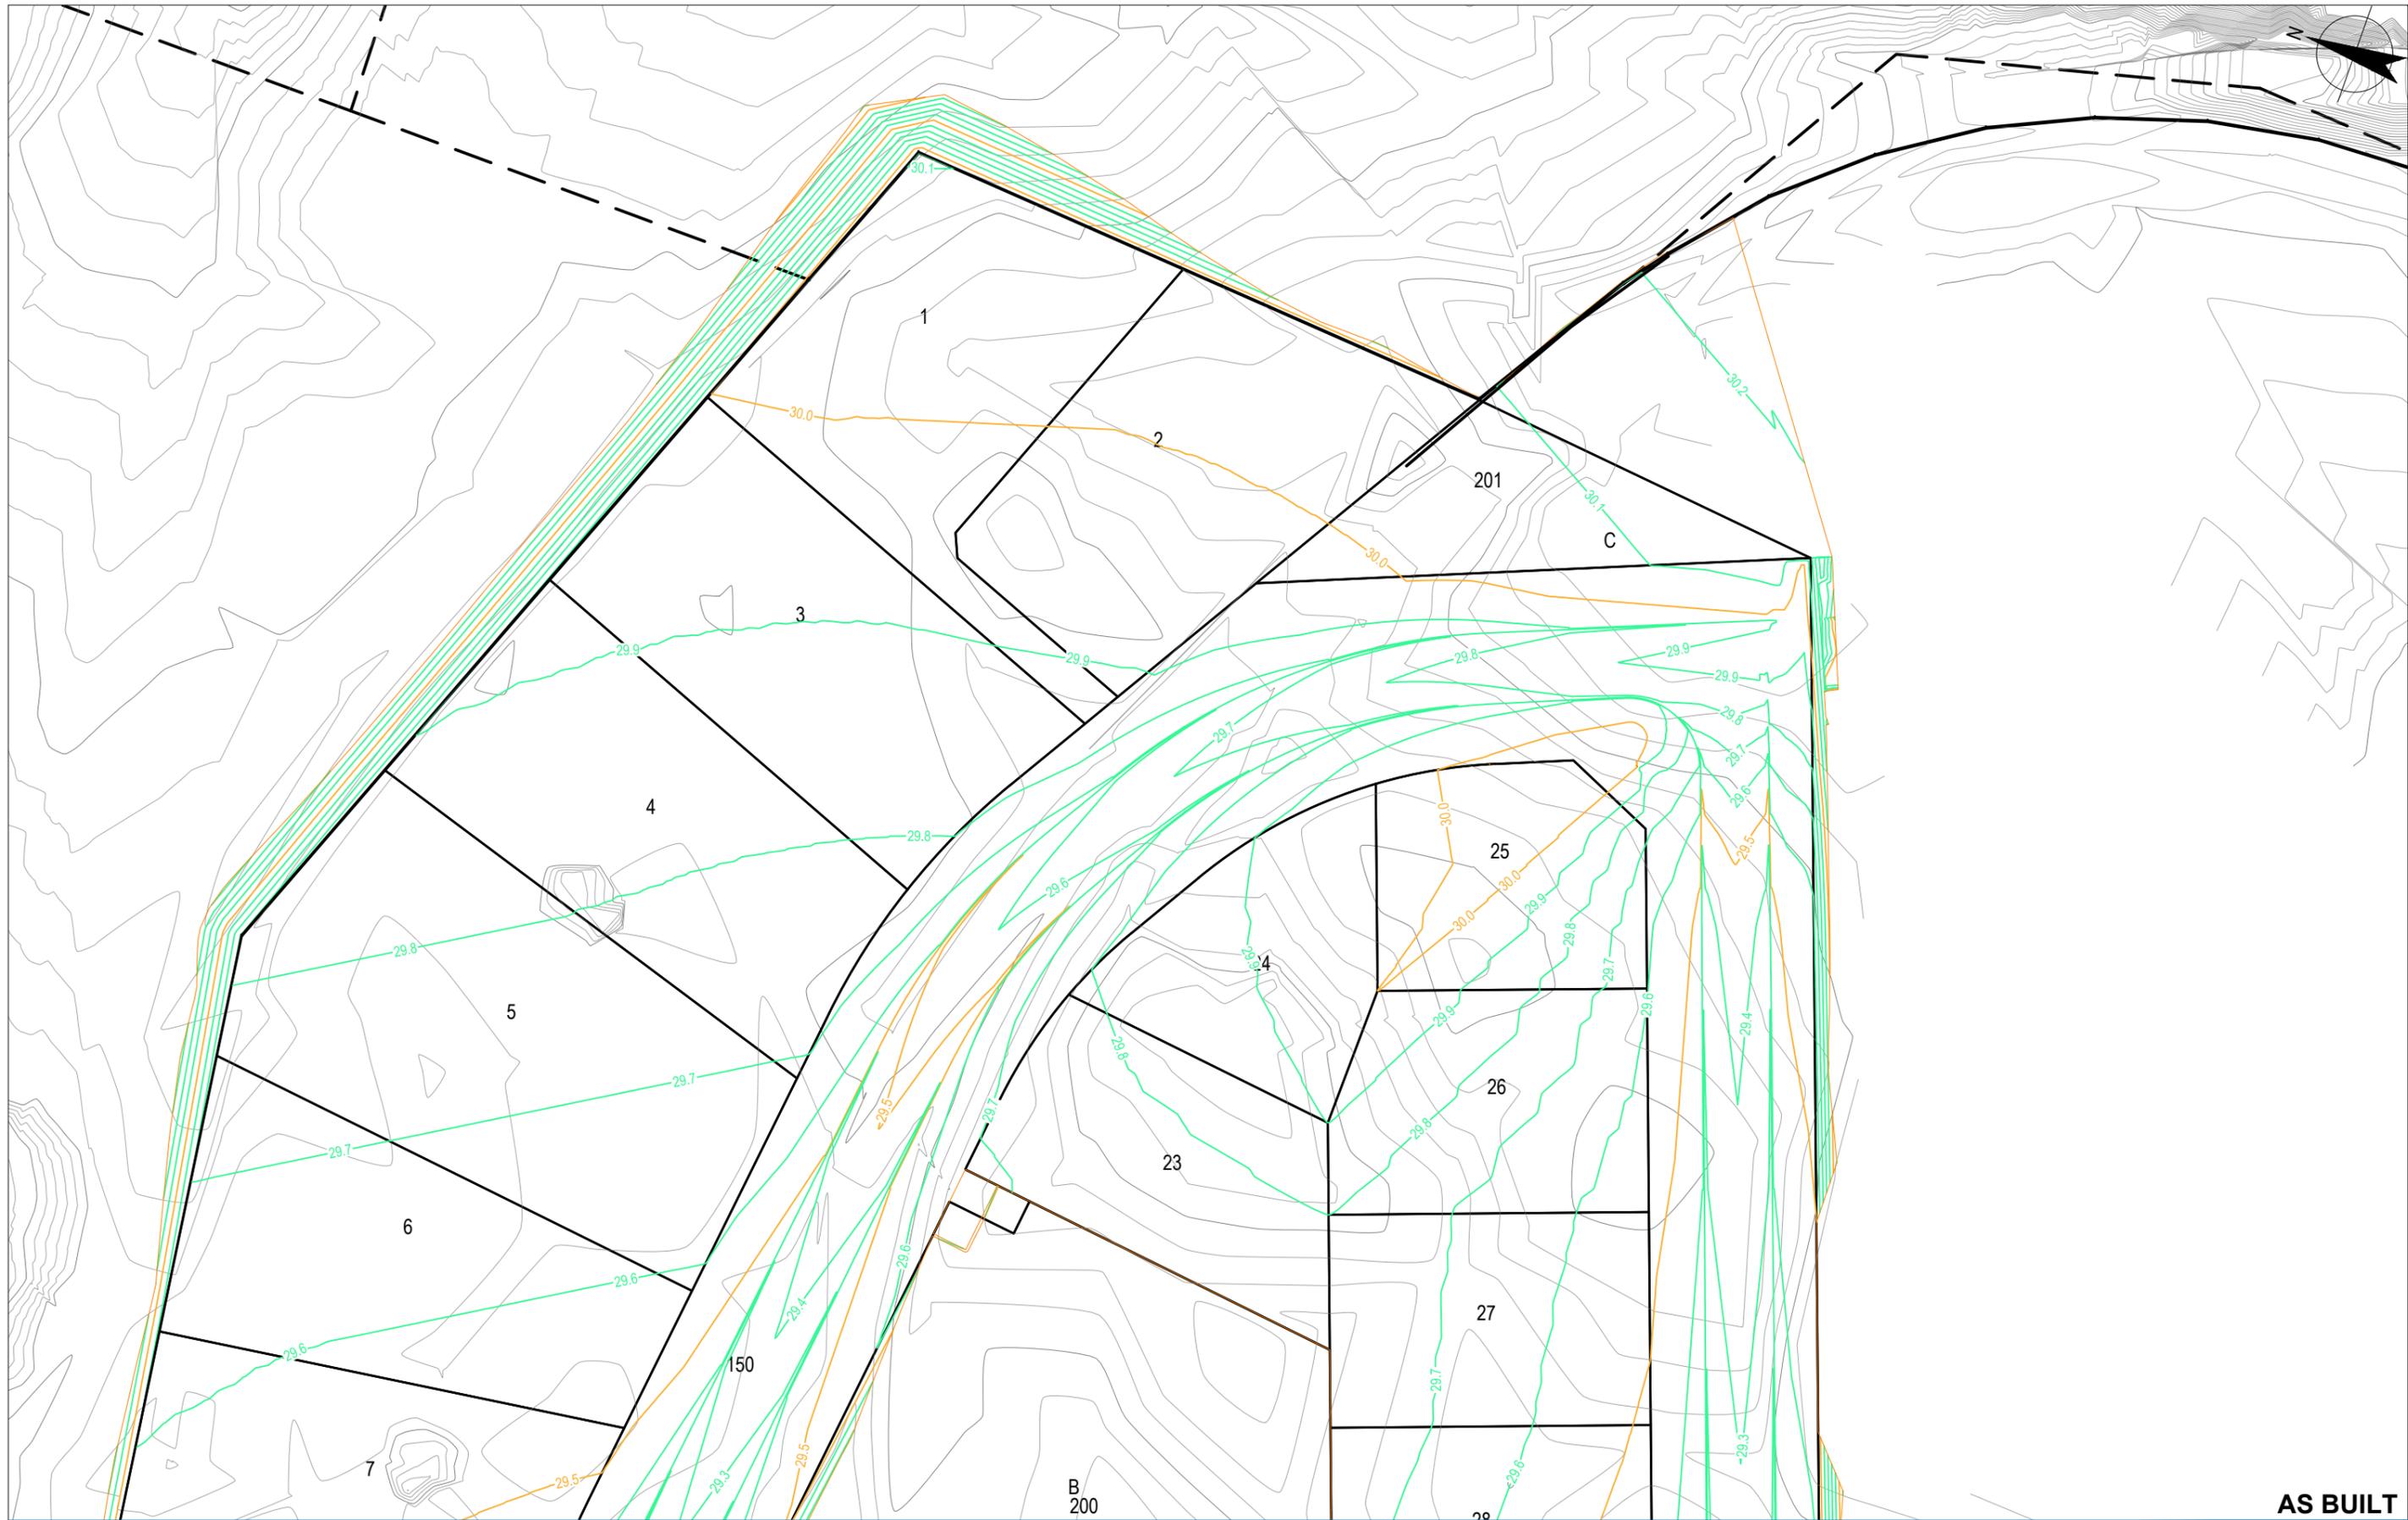
Client **WALLACE DEVELOPMENT COMPANY LTD**
Project **CENTENNIAL PARK - STAGE 1**
Title **EXISTING AND PROPOSED CONTOURS**

AS BUILT

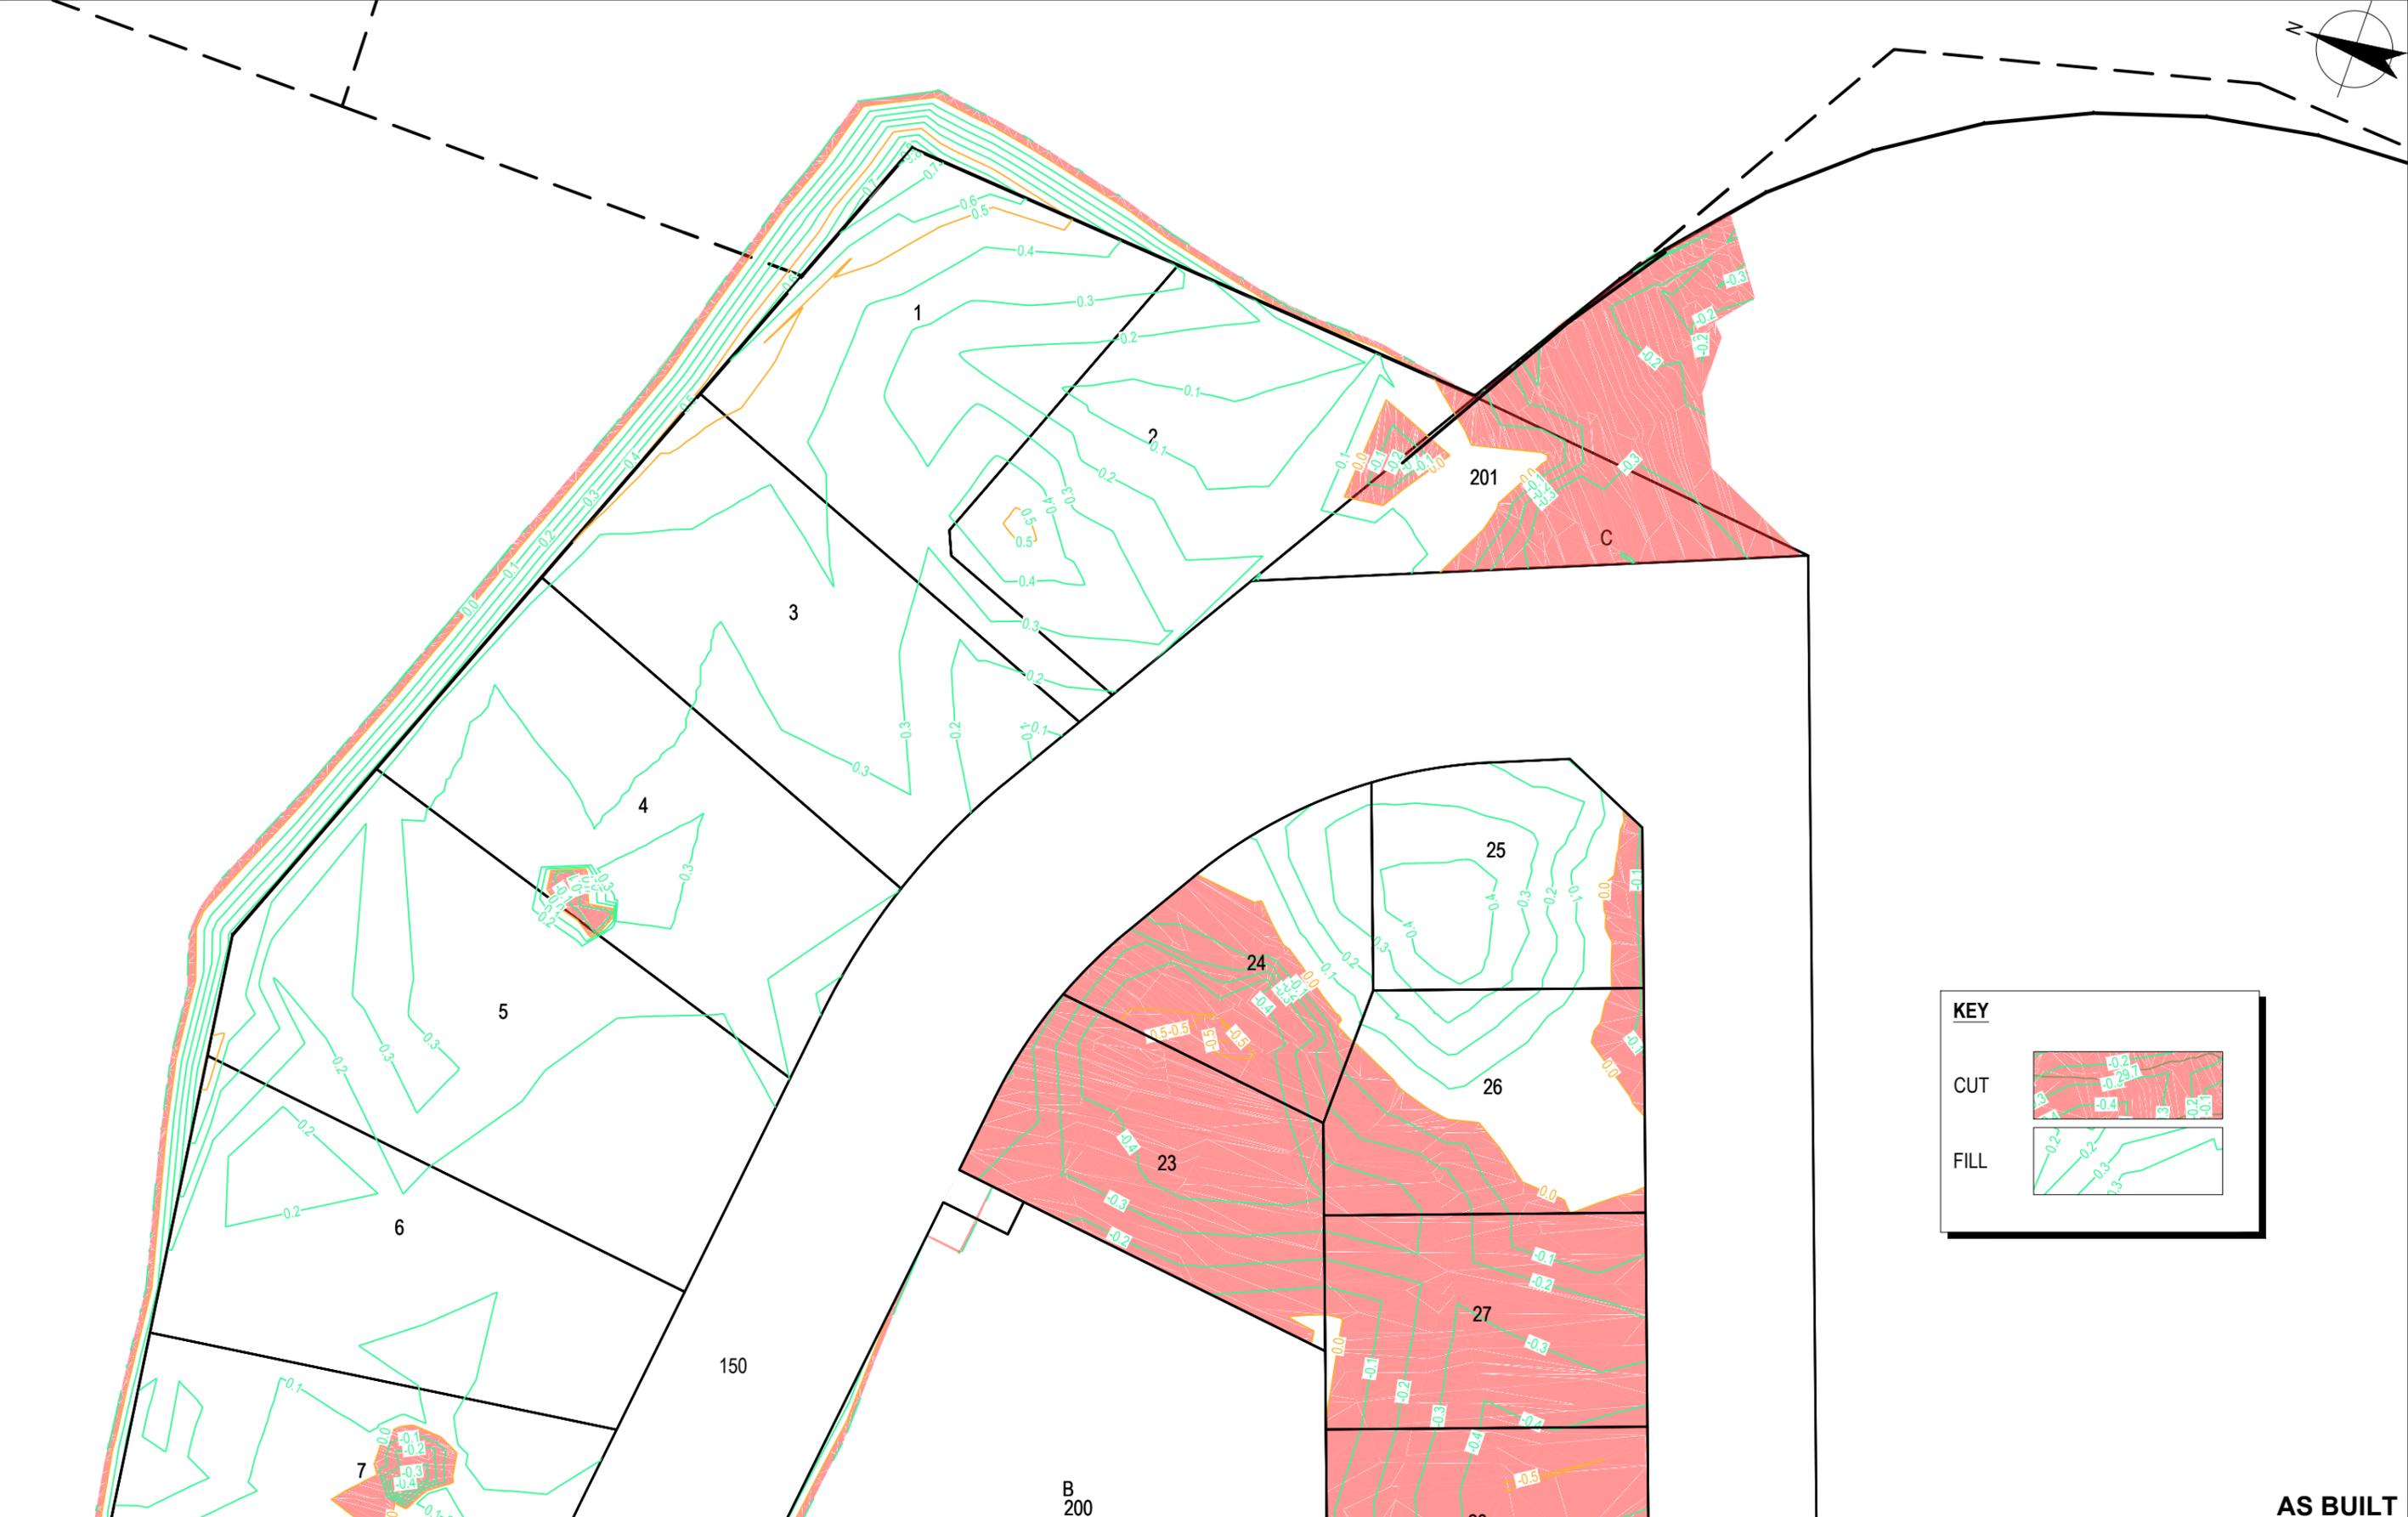
Original Size **A1**
 Drawing No: **51-37652-C007**
 Rev: **AB**

KEY

CUT

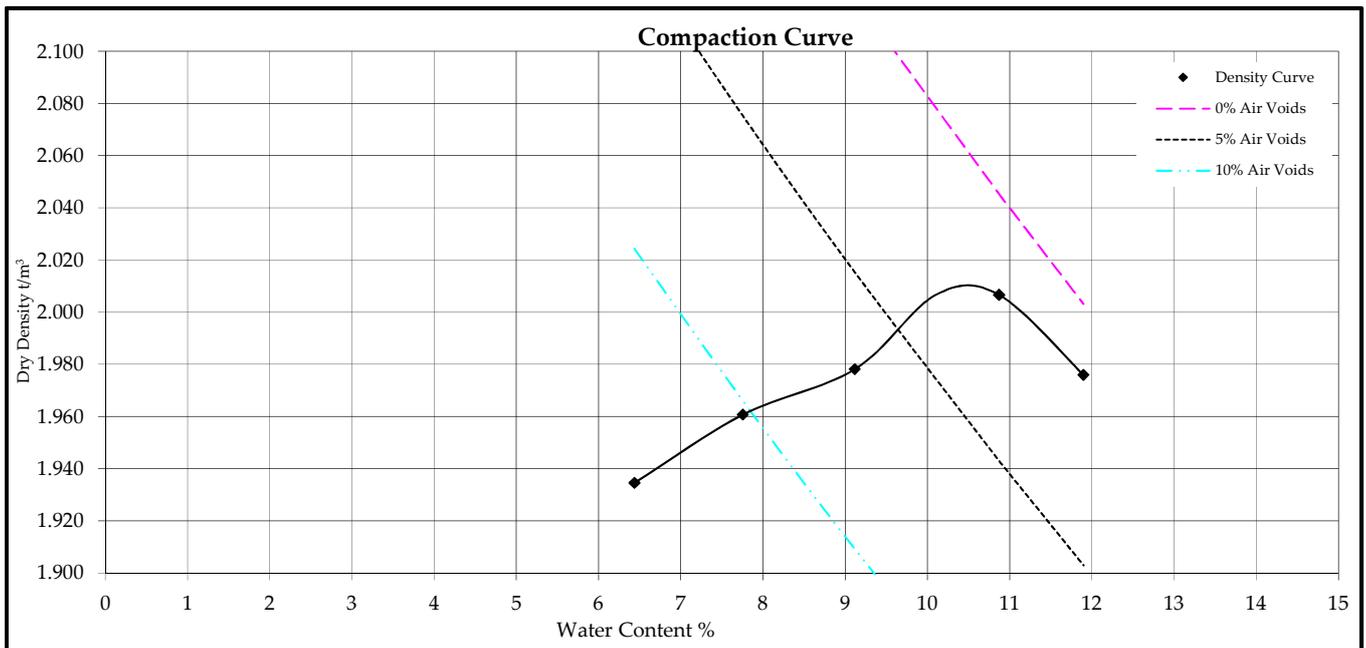
Test Results							
Maximum dry density	2.01	t/m ³	Natural water content	6.4	%		
Optimum water content	10	%	Fraction tested	Minus 19 mm			
Sample ID	Nat	1.5	3	4.5	6		
Bulk density	t/m ³	2.059	2.113	2.158	2.225	2.211	
Water content	%	6.4	7.8	9.1	10.9	11.9	
Dry density	t/m ³	1.935	1.961	1.978	2.007	1.976	
Sample condition				Spongy	Free water

Test Methods	Notes
Compaction NZS 4402 : 1986 Test 4.1.1 (Standard)

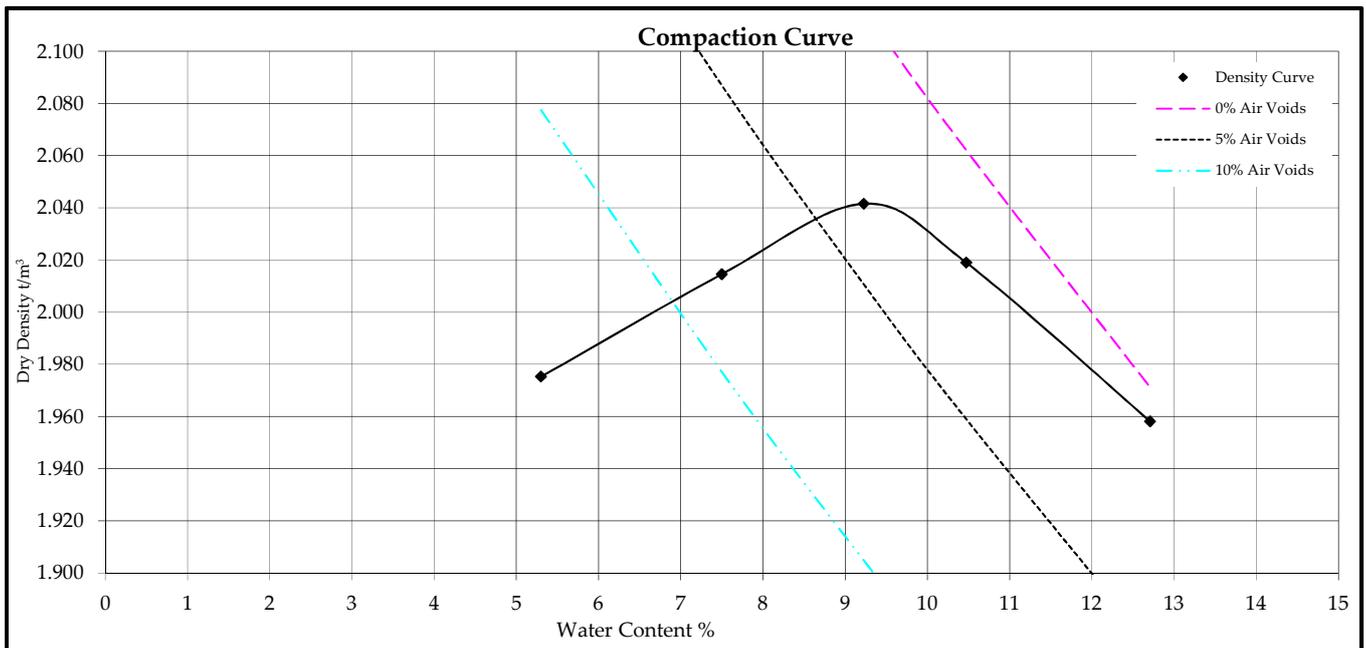
Test Results							
Maximum dry density	2.04	t/m ³	Natural water content	12.7	%		
Optimum water content	9.0	%	Fraction tested	Minus 19 mm			
Sample ID	-6	-4.5	-3	-1.5	Nat		
Bulk density	t/m ³	2.080	2.166	2.230	2.230	2.207	
Water content	%	5.3	7.5	9.2	10.5	12.7	
Dry density	t/m ³	1.975	2.015	2.042	2.019	1.958	
Sample condition				Soft	Spongy

Test Methods	Notes
Compaction NZS 4402 : 1986 Test 4.1.1 (Standard)

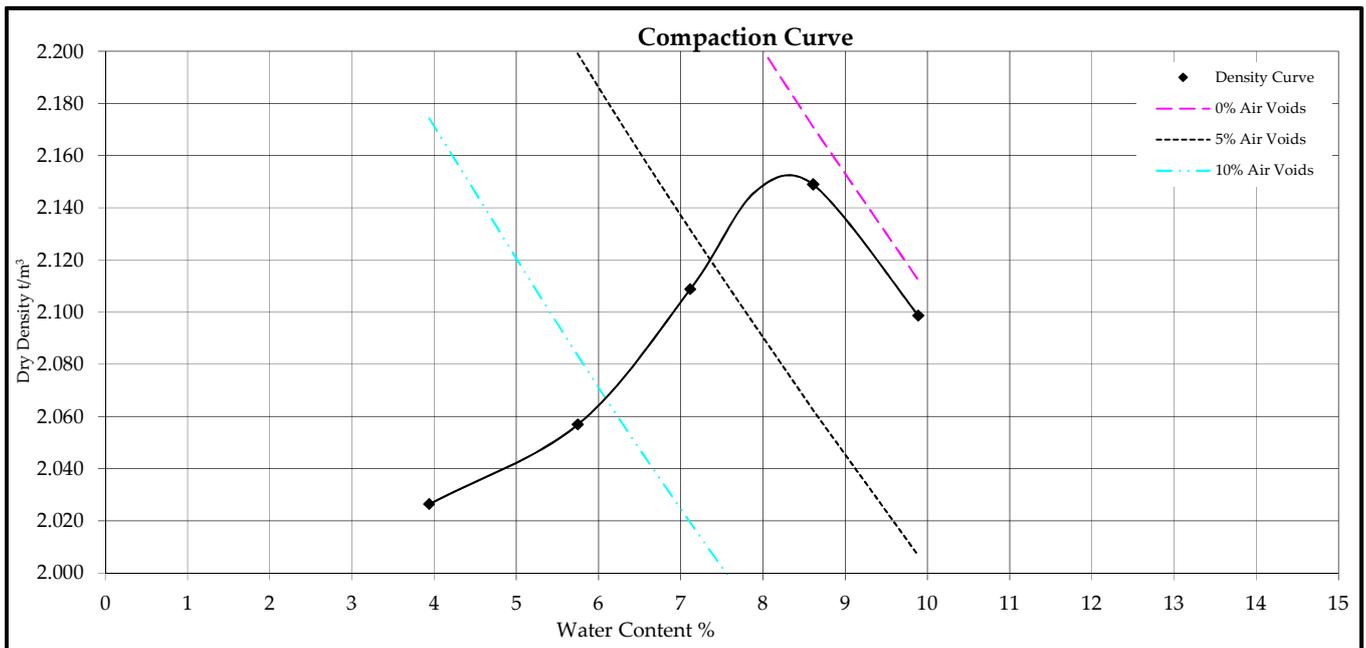
Test Results							
Maximum dry density	2.15	t/m ³	Natural water content		8.6	%	
Optimum water content	8.5	%	Fraction tested		Minus 19 mm		
Sample ID	-4.5	-3	-1.5	Nat	1.5		
Bulk density t/m ³	2.106	2.175	2.259	2.334	2.306		
Water content %	3.9	5.7	7.1	8.6	9.9		
Dry density t/m ³	2.026	2.057	2.109	2.149	2.099		
Sample condition					Spongy

Test Methods	Notes
Compaction NZS 4402 : 1986 Test 4.1.1 (Standard)

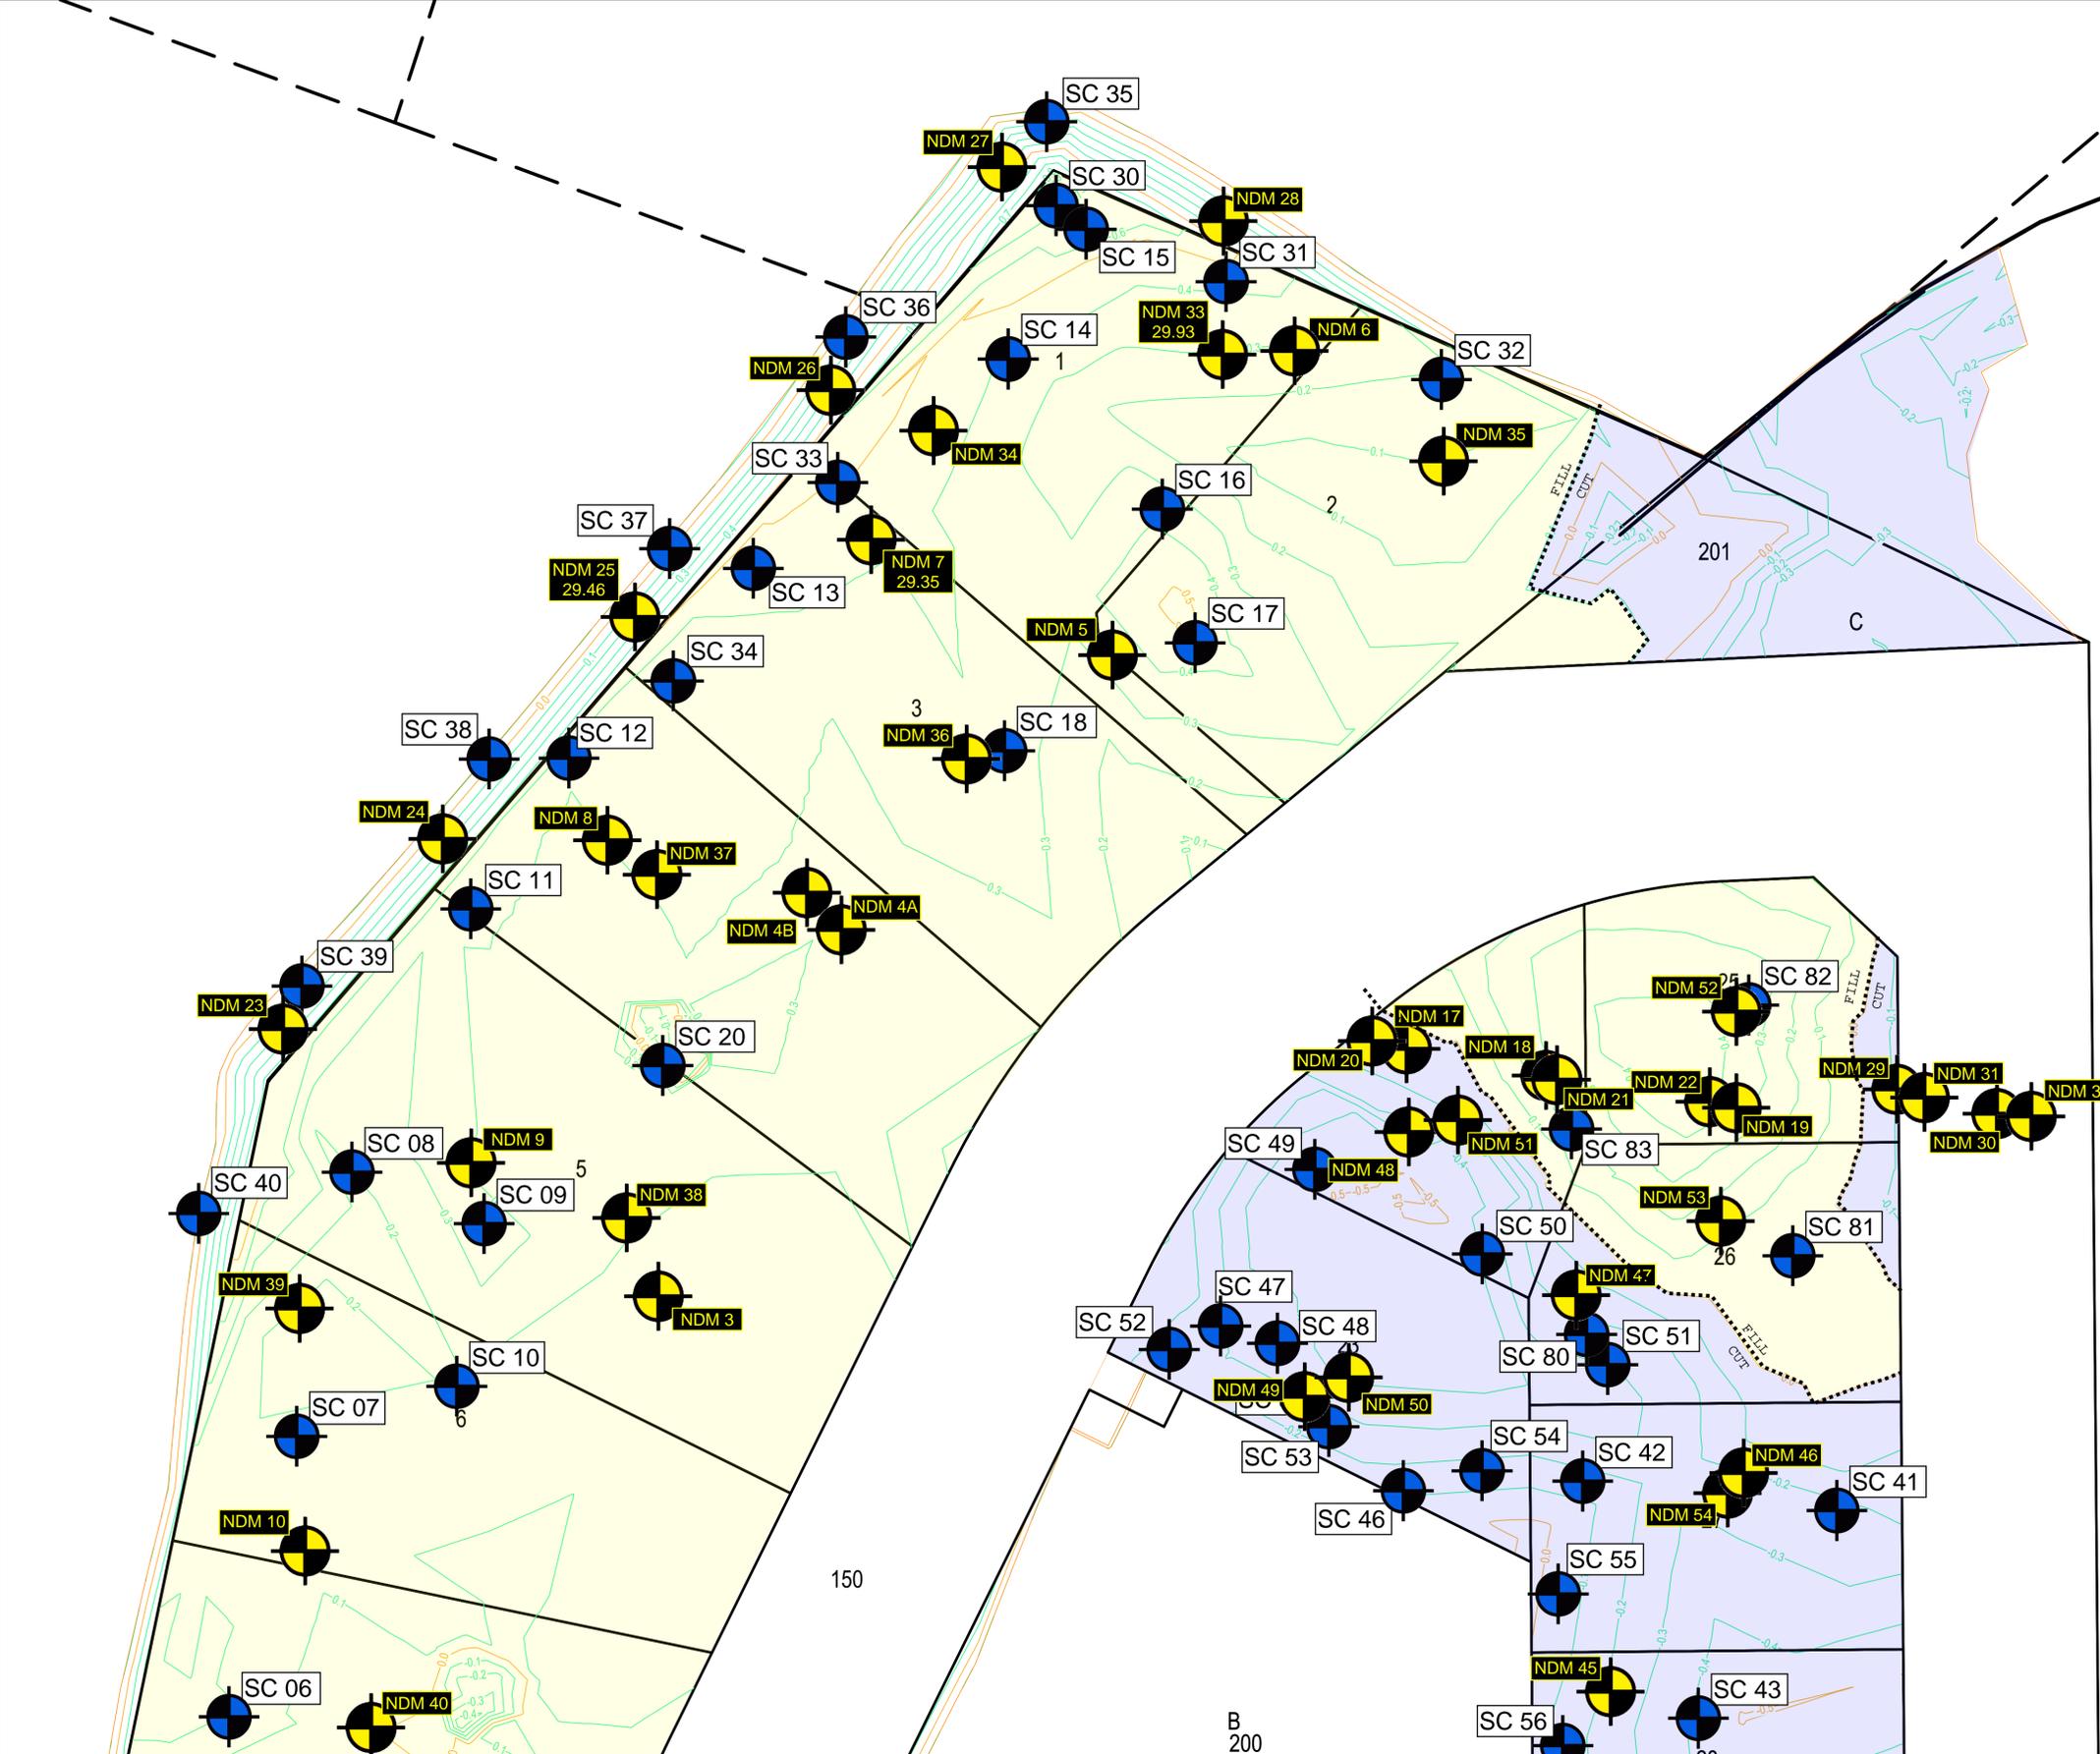
Original Size **A1**
Drawing No: **51-37652-C008**
Rev: **AB**

AS BUILT
