**Centennial Park Earthworks
Geotechnical Completion
Report**

Stage 1 Lots 1 to 16 and 19 to 28

Prepared for
Wallace Development Company Ltd.

Prepared by
Tonkin & Taylor Ltd

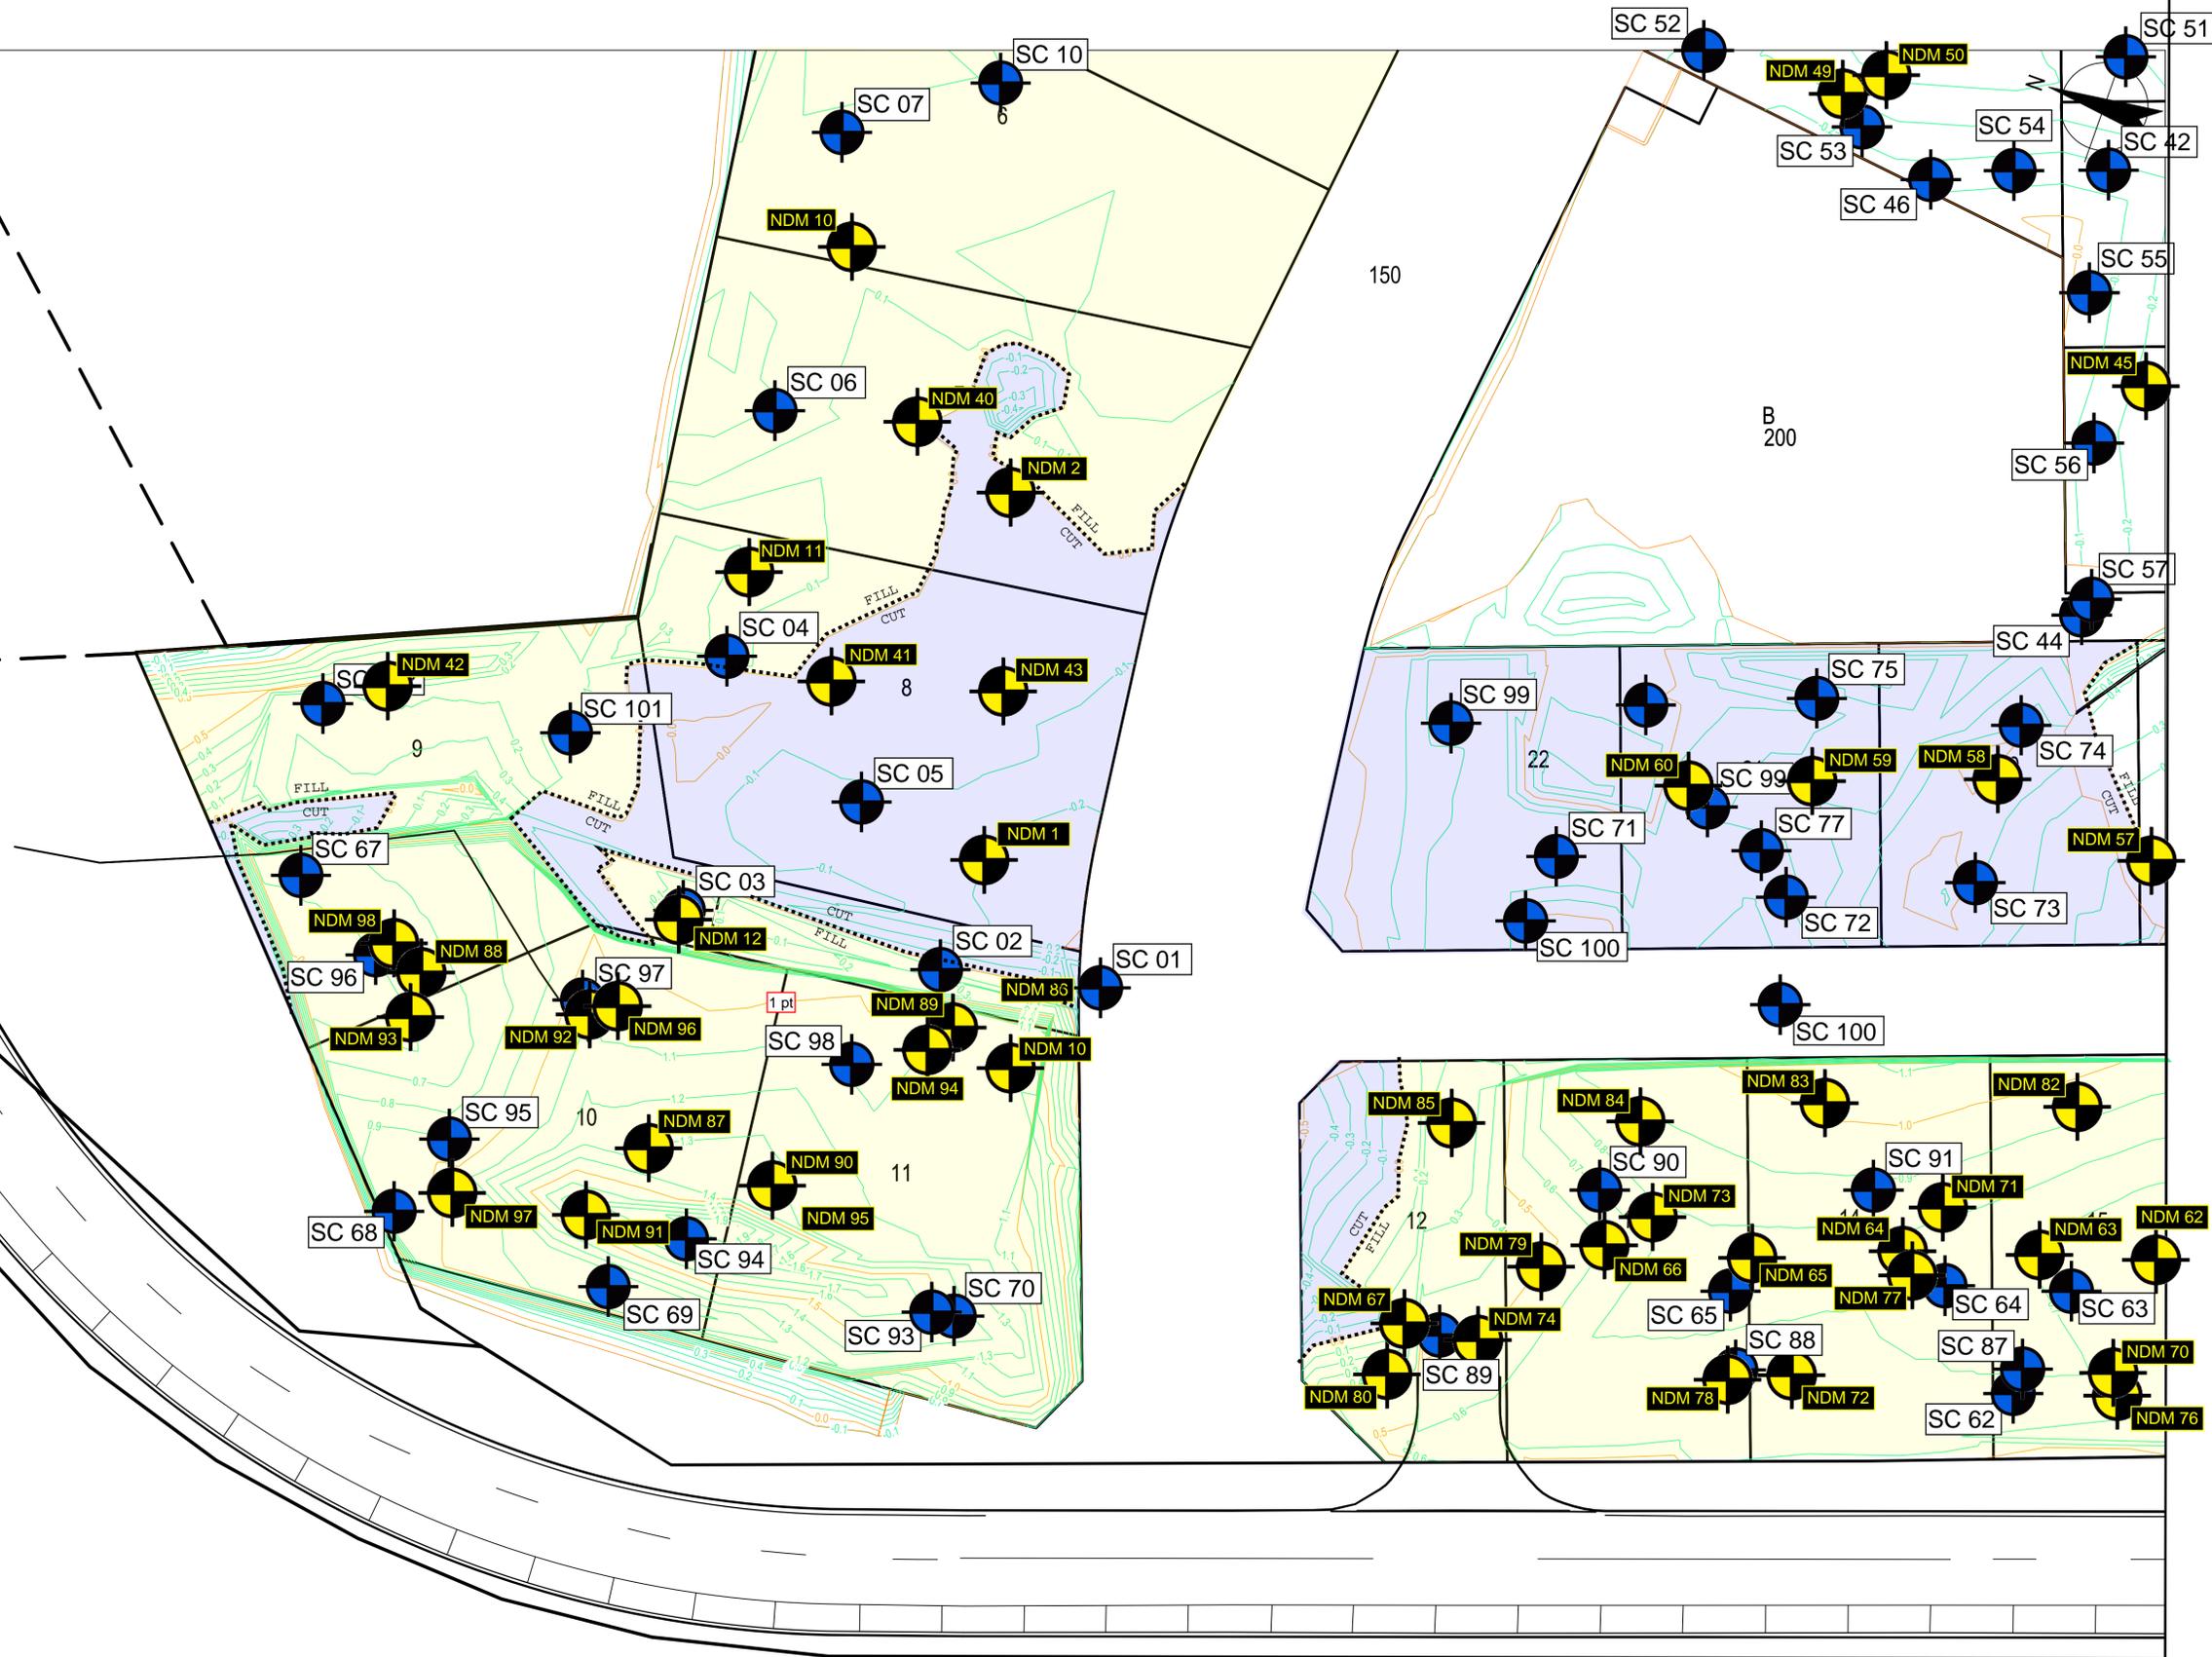
As-Built Markups
 Test Location Plan
 Sheet 3 of 3

- Cut Areas
- Fill Areas
- SC 51: Approximate location of Scala test performed by T+T
- NDM 52: Approximate location of NDM test performed by Resonant
- Approximate Location of the CUT/FILL boundary refer to GHD base drawings for information

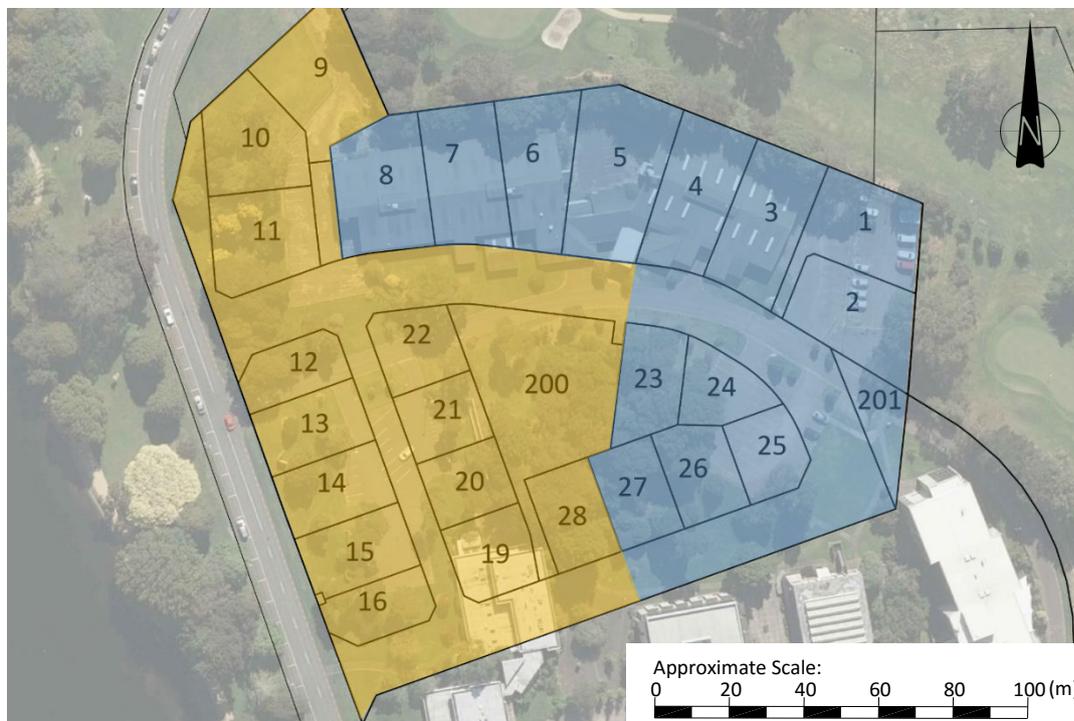
Figure 1.1: Layout of Centennial Park Stage 1 subdivision. Two portions of Stage 1 have been defined for the purposes of this letter: Stage 1-West shaded yellow, and Stage 1-East shaded blue. Subdivision layout is as per the GHD Drawings 51-37652 Sheets -C003 to -C008 dated 26 June 2020.

3.1.2	Earthworks – fill	5
3.1.3	Variable ground conditions	5
3.1.4	Stormwater control	6
3.2	Specific building development requirements for each lot	6
3.2.1	Stage 1-West (Yellow area in Figure 1.1)	6

3.2.2	Stage 1-East (Blue area in Figure 1.1)	6
4	Applicability	9
Appendix A :	Asbuilt drawings provided by GHD	
Appendix B :	Specification – geotechnical section	
Appendix C :	Compaction control testing provided by Resonant	
Appendix D :	Dynamic cone (scala) penetrometer test results	
Appendix E :	Minimum lot requirements	
Appendix F :	Statement of Suitability of Earth Fill for Residential Development (NZS 4431:1989)	
Appendix G :	Geotechnical considerations for specific engineering design

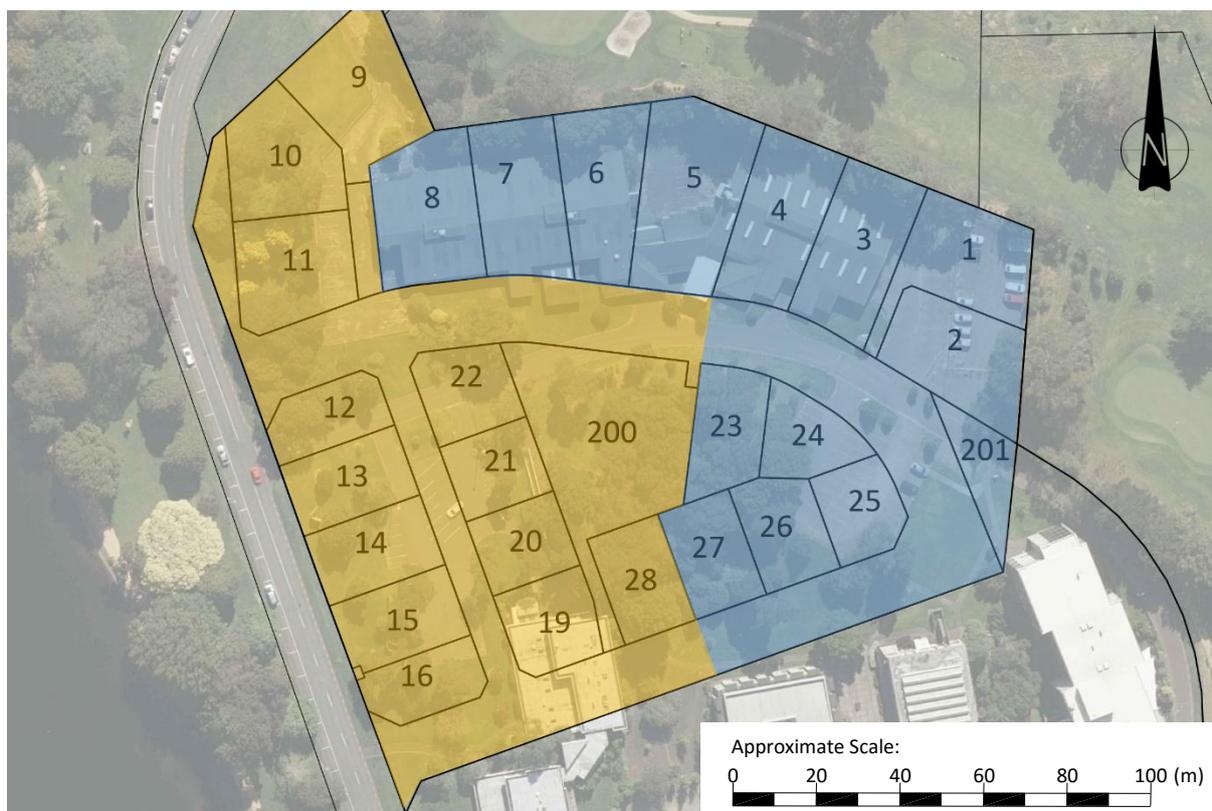
Figure 1.1: Layout of Centennial Park Stage 1 subdivision. Two portions of Stage 1 have been defined for the purposes of this letter: Stage 1-West shaded yellow, and Stage 1-East shaded blue. Subdivision layout is as per the GHD Drawings 51-37652 Sheets -C003 to -C008 dated 26 June 2020.
