Centennial Park, Palmerston North

Geotechnical Investigation and Liquefaction Assessment

Prepared for
Wallace Development Company Ltd

Prepared by
Tonkin & Taylor Ltd

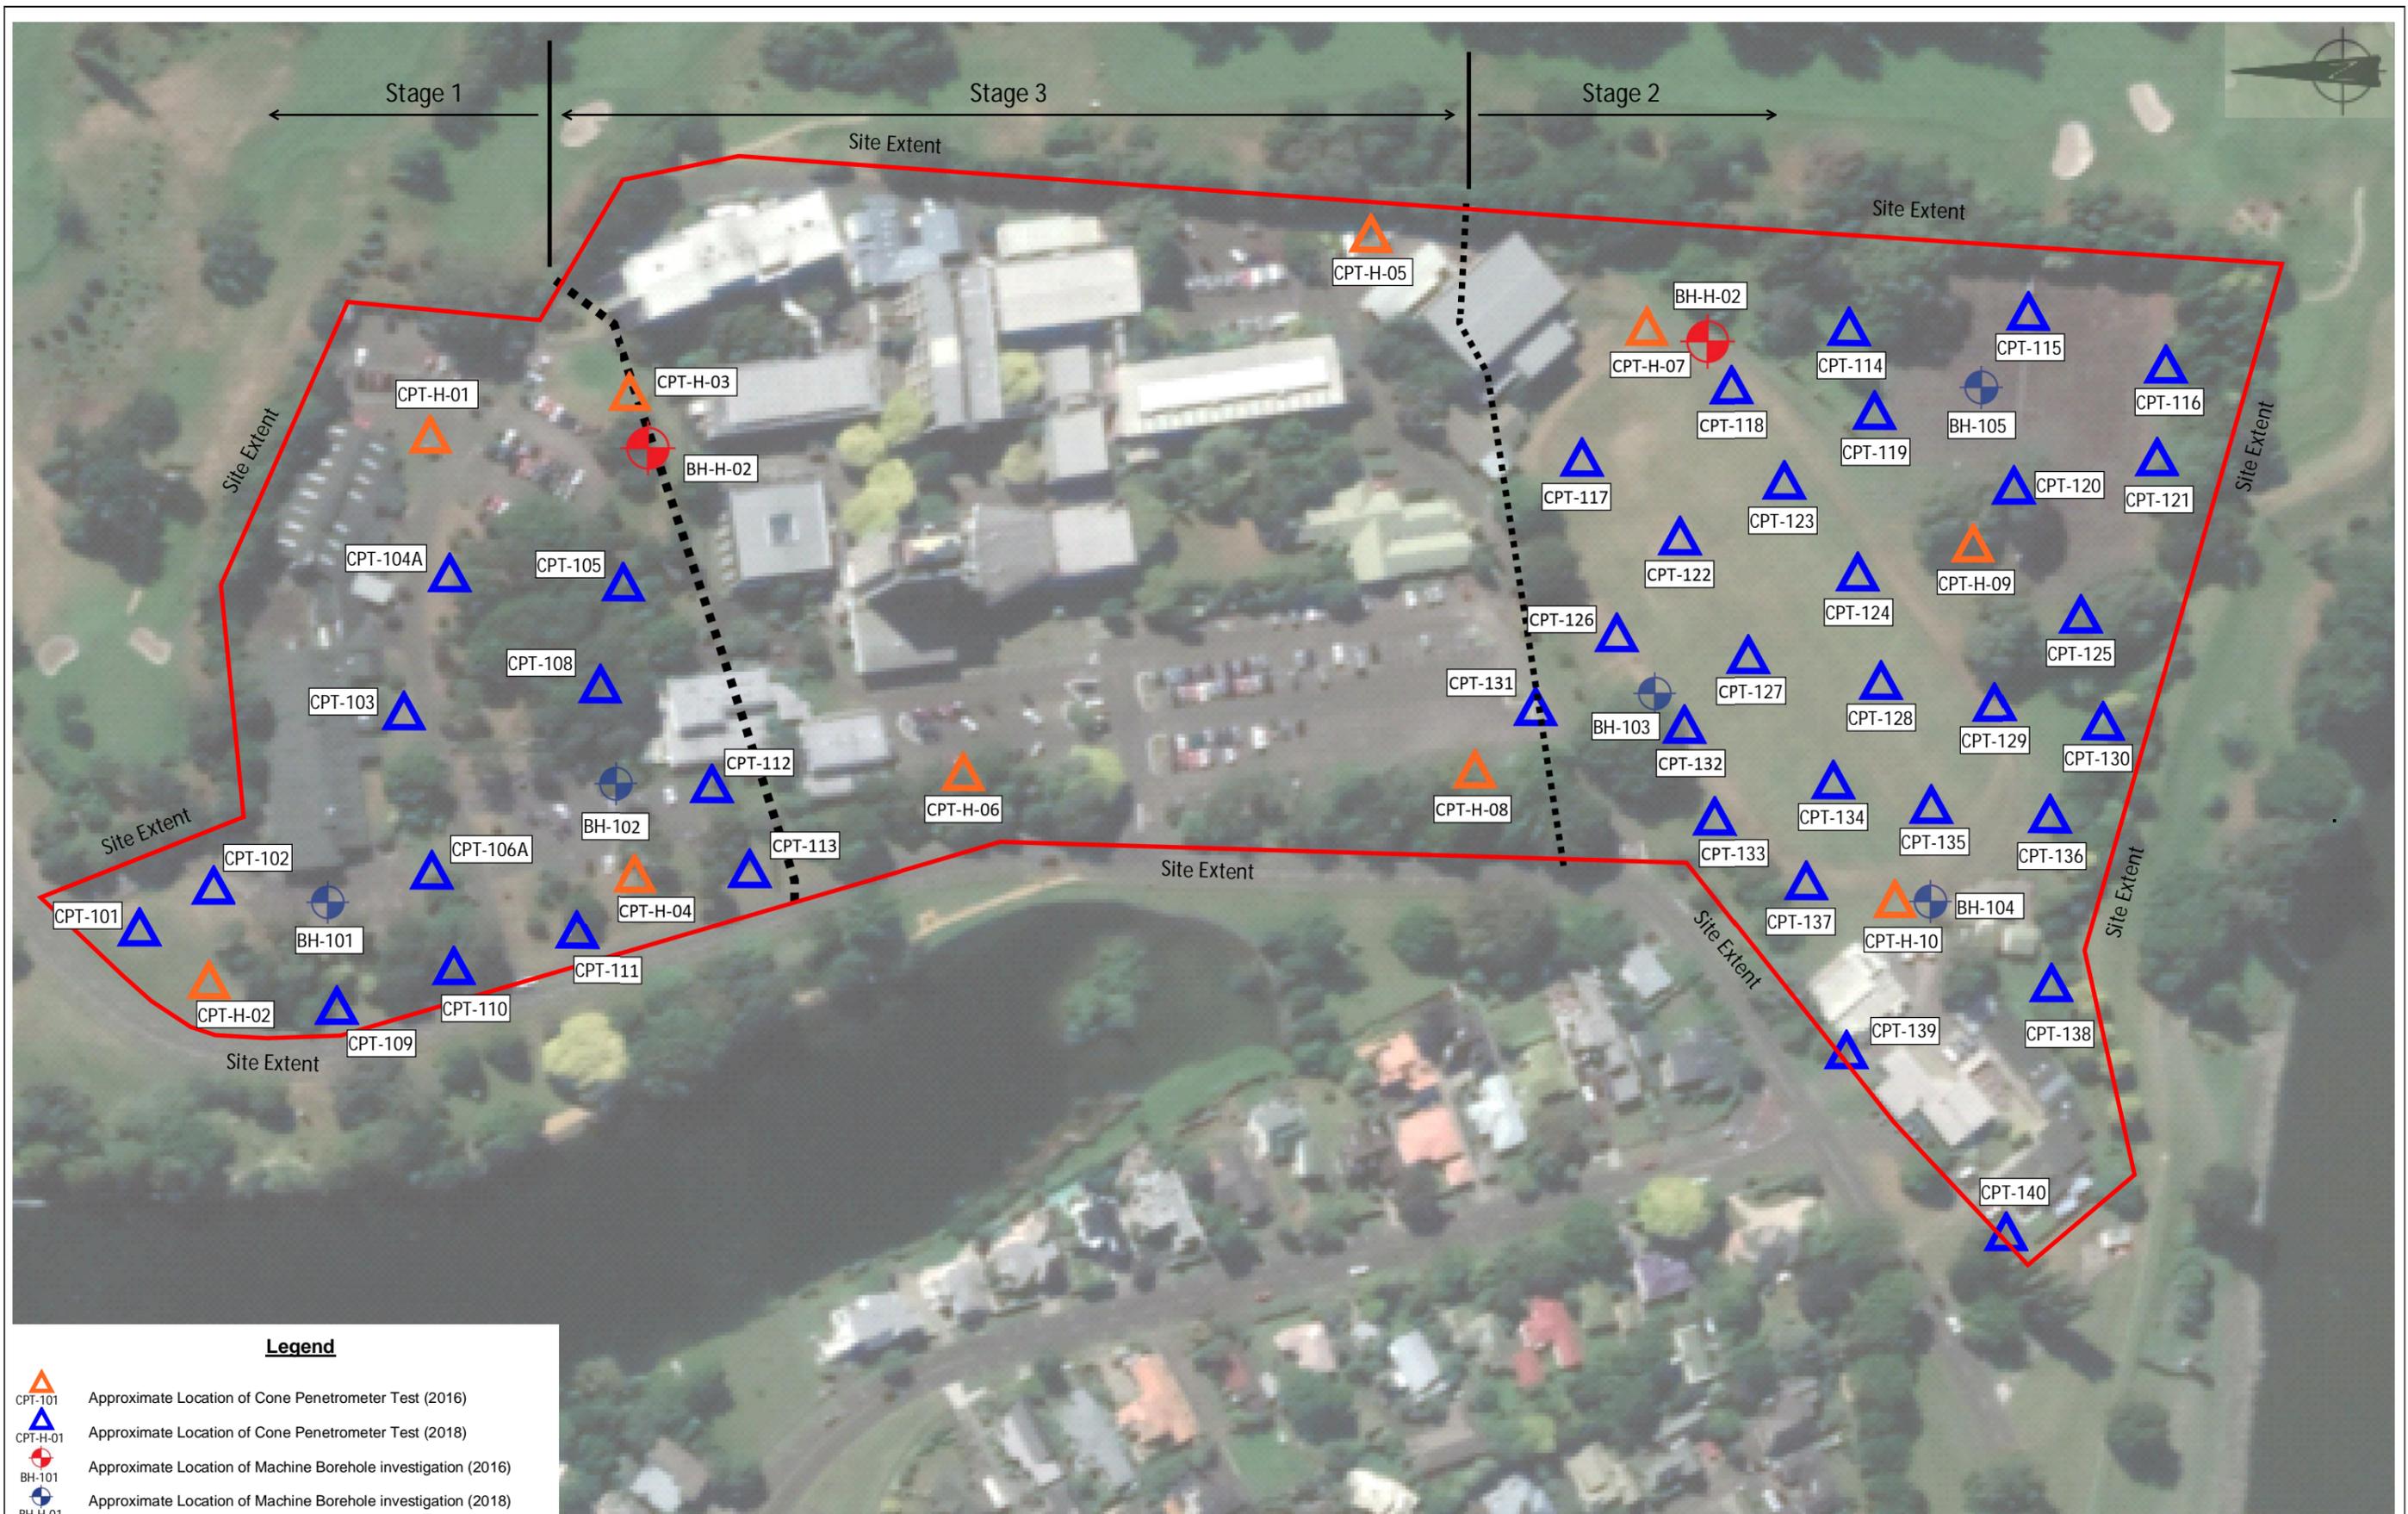
DRAWN	AGDS	10/18
DRAFTING CHECKED	CVS	10/18
APPROVED	MES	10/18
CADFILE : \\85442.0040-LQ-F3.dwg		
SCALES (AT A3 SIZE)		
1:2000		
PROJECT No.	1004625.001	FIG. No. Figure 1

WALLACE DEVELOPMENT GROUP
CENTENNIAL PARK
Hokowhitu Campus, Palmerston North
Geotechnical Site Investigation Plan

The locations of the investigations are presented on Figure 2 in Appendix A, with a typical spacing between investigation locations of approximately 30 – 50m. A detailed summary of the site investigation is provided in Appendix B. The liquefaction assessment presented in this report has been undertaken at detail Level C (detailed area wide assessment) as defined in MBIE/MfE guidance ¹, with the intended purpose of supporting resource consent for subdivision. However, the area-wide site investigation layout has been designed with the intention to provide sufficient deep ground investigation information to support Level D (site specific assessment) for individual sites in future (e.g. to support specific engineering design for Building Consent) without the need for additional site-specific deep investigations in most cases.

The CPT locations are presented on Figure 1 in Appendix A. A summary of the CPT locations and termination depths is presented in Table B.1 below.

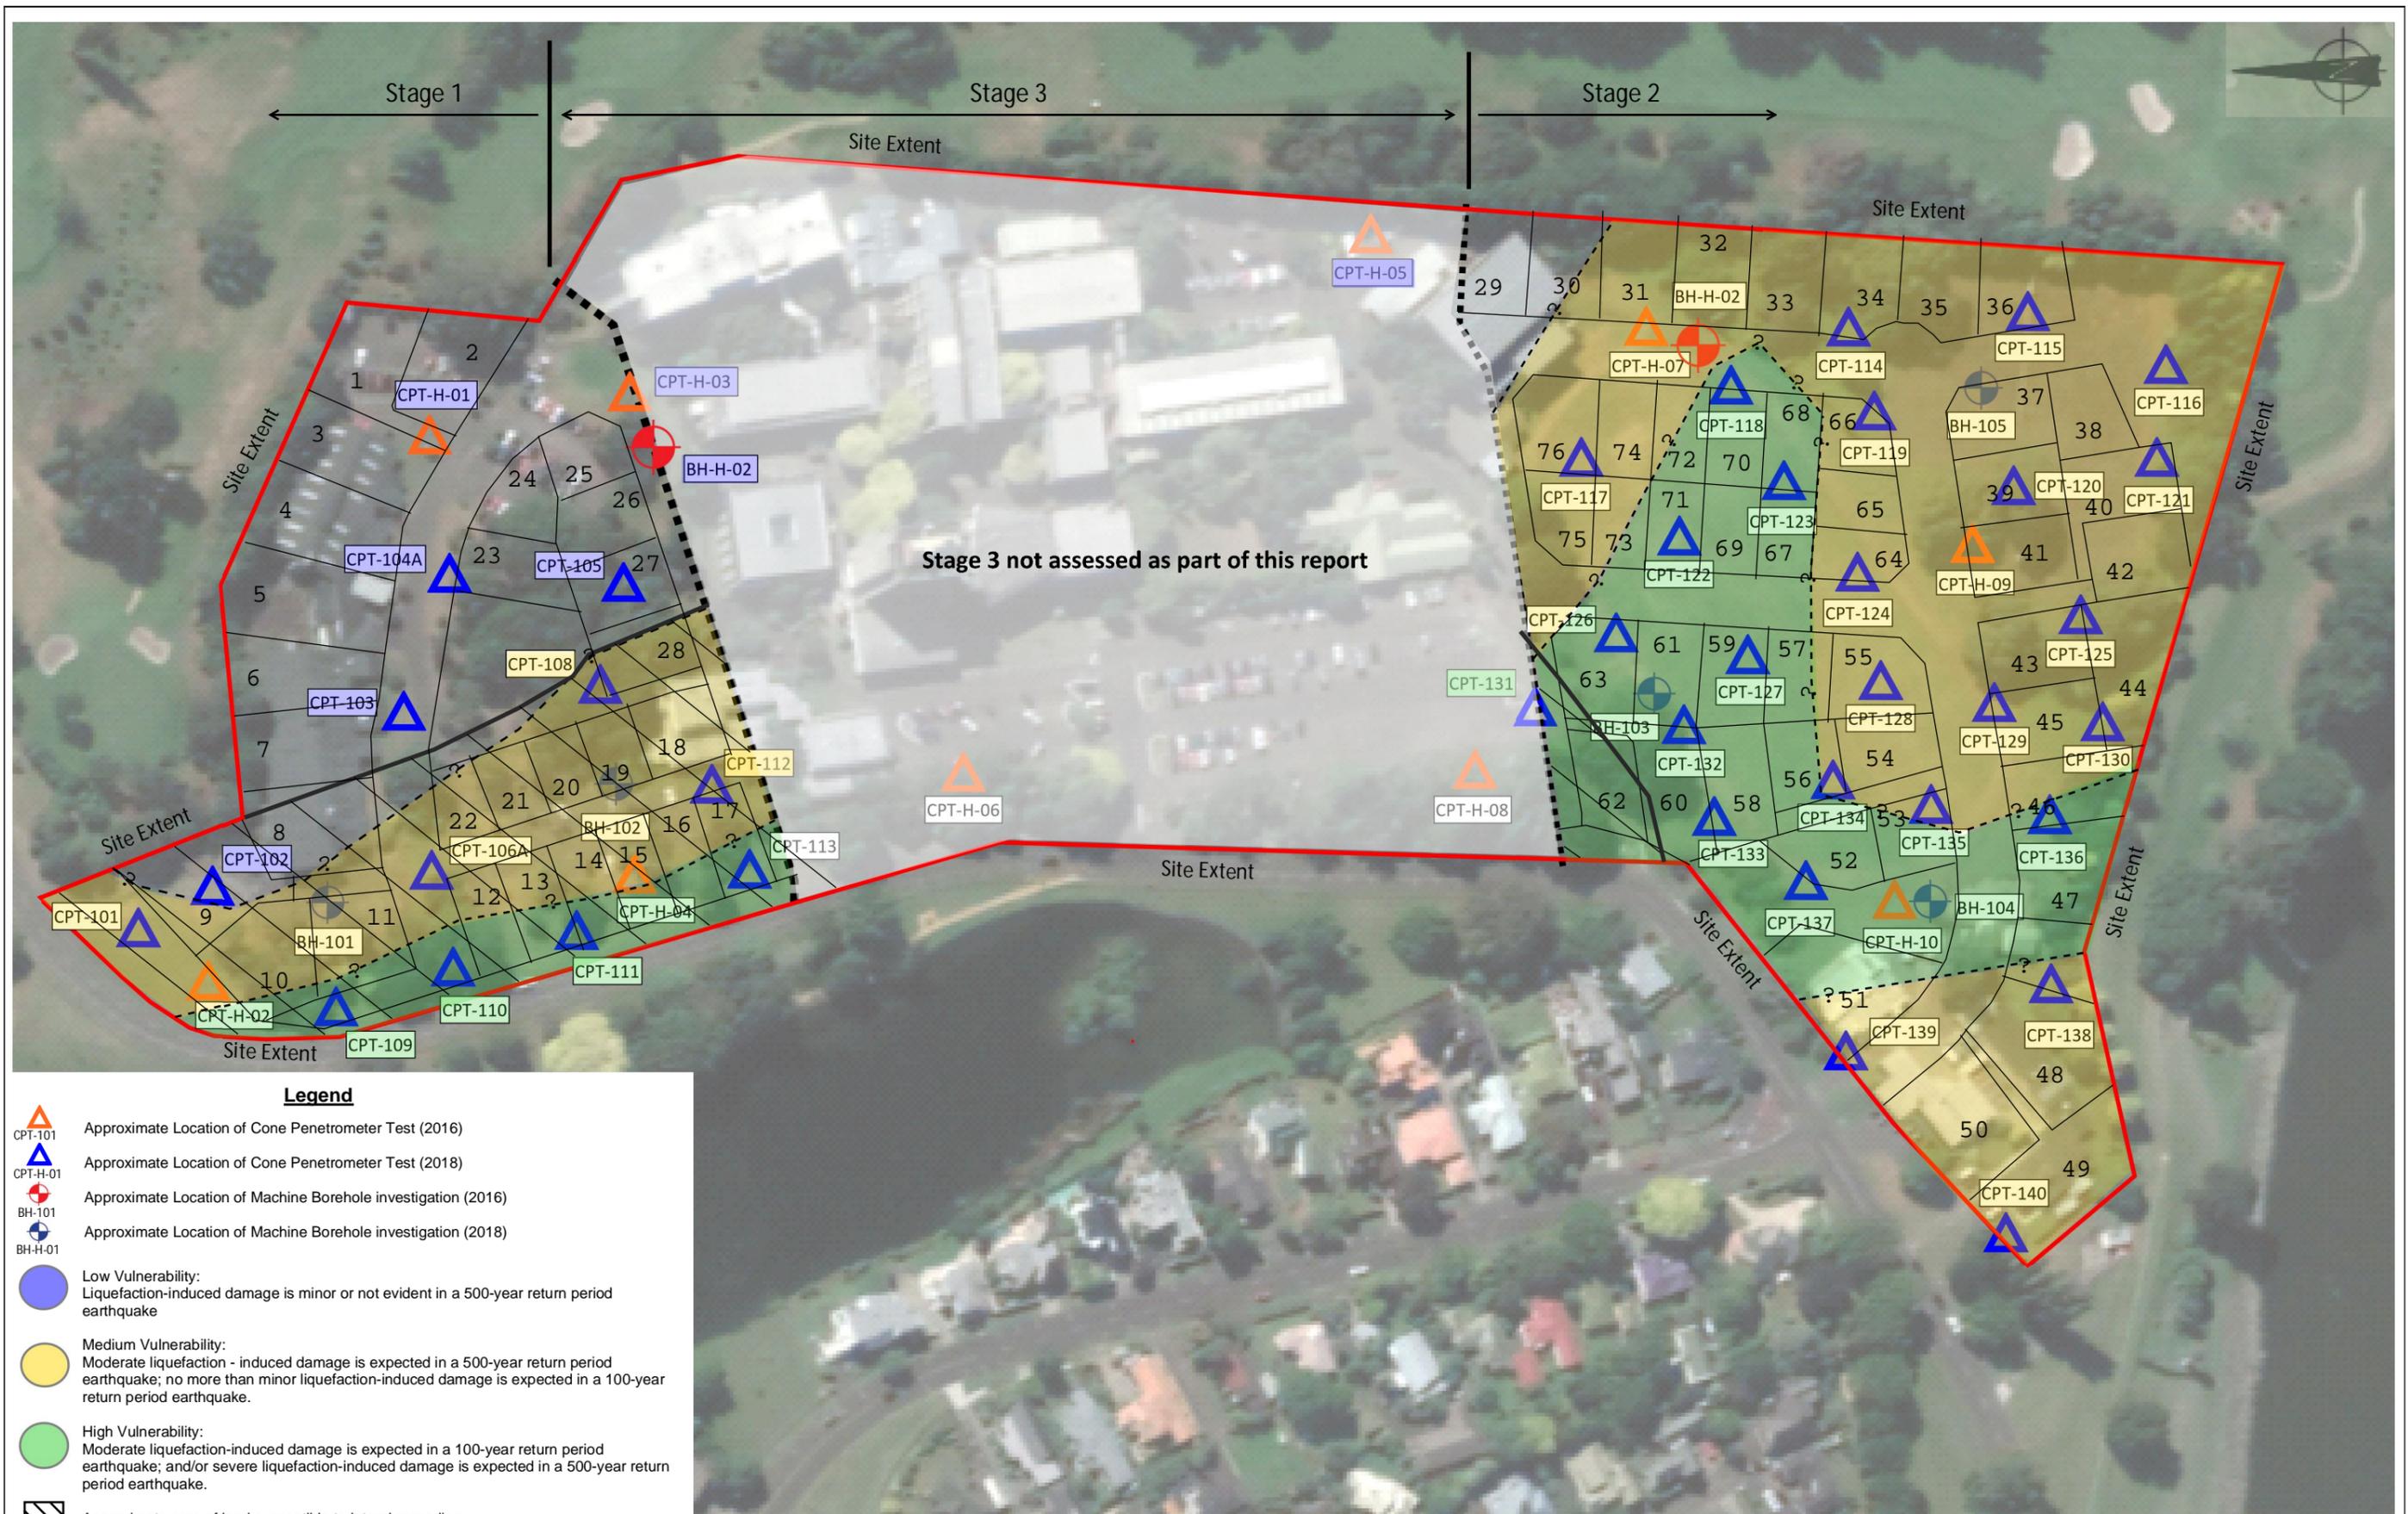
The majority of the site is assigned a liquefaction vulnerability category of **Low** or **Medium** with some portions of the site (adjacent to the lagoon and the central area at the southern end of the site) assigned a liquefaction vulnerability category of **High**. The liquefaction categories assigned across the site are presented in Appendix A, Figure 2.

A strip of land approximately 100 m wide along the western boundary of the site, adjacent to Hokowhitu Lagoon, is potentially susceptible to lateral spreading⁵ during large earthquake events (e.g. 500-year level shaking). This area is shown in Appendix A, Figure 2. The area susceptible to lateral spreading is located within the areas assigned liquefaction categories of **Medium** and **High**.

The calculations and analyses used in our liquefaction assessment focused on 50 Cone Penetration Tests (CPTs) from the 2017 and 2018 investigations of the site. Areas outside the limits of the Site Extent as shown on Figure 2, Appendix A, have not been included in this assessment.

The locations of the investigations were surveyed by hand held GPS, and are presented on Figure 2 in Appendix A.

Geotechnical investigations were carried out at the project site on 27 and 28 July 2016. The investigations comprised of ten (10) cone penetrometer tests (CPTs) and two (2) machine borehole. These investigations were part of a larger scope of investigations and assessment of the Hokowhitu Campus areas¹³. The locations of the investigations were surveyed by hand held GPS, and are presented on Figure 2 in Appendix A.

The CPT locations are presented on Figure 2 in Appendix A. A summary of the CPT locations and termination depths is presented in Table C.1 below.

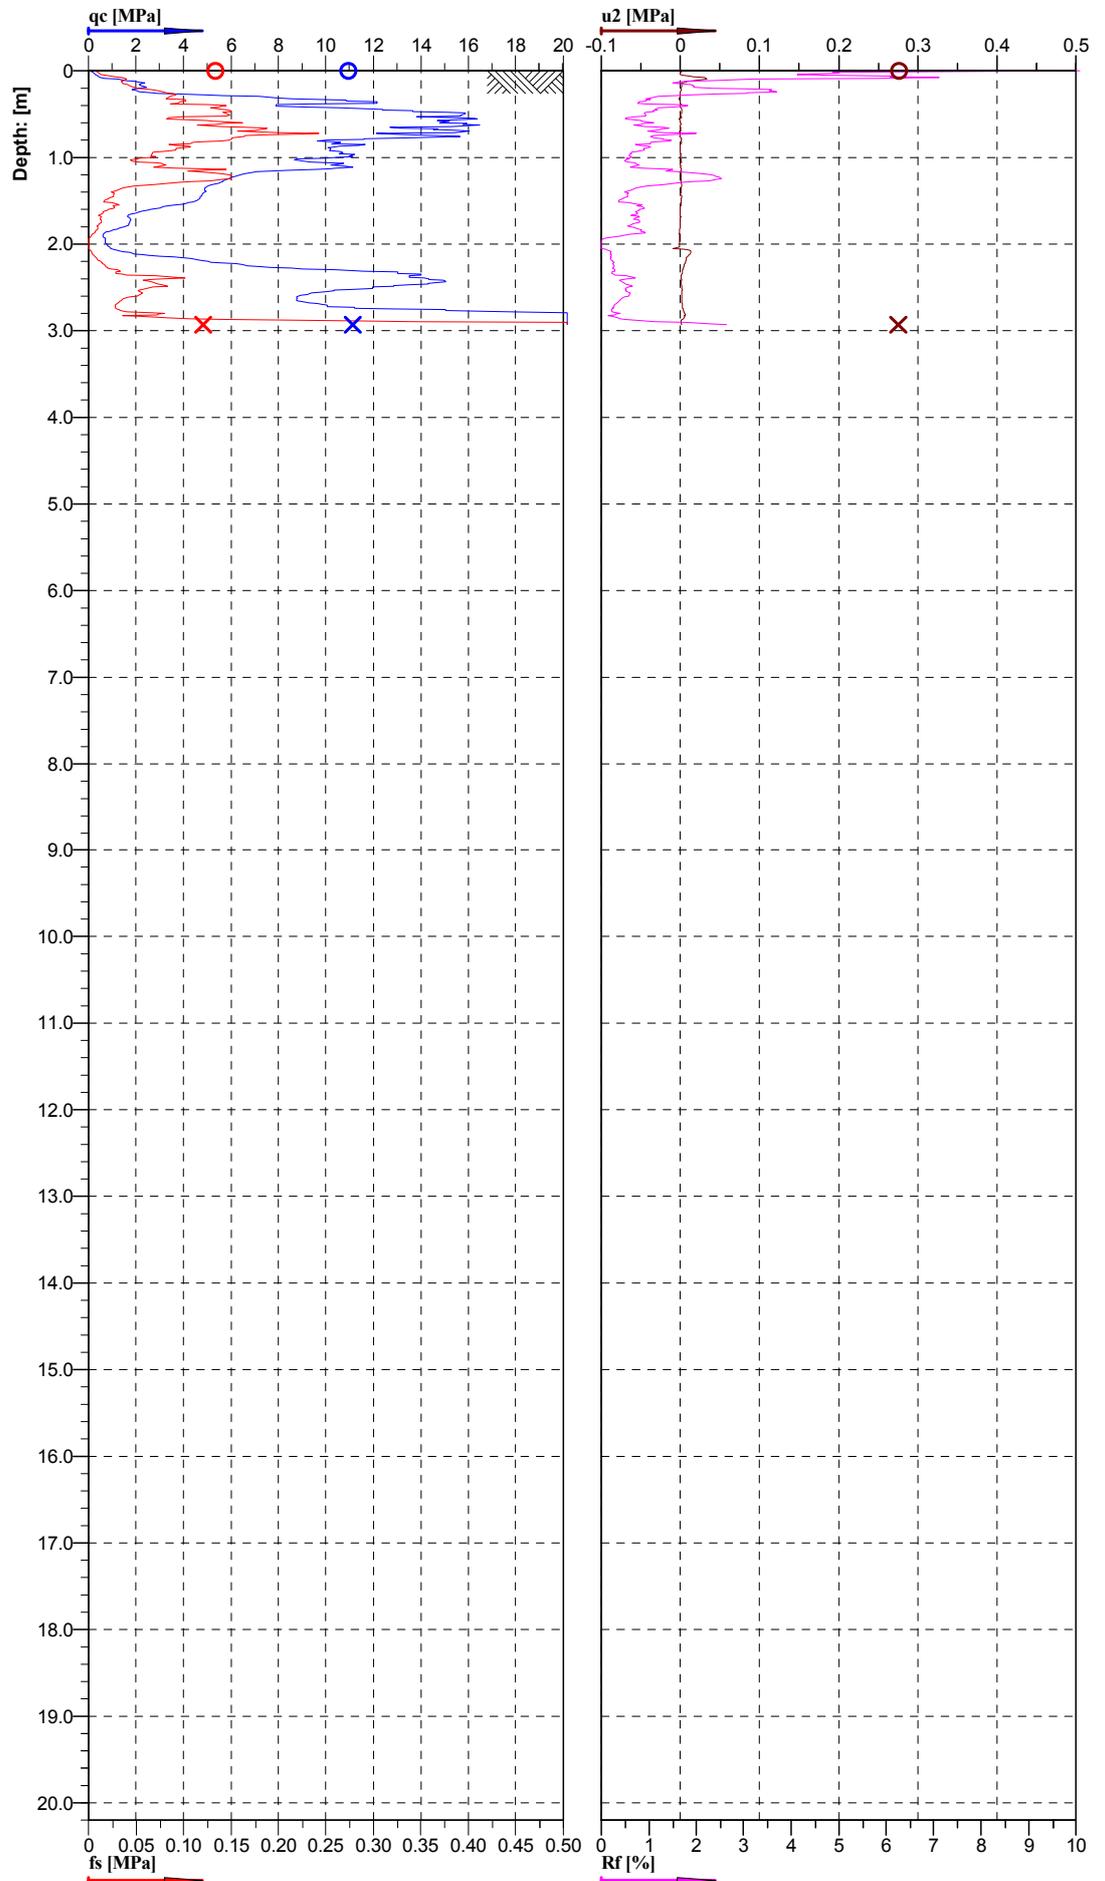
Location: PALMERSTON NORTH	Position: X: 0.00 m, Y: 0.00 m	Ground level: 0.00	Test No.: CPT 101
Project ID:	Client: T&T	Date: 16/08/2018	Scale: 1 : 87
Project: HOKOWHITU		Page: 1/1	Fig.:
		File: hokowhituCPT101.cpt

- Clay (3)
- Sand to silty sand (8)
- Sandy silt to clayey silt (6)
- Sensitive fine grained (1)
- Sand (9)

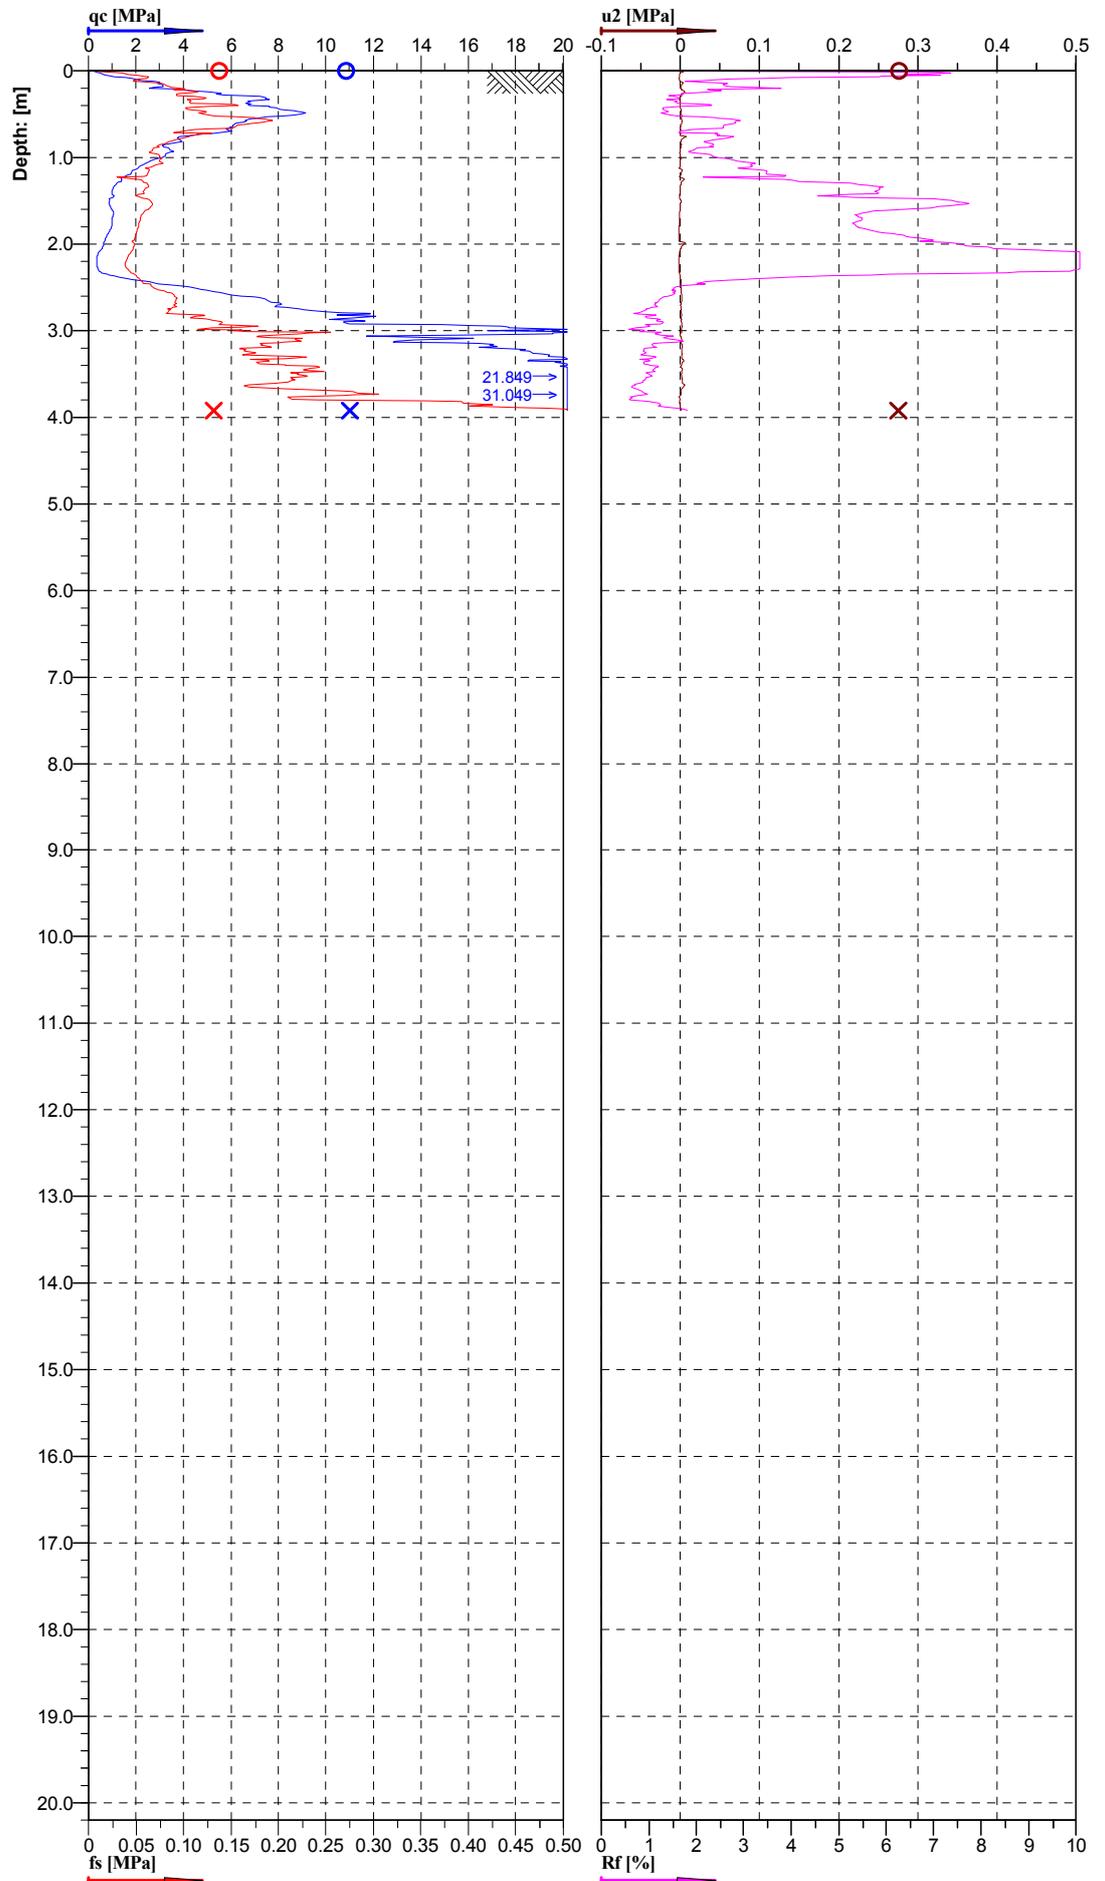
Location: PALMERSTON NORTH	Position: X: 0.00 m, Y: 0.00 m	Ground level: 0.00	Test No.: CPT102
Project ID:	Client: T&T	Date: 16/08/2018	Scale: 1 : 87
Project: HOKOWHITU		Page: 1/1	Fig.:
		File: hokowhituCPT102.cpt

- Organic material (2)
- Sandy silt to clayey silt (6)
- Clay (3)
- Organic material (2)
- Sand to silty sand (8)
- Sand (9)

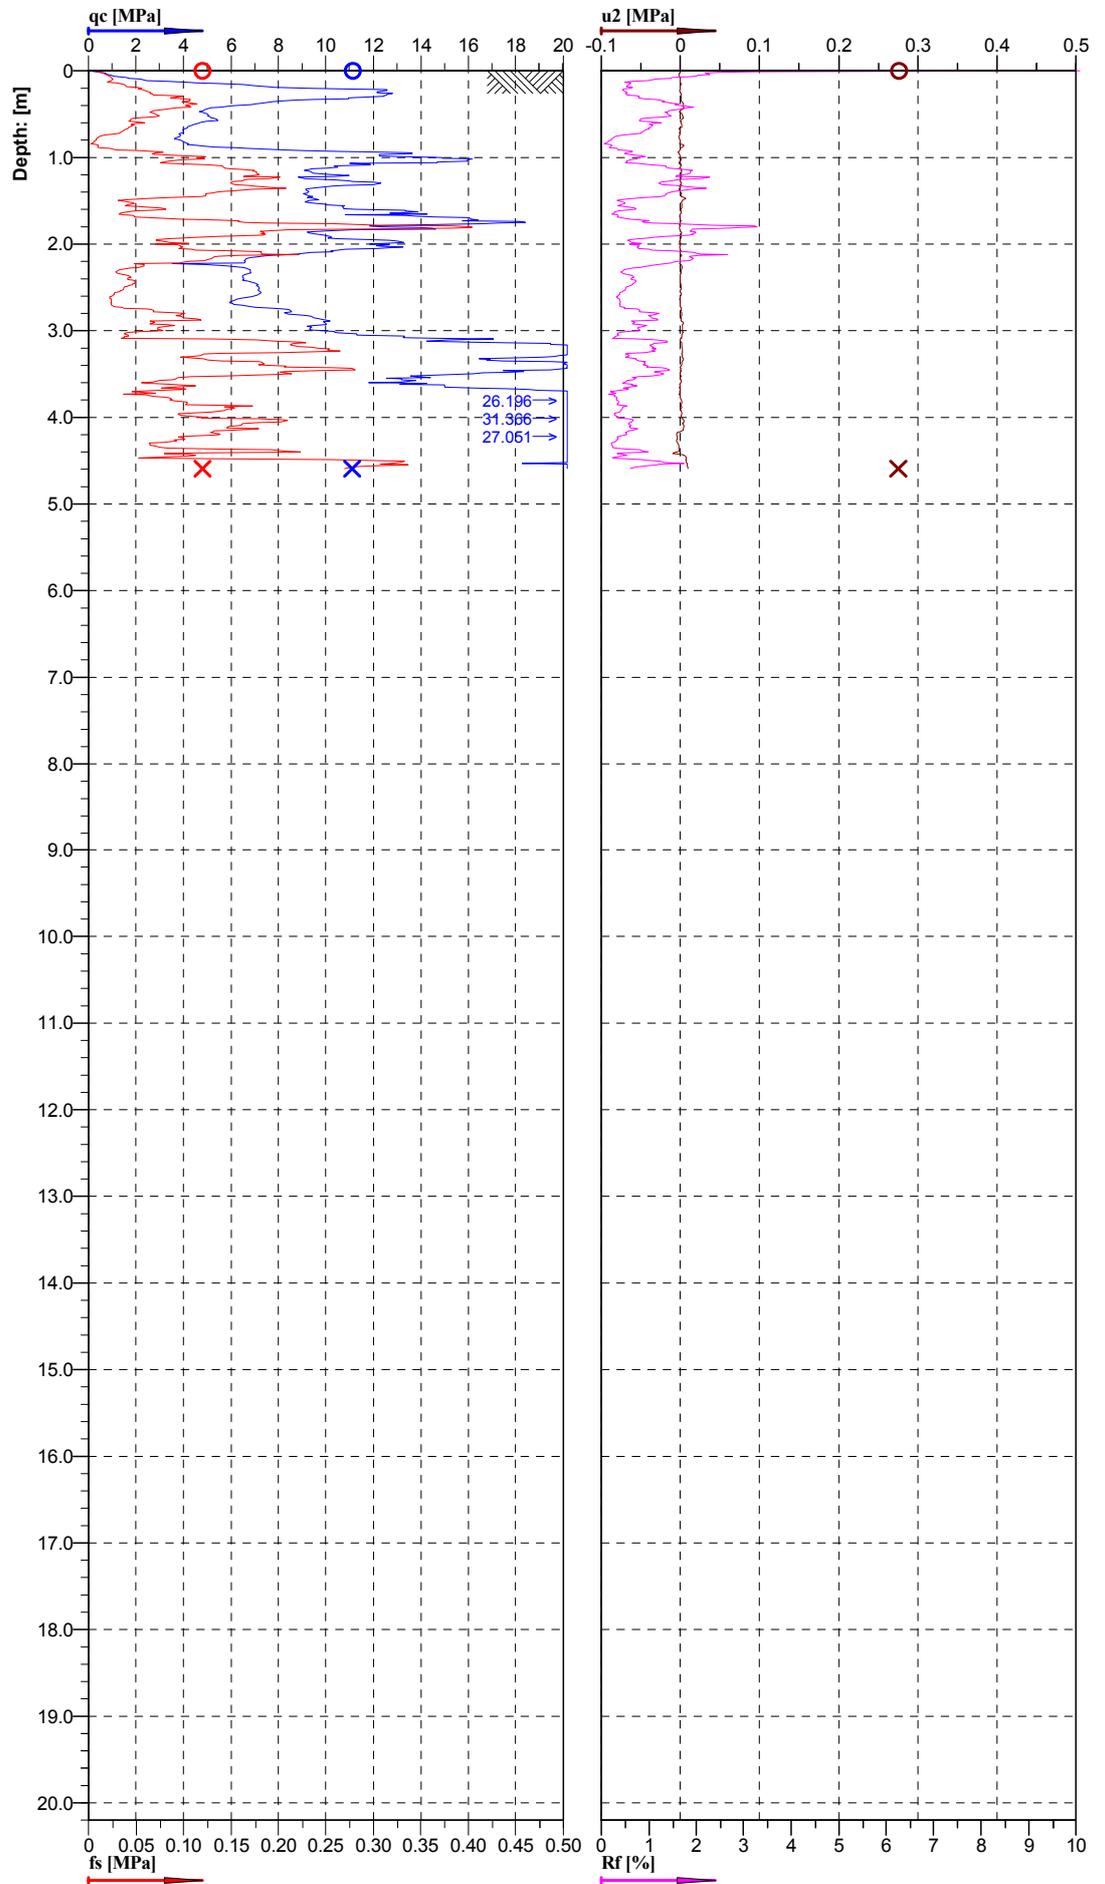
Location: PALMERSTON NORTH	Position: X: 0.00 m, Y: 0.00 m	Ground level: 0.00	Test No.: CPT103
Project ID:	Client: T&T	Date: 16/08/2018	Scale: 1 : 87
Project: HOKOWHITU		Page: 1/1	Fig.:
		File: hokowhituCPT103.cpt

- Silty clay to clay (4)
- Silty sand to sandy silt (7)
- Sand (9)
- Sand to silty sand (8)
- Sand (9)
- Gravely sand to sand (10)

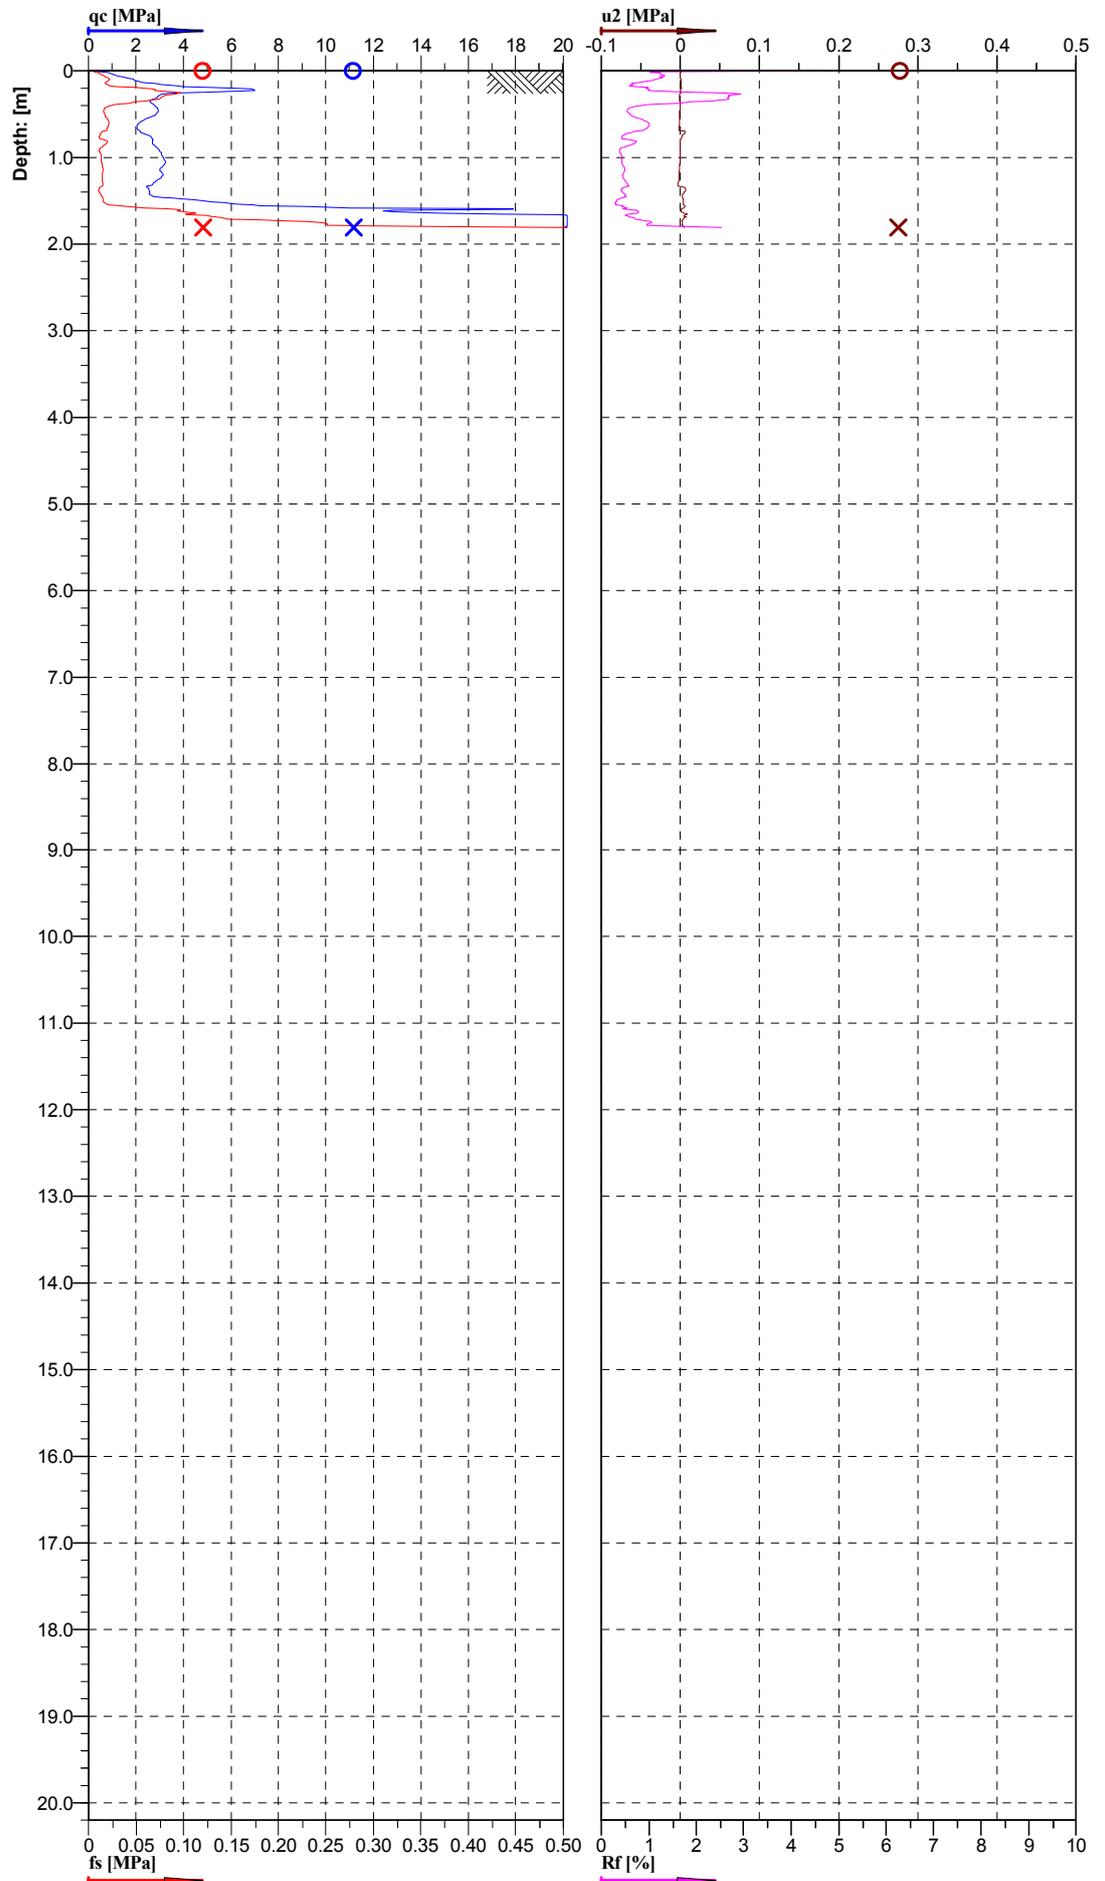
Location: PALMERSTON NORTH	Position: X: 0.00 m, Y: 0.00 m	Ground level: 0.00	Test No.: CPT 104
Project ID:	Client: T&T	Date: 16/08/2018	Scale: 1 : 87
Project: HOKOWHITU		Page: 1/1	Fig.:
		File: hokowhituCPT104.cpt

- Sand to silty sand (8)
- Silty sand to sandy silt (7)
- Sand (9)

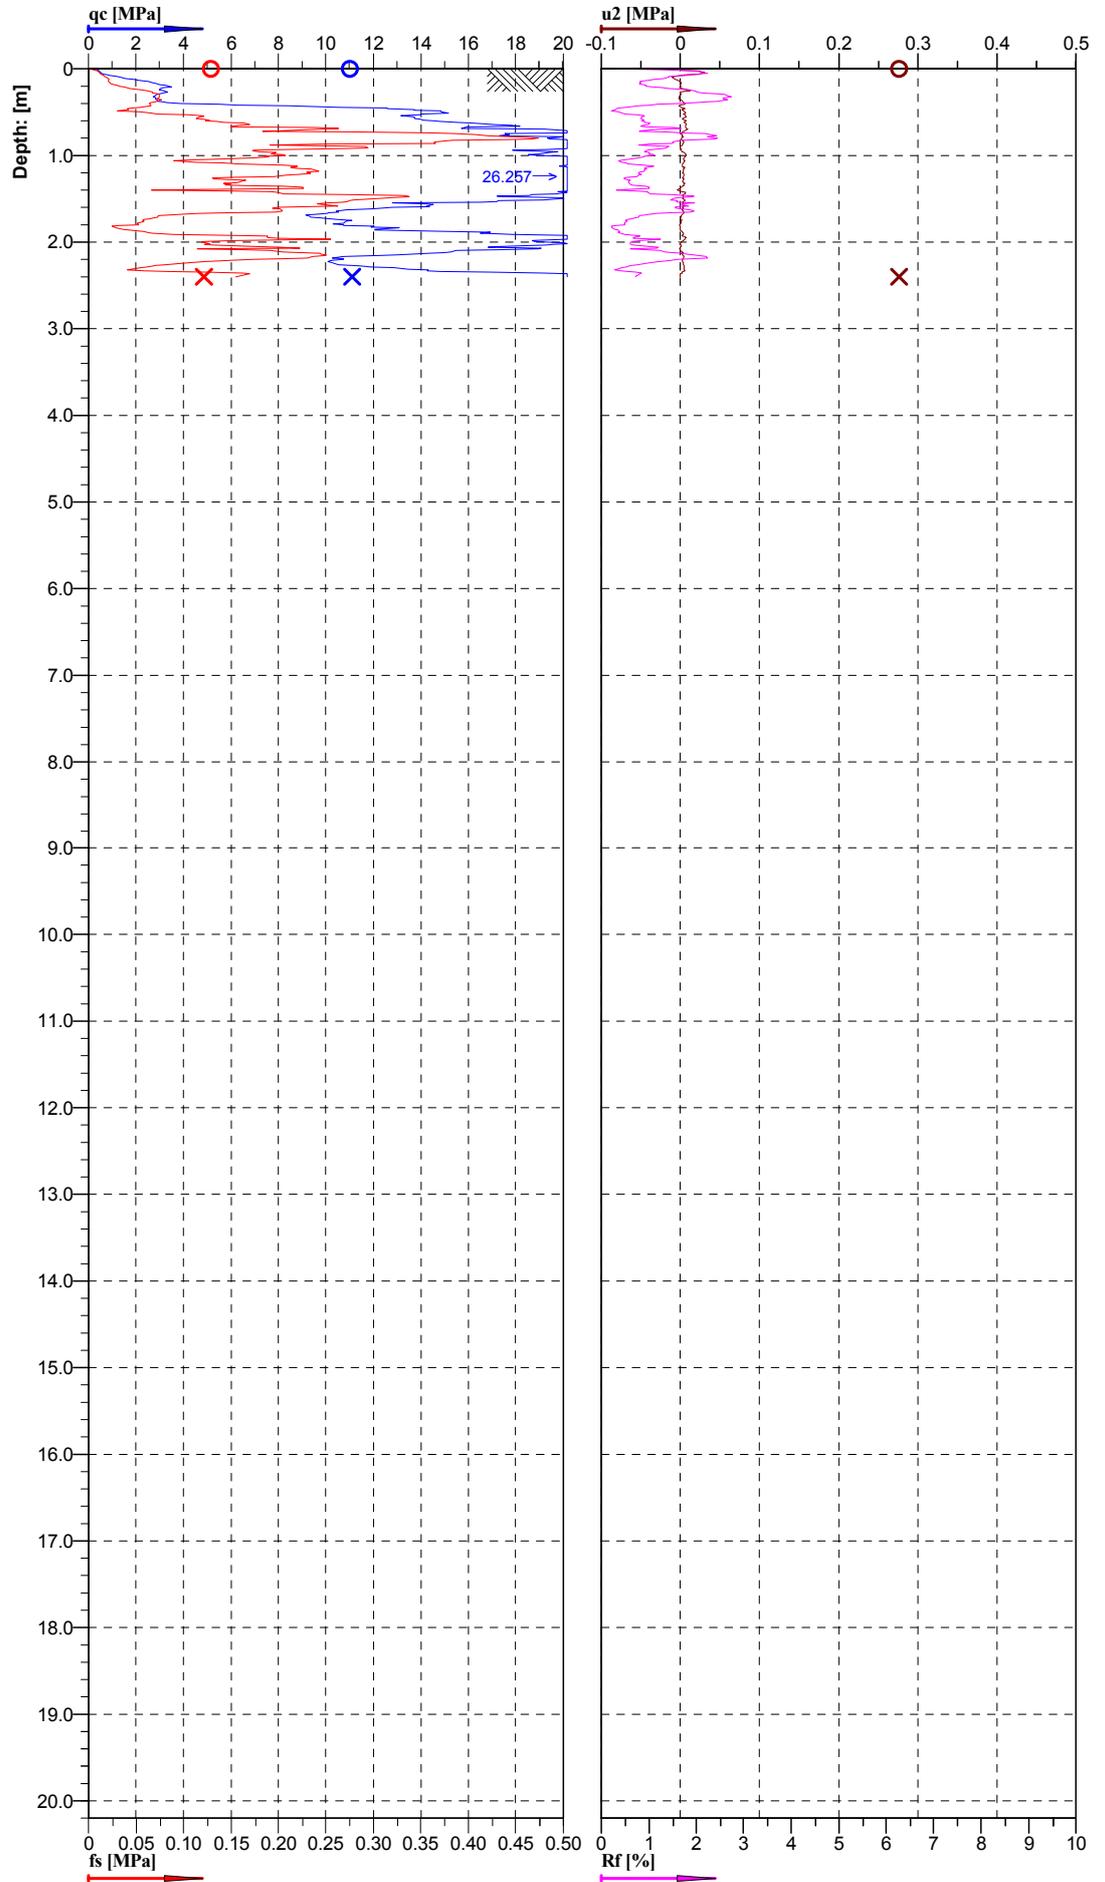
Location: PALMERSTON NORTH	Position: X: 0.00 m, Y: 0.00 m	Ground level: 0.00	Test No.: CPT106A
Project ID:	Client: T&T	Date: 16/08/2018	Scale: 1 : 87
Project: HOKOWHITU		Page: 1/1	Fig.:
		File: hokowhituCPT106A.cpt

- Clay (3)
- Sandy silt to clayey silt (6)
- Sand (9)
- Sand to silty sand (8)
- Sand (9)

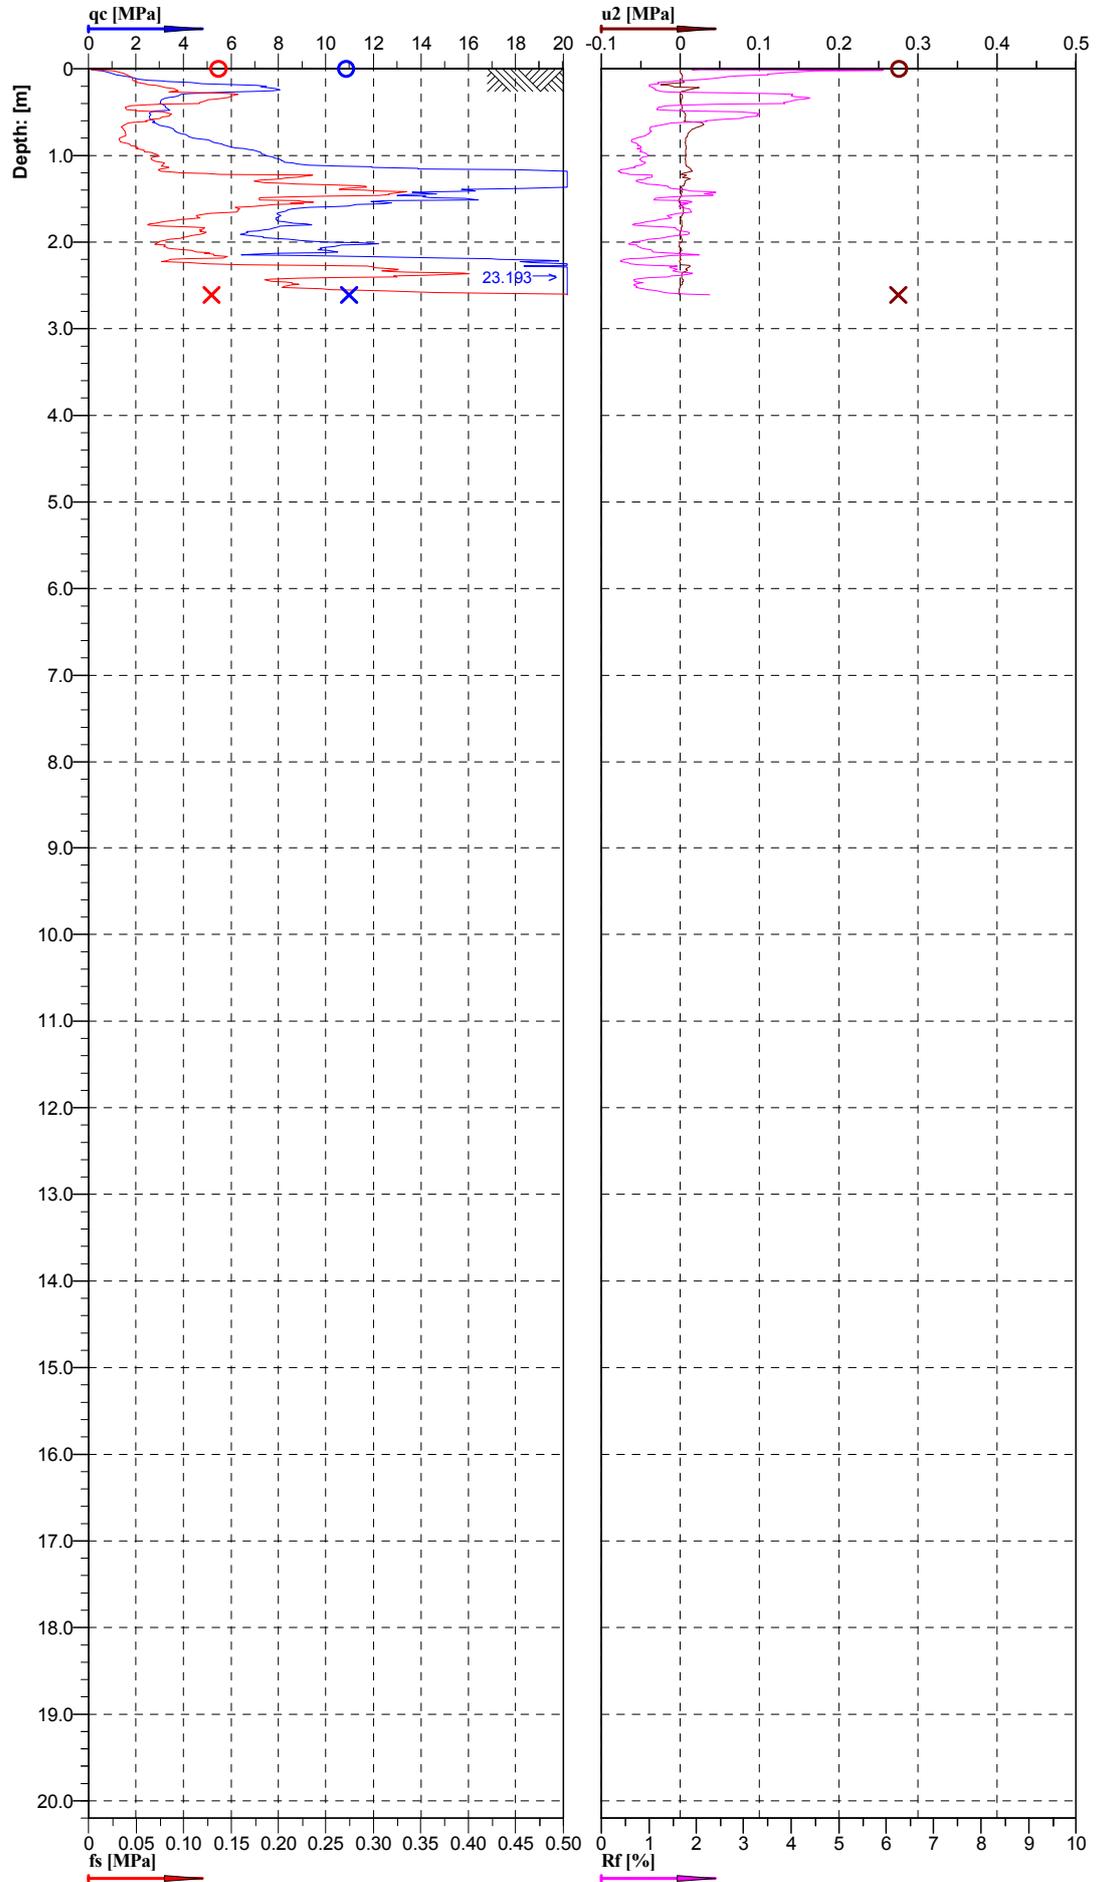
Location: PALMERSTON NORTH	Position: X: 0.00 m, Y: 0.00 m	Ground level: 0.00	Test No.: CPT107
Project ID:	Client: T&T	Date: 15/08/2018	Scale: 1 : 87
Project: HOKOWHITU		Page: 1/1	Fig.:
		File: hokowhituCPT107.cpt

- Clay (3)
- Silty sand to sandy silt (7)
- Sand to silty sand (8)
- Sand (9)
- Silty sand to sandy silt (7)
- Sand (9)
