Centennial Park, Palmerston North

Geotechnical Investigation and Liquefaction Assessment

Prepared for
Wallace Development Company Ltd

Prepared by
Tonkin & Taylor Ltd

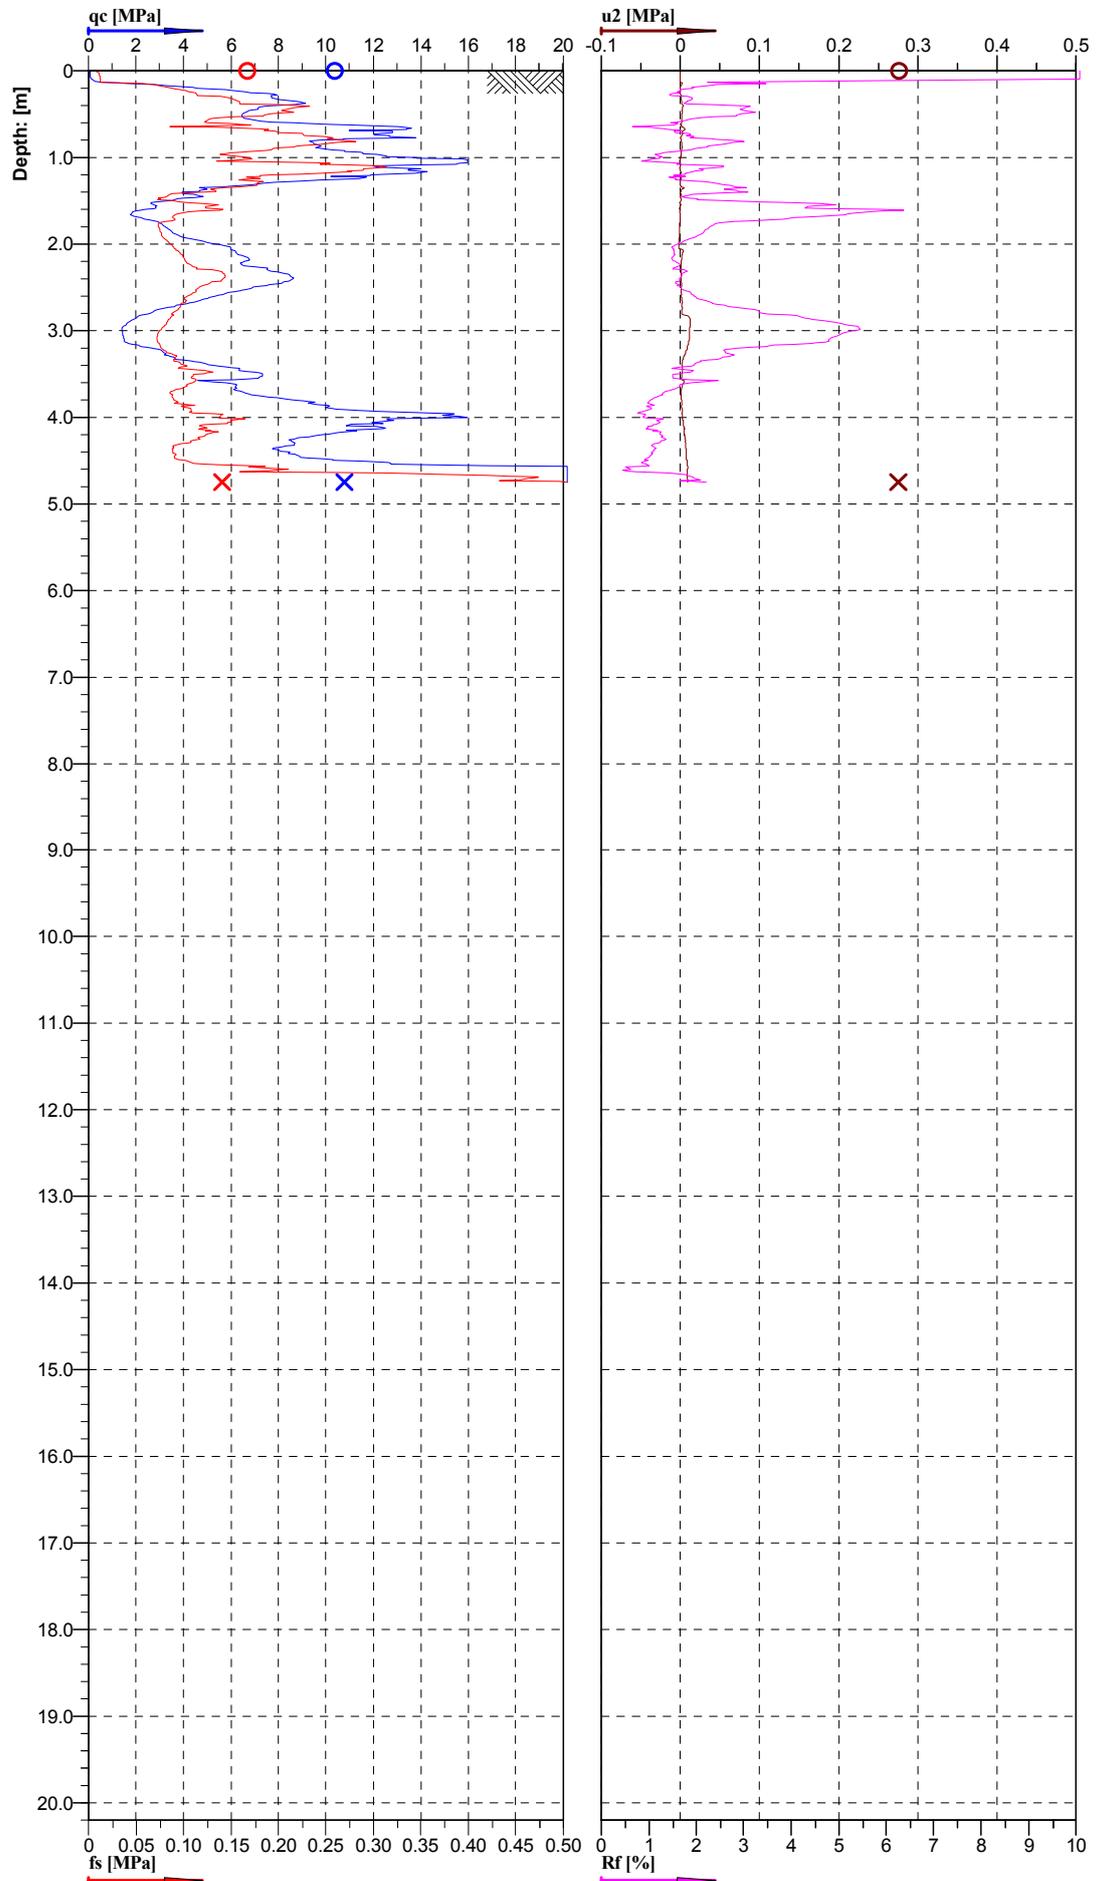
Location: PALMERSTON NORTH	Position: X: 0.00 m, Y: 0.00 m	Ground level: 0.00	Test No.: CPT108
Project ID:	Client: T&T	Date: 15/08/2018	Scale: 1 : 87
Project: HOKOWHITU		Page: 1/1	Fig.:
		File: hokowhituCPT108.cpt

- Organic material (2)
- Silty sand to sandy silt (7)
- Sand to silty sand (8)
- Clay (3)
- Sandy silt to clayey silt (6)
- Silty sand to sandy silt (7)
- Clay (3)
- Silty sand to sandy silt (7)
- Sand to silty sand (8)

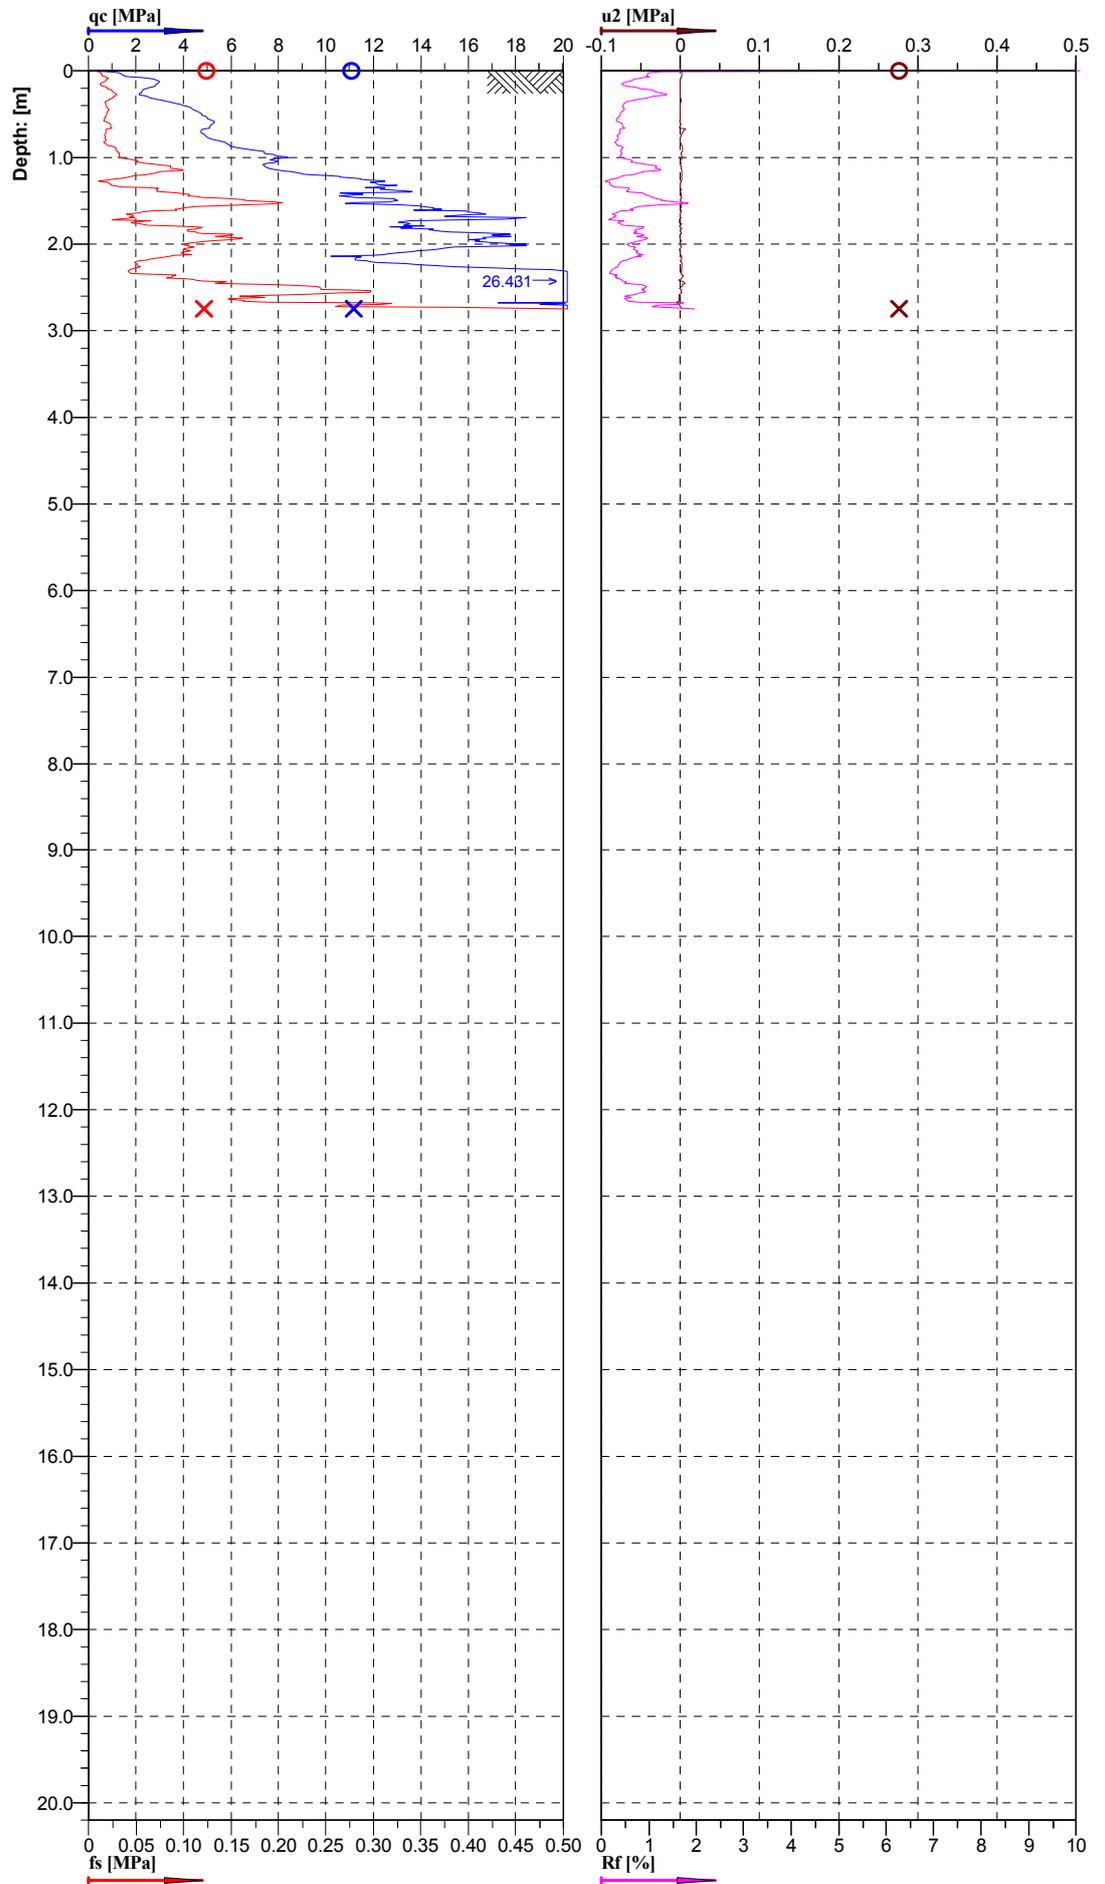
Location: PALMERSTON NORTH	Position: X: 0.00 m, Y: 0.00 m	Ground level: 0.00	Test No.: CPT110
Project ID:	Client: T&T	Date: 16/08/2018	Scale: 1 : 87
Project: HOKOWHITU		Page: 1/1	Fig.:
		File: hokowhituCPT110.cpt

- Silty sand to sandy silt (7)
- Sand to silty sand (8)
- Sand (9)

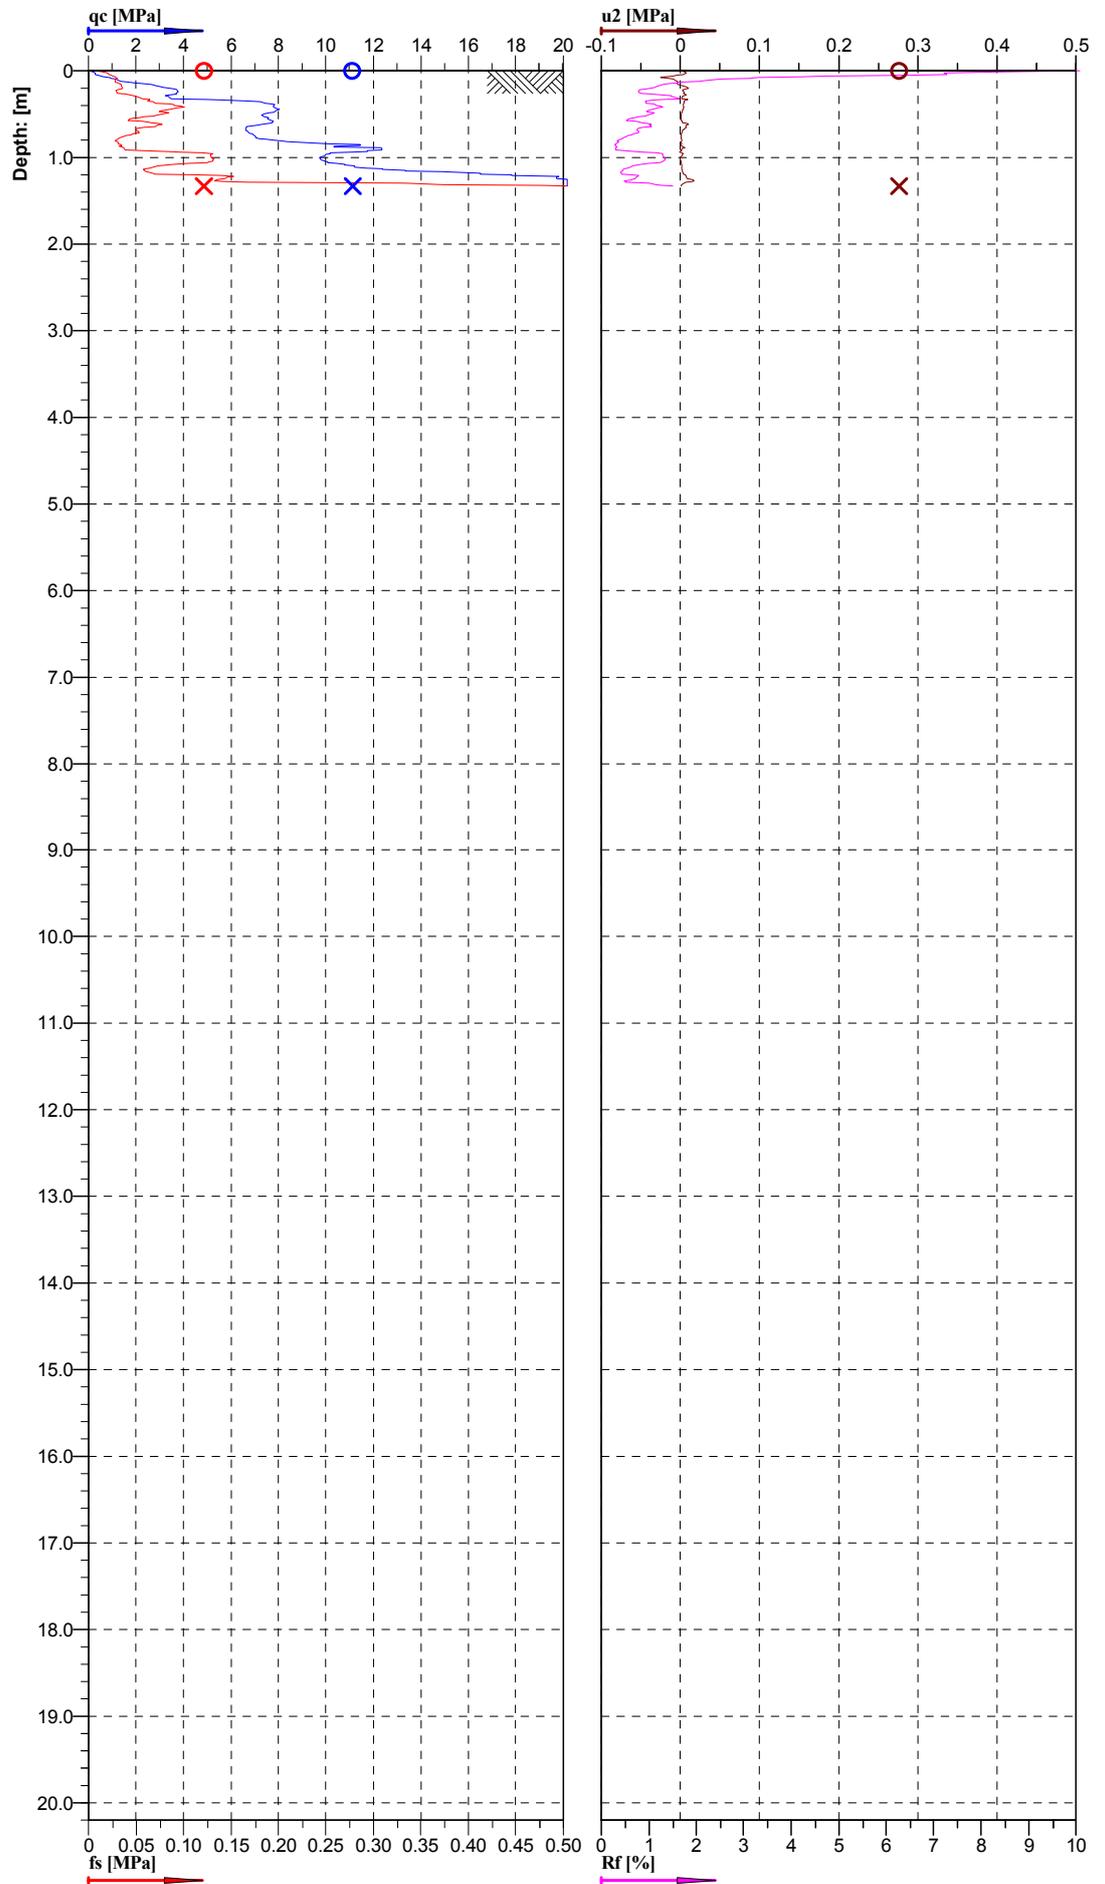
Location: PALMERSTON NORTH	Position: X: 0.00 m, Y: 0.00 m	Ground level: 0.00	Test No.: CPT111
Project ID:	Client: T&T	Date: 15/08/2018	Scale: 1 : 87
Project: HOKOWHITU		Page: 1/1	Fig.:
		File: hokowhituCPT111.cpt

- Organic material (2)
- Sand to silty sand (8)
- Sand (9)

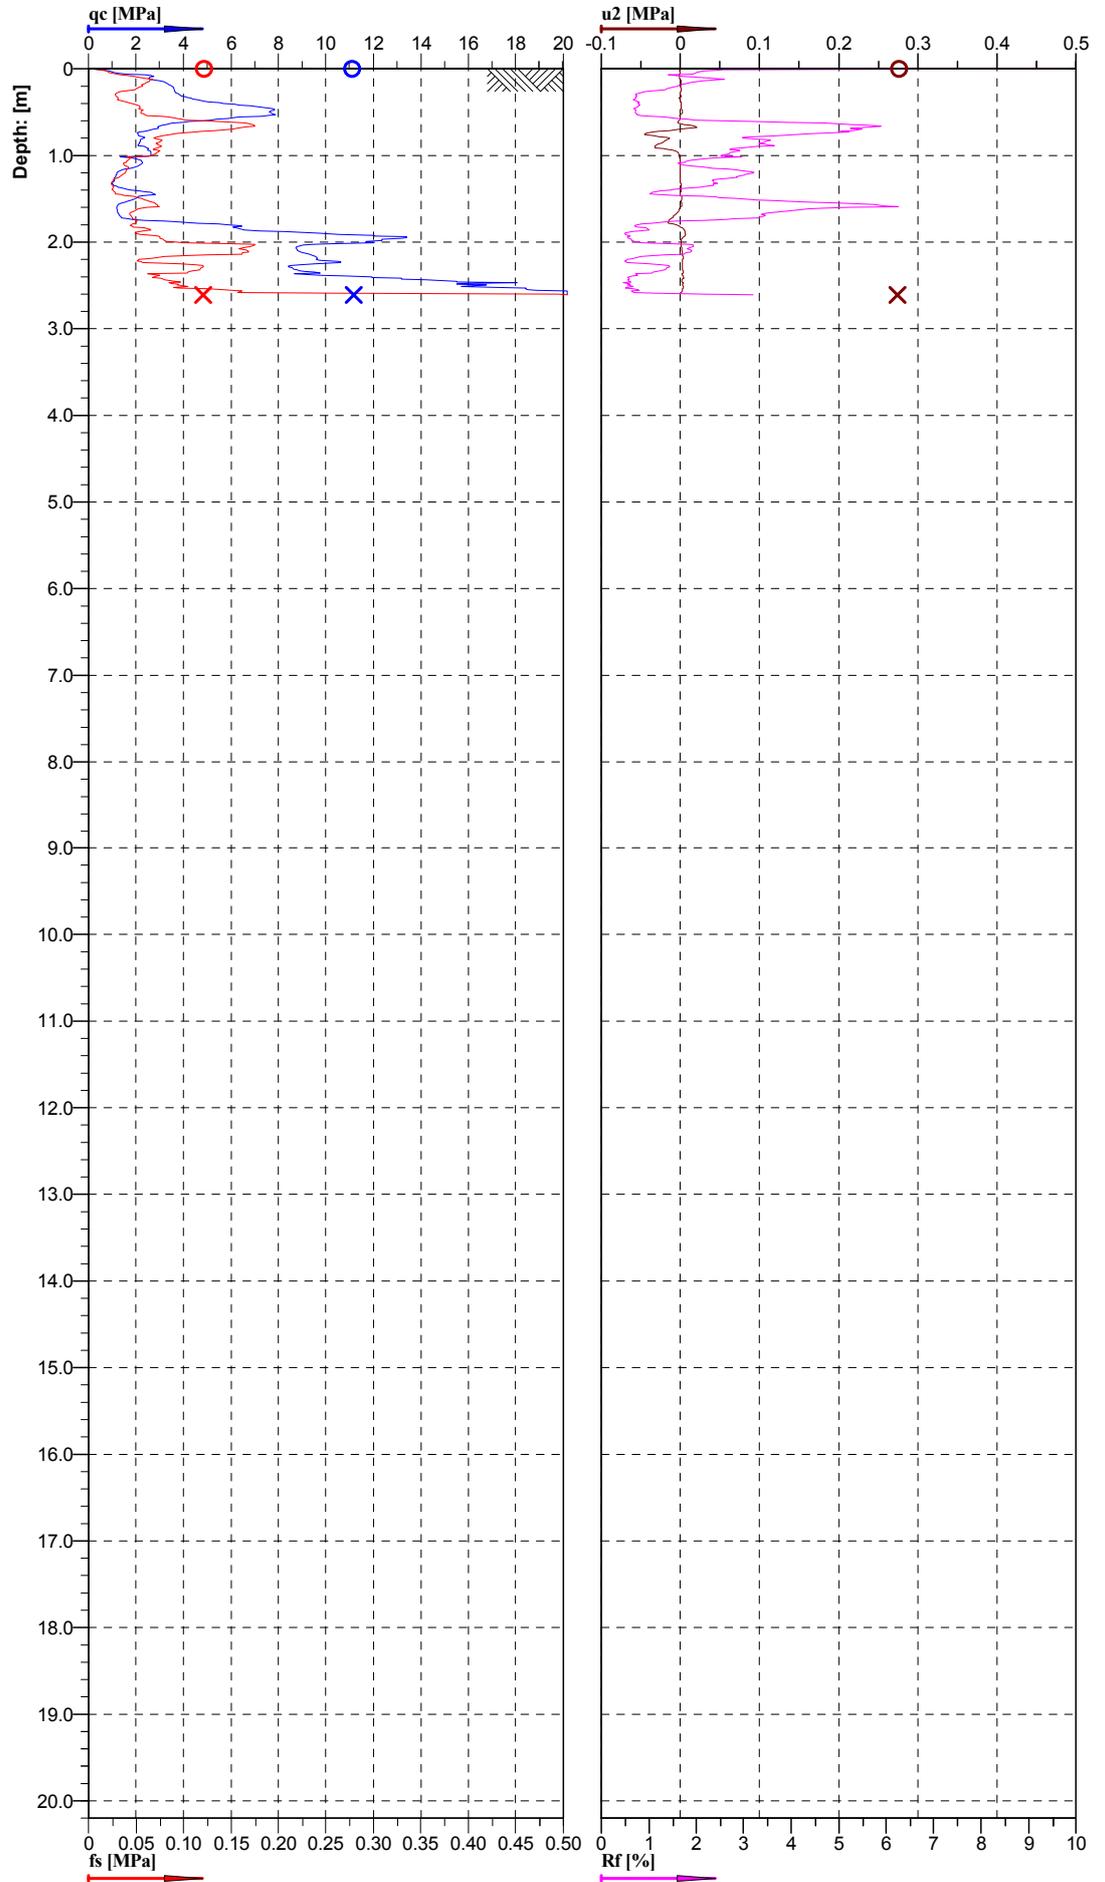
Location: PALMERSTON NORTH	Position: X: 0.00 m, Y: 0.00 m	Ground level: 0.00	Test No.: CPT112
Project ID:	Client: T&T	Date: 16/08/2018	Scale: 1 : 87
Project: HOKOWHITU		Page: 1/1	Fig.:
		File: hokowhituCPT112.cpt

- Clayey silt to silty clay (5)
- Sand to silty sand (8)
- Clayey silt to silty clay (5)
- Sand (9)

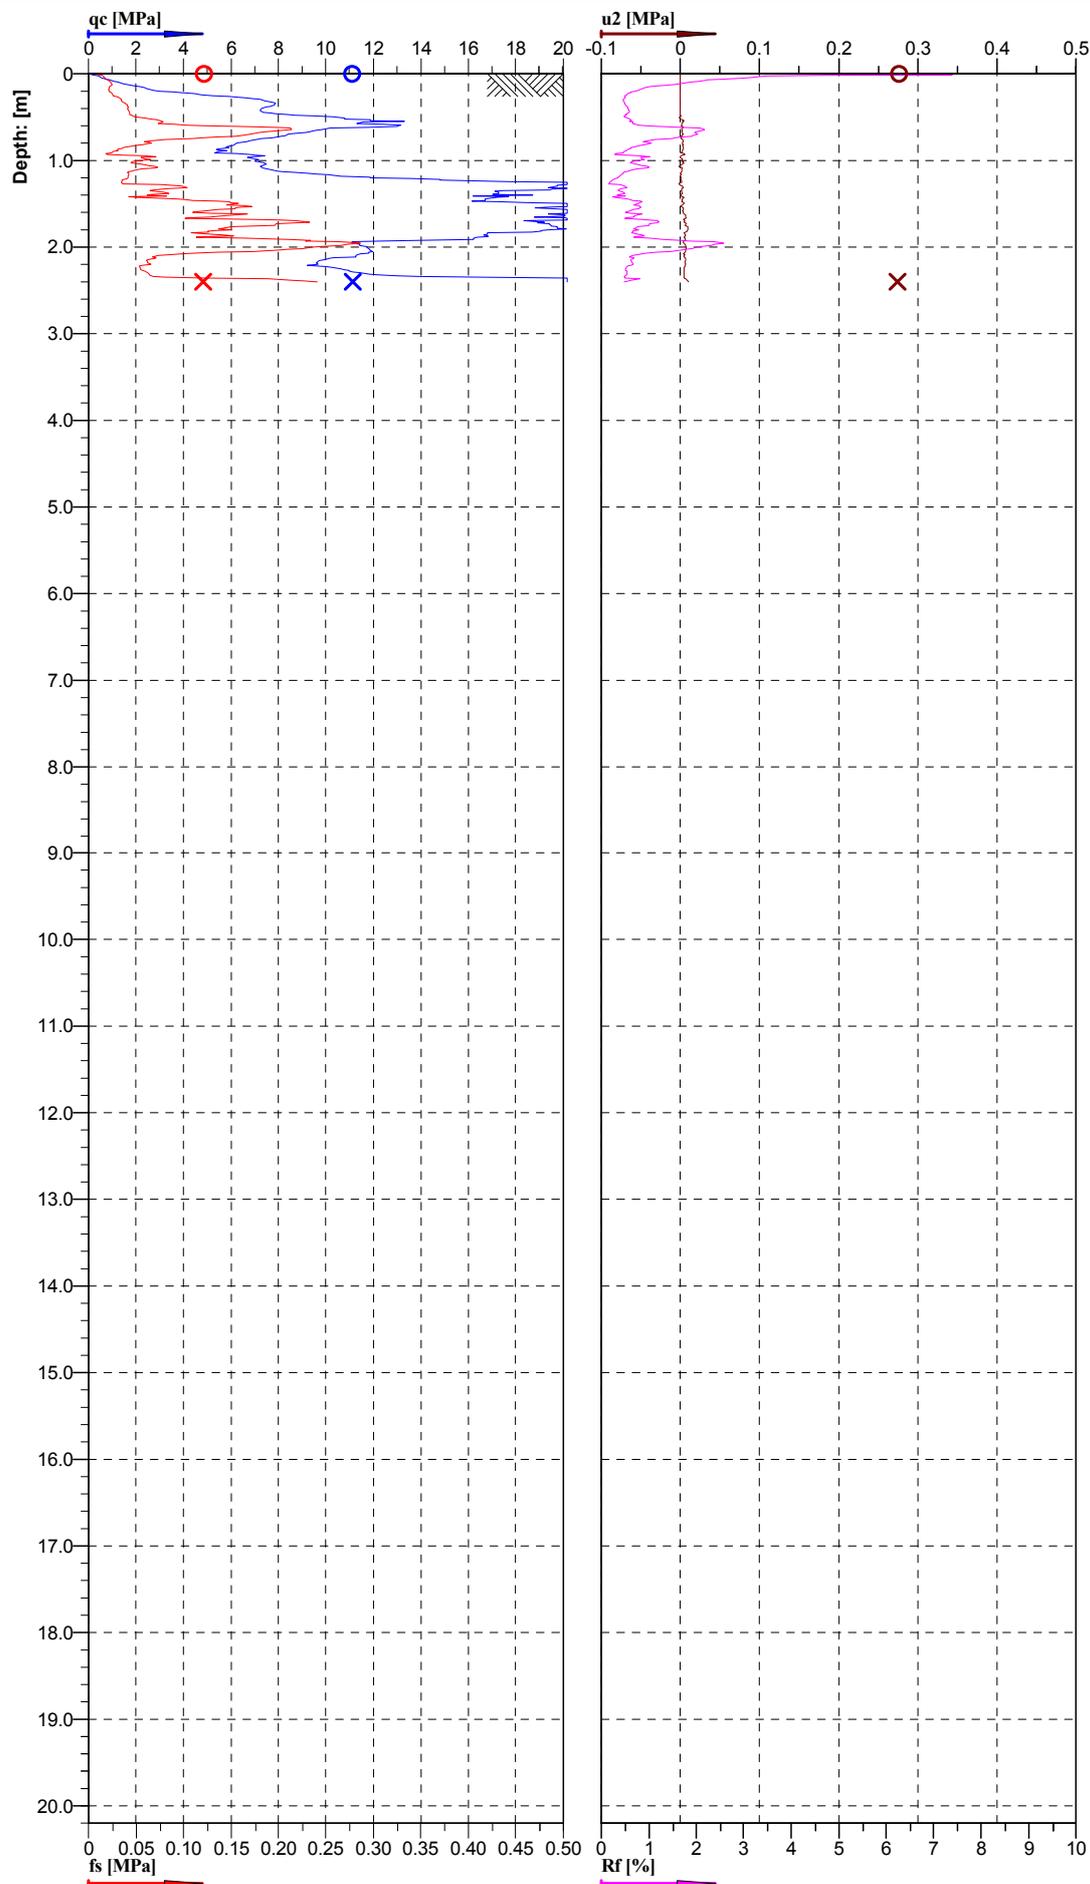
Location: PALMERSTON NORTH	Position: X: 0.00 m, Y: 0.00 m	Ground level: 0.00	Test No.: CPT113
Project ID:	Client: T&T	Date: 15/08/2018	Scale: 1 : 87
Project: HOKOWHITU		Page: 1/1	Fig.:
		File: hokowhituCPT113.cpt

- Clay (3)
- Sand to silty sand (8)
- Sand (9)

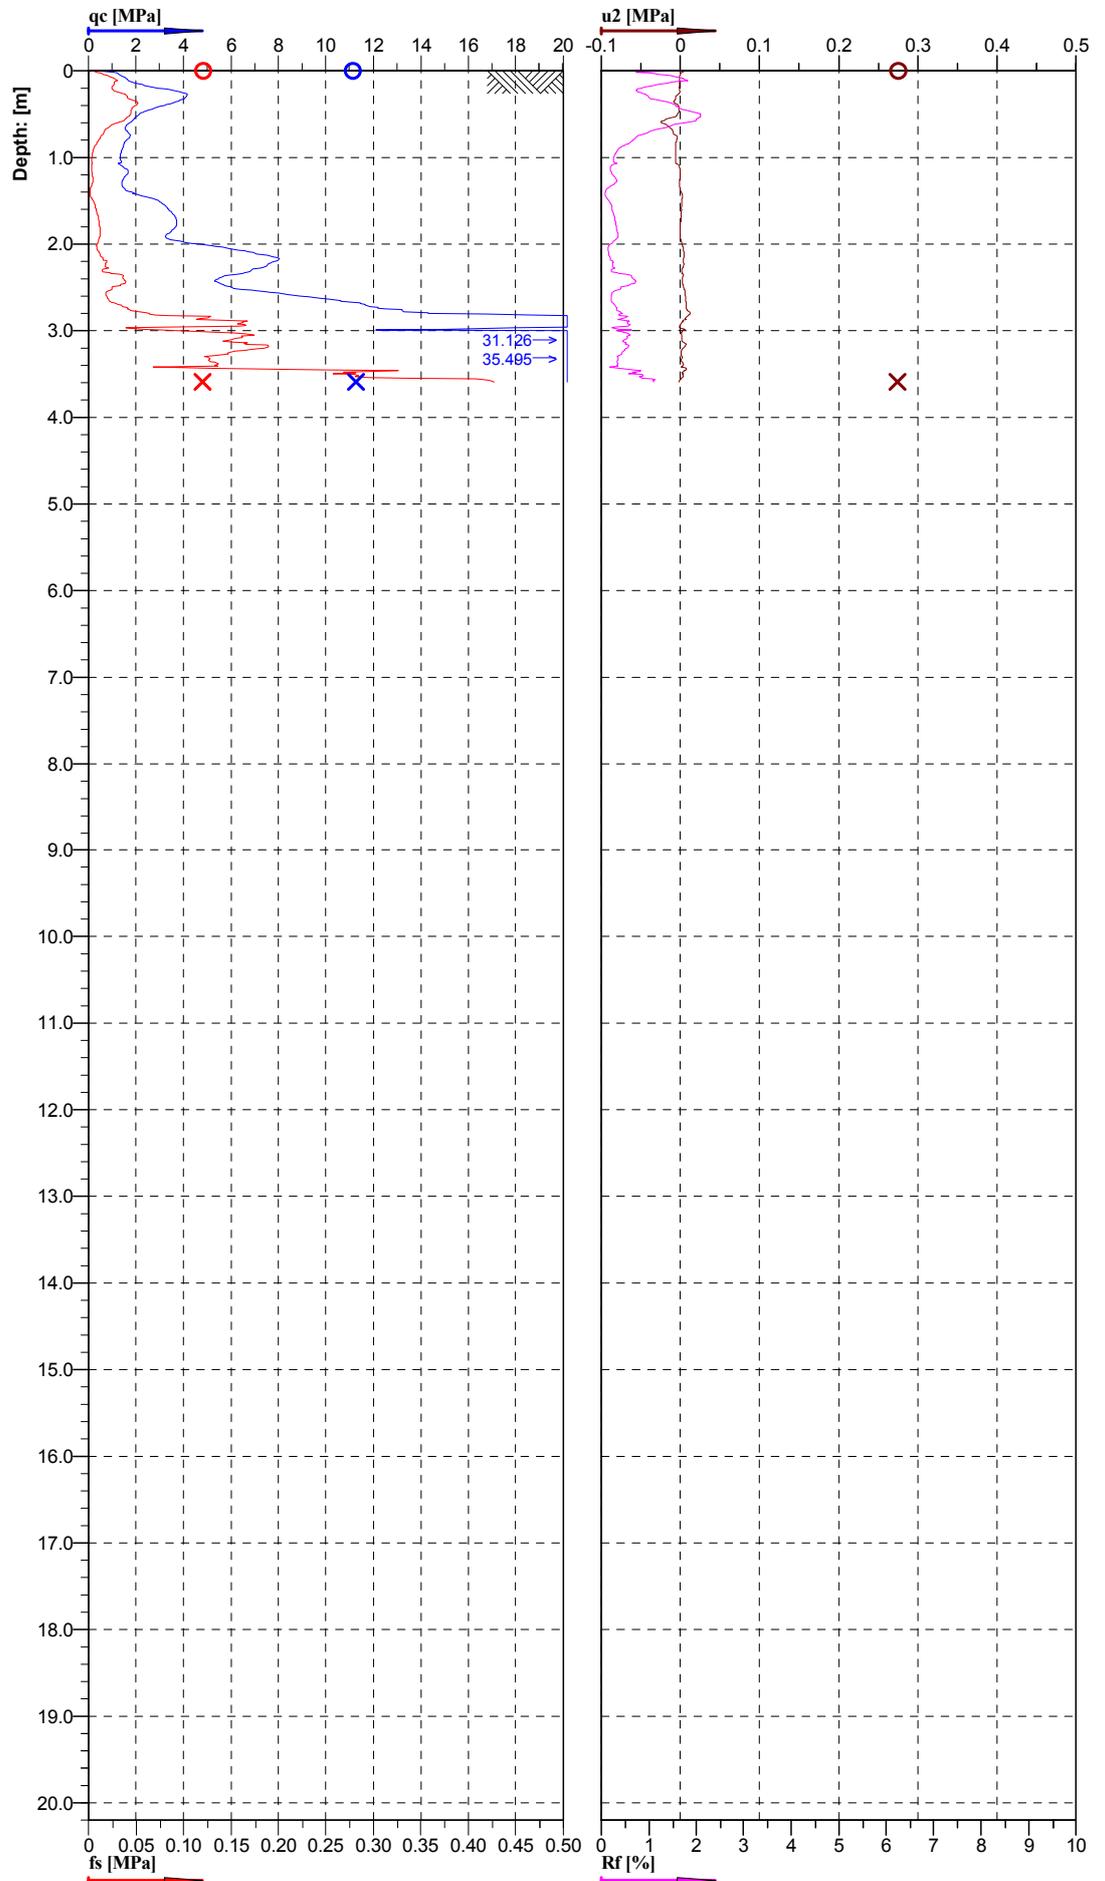
Location: PALMERSTON NORTH	Position: X: 0.00 m, Y: 0.00 m	Ground level: 0.00	Test No.: CPT116
Project ID:	Client: T&T	Date: 15/08/2018	Scale: 1 : 87
Project: HOKOWHITU		Page: 1/1	Fig.:
		File: hokowhituCPT116.cpt

- Silty sand to sandy silt (7)
- Silty sand to sandy silt (7)
- Silty sand to sandy silt (7)
- Sand to silty sand (8)
- Sand (9)
- Gravelly sand to sand (10)

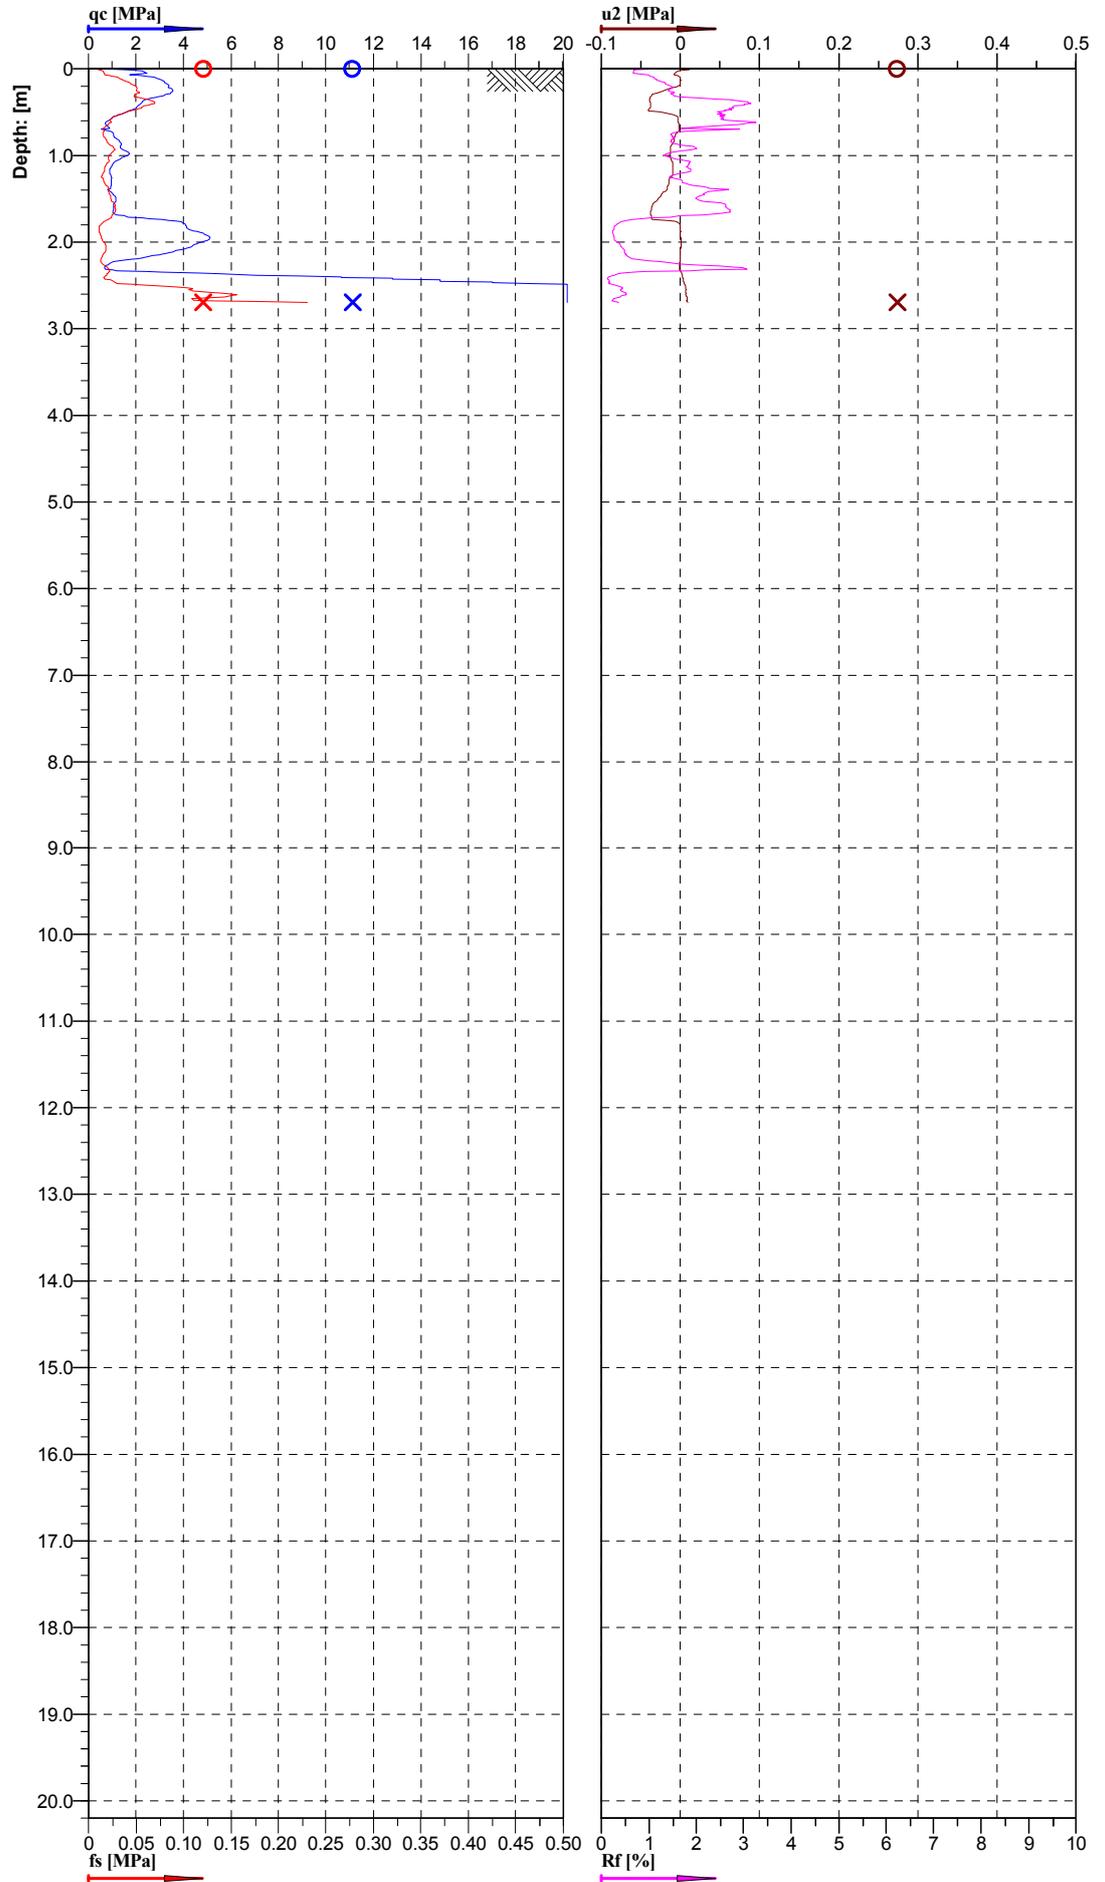
Location: PALMERSTON NORTH	Position: X: 0.00 m, Y: 0.00 m	Ground level: 0.00	Test No.: CPT117
Project ID:	Client: T&T	Date: 14/08/2018	Scale: 1 : 87
Project: HOKOWHITU		Page: 1/1	Fig.:
		File: hokowhituCPT117.cpt

- Silty sand to sandy silt (7)
- Clayey silt to silty clay (5)
- Sand to silty sand (8)
- Silty sand to sandy silt (7)
- Sand (9)

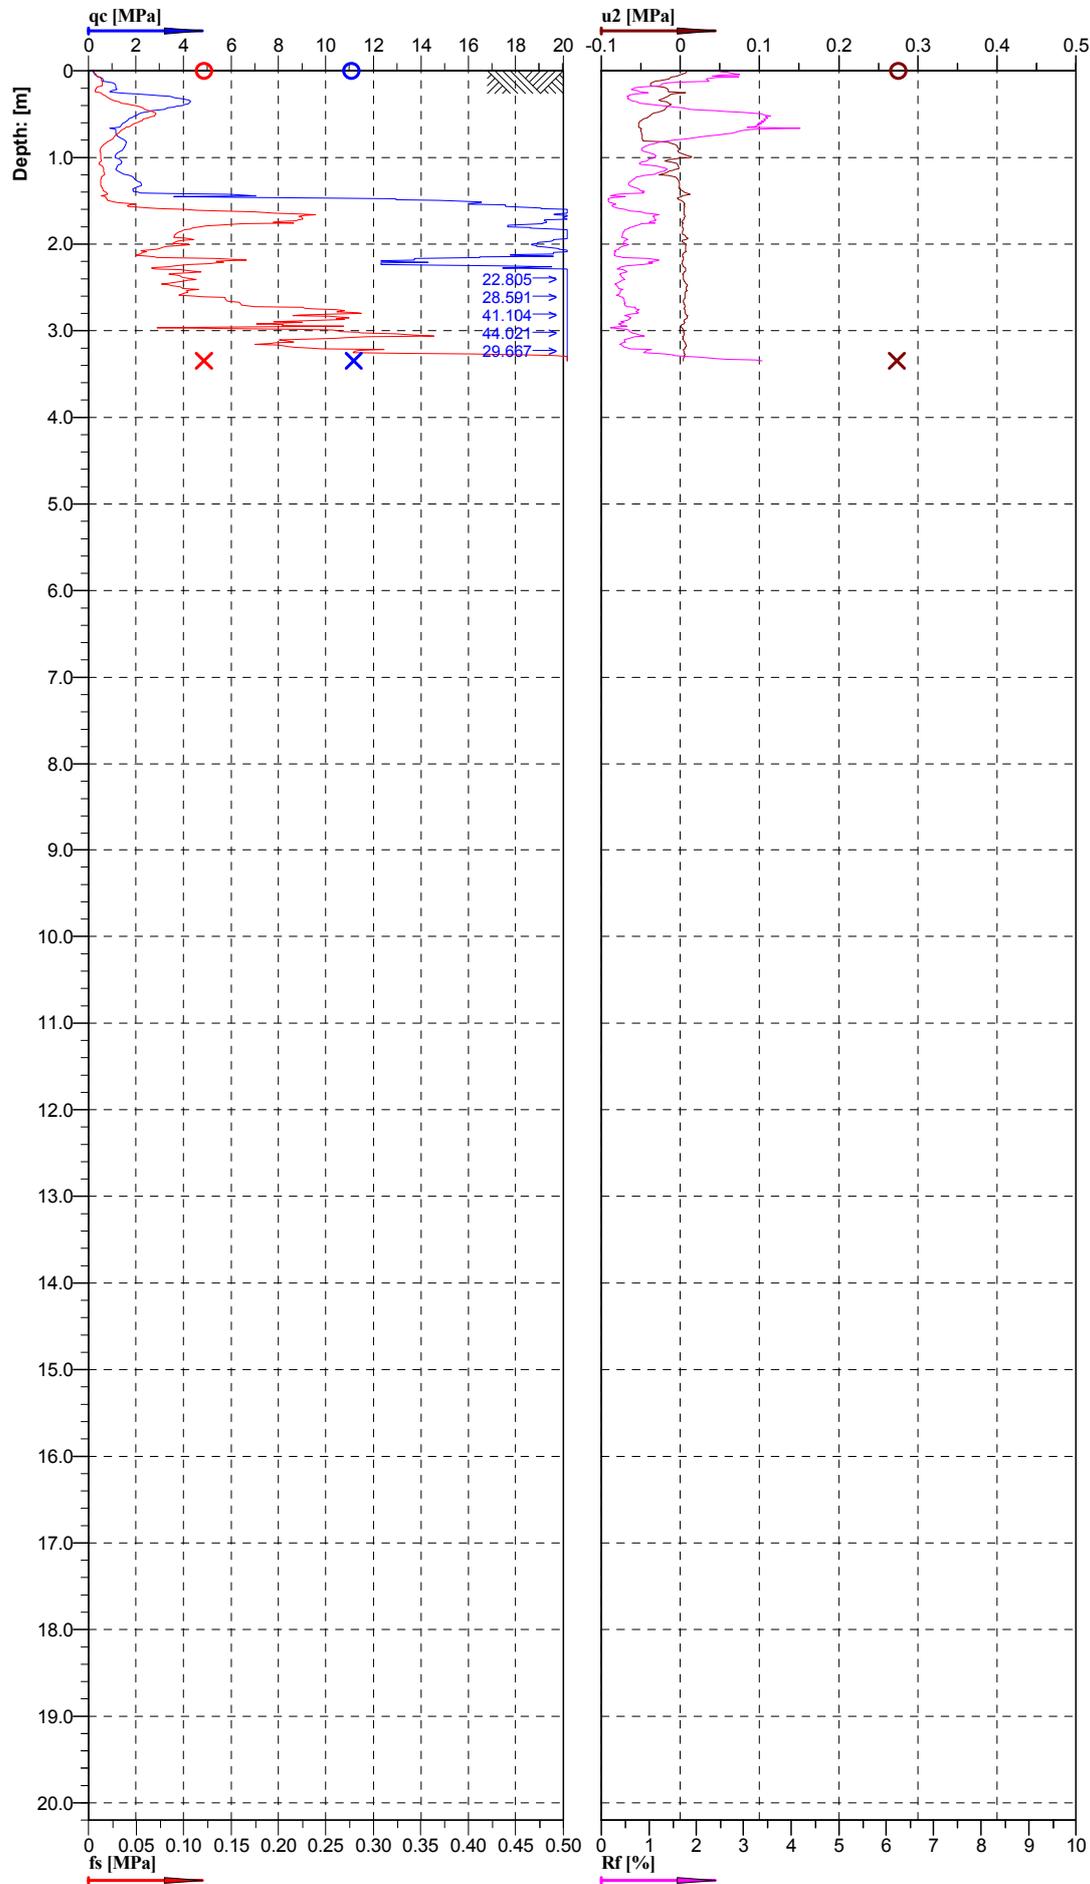
Location: PALMERSTON NORTH	Position: X: 0.00 m, Y: 0.00 m	Ground level: 0.00	Test No.: CPT119
Project ID:	Client: T&T	Date: 14/08/2018	Scale: 1 : 87
Project: HOKOWHITU		Page: 1/1	Fig.:
		File: hokowhituCPT119.cpt

- Clay (3)
- Silty clay to clay (4)
- Sandy silt to clayey silt (6)
- Sand (9)
- Gravely sand to sand (10)

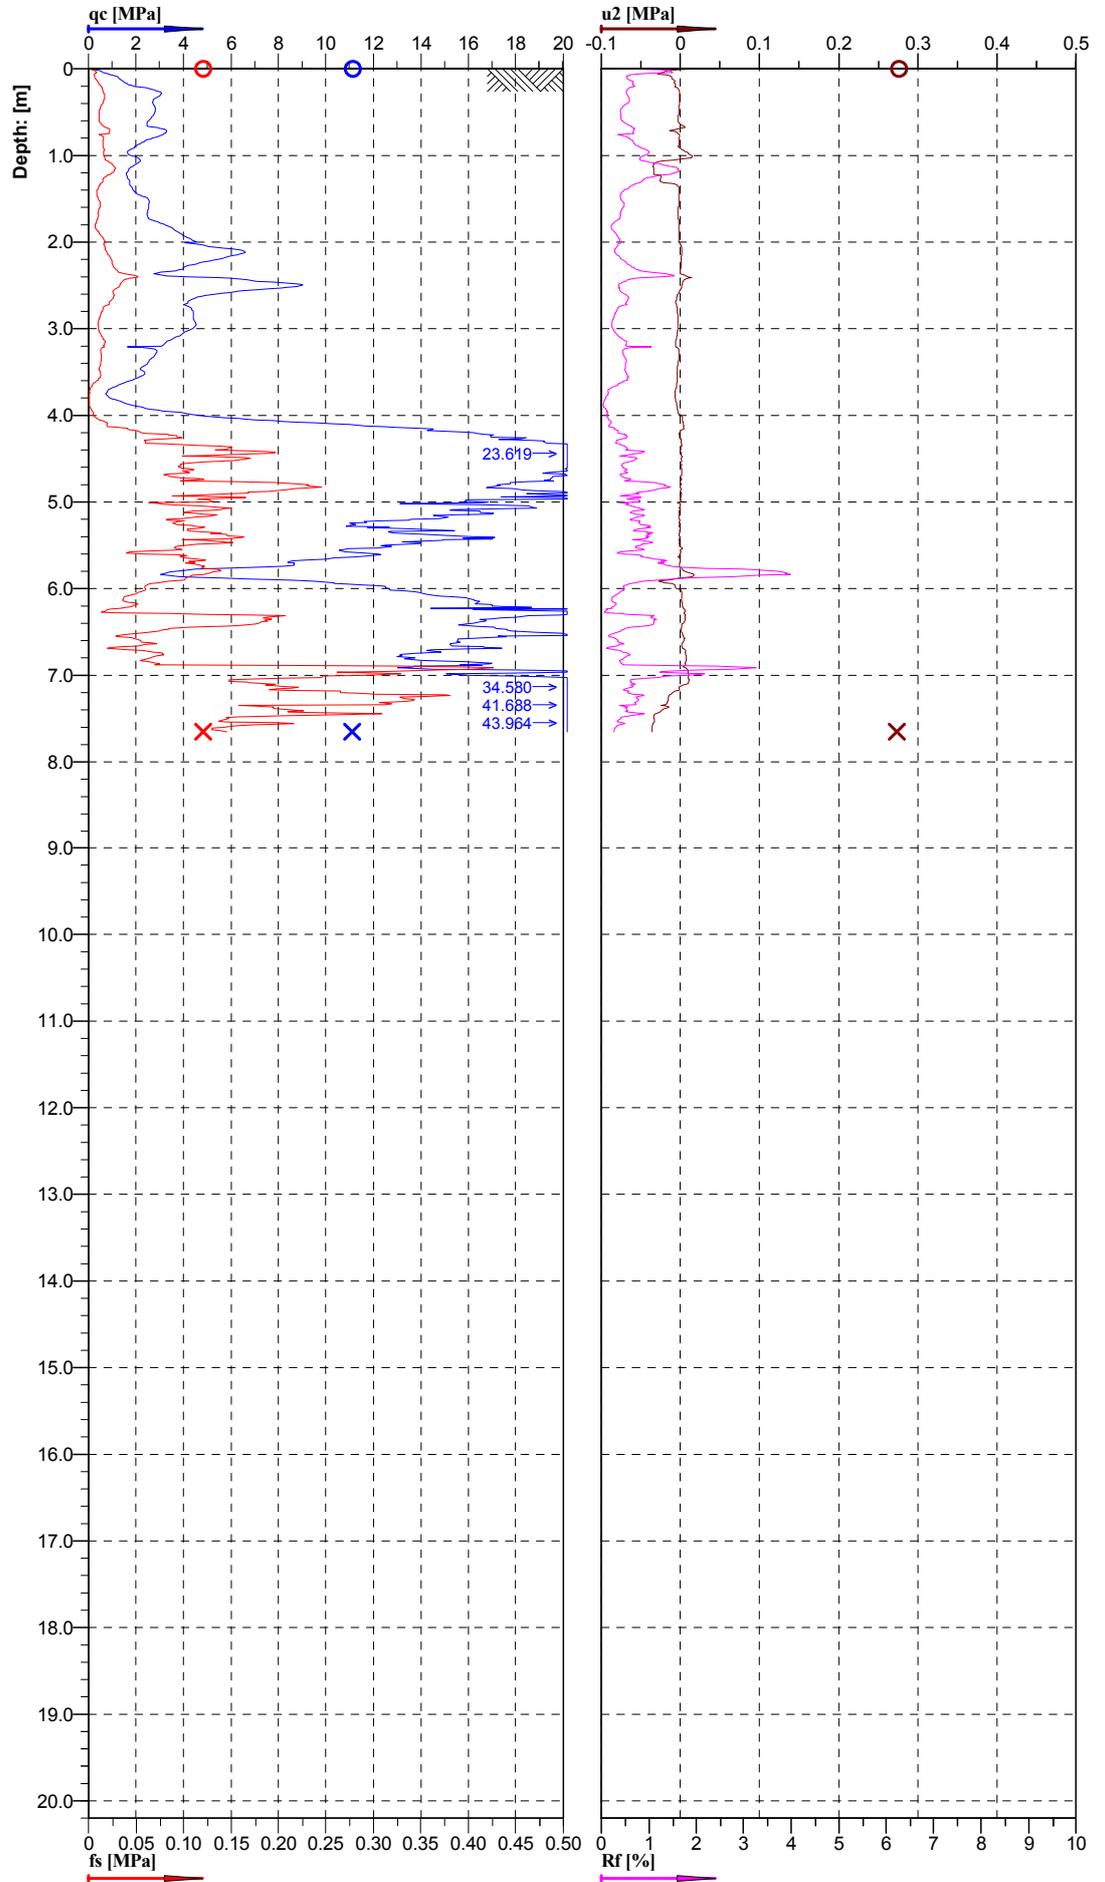
Location: PALMERSTON NORTH	Position: X: 0.00 m, Y: 0.00 m	Ground level: 0.00	Test No.: CPT121
Project ID:	Client: T&T	Date: 15/08/2018	Scale: 1 : 87
Project: HOKOWHITU		Page: 1/1	Fig.:
		File: hokowhituCPT121.cpt

- -
 -
 -
 -
 -
 -
 -
- Silty sand to sandy silt (7)
 - Sandy silt to clayey silt (6)
 - Silty sand to sandy silt (7)
 - Sand to silty sand (8)
 - Silty sand to sandy silt (7)
 - Sensitive fine grained (1)
 - Sand (9)
 - Gravely sand to sand (10)

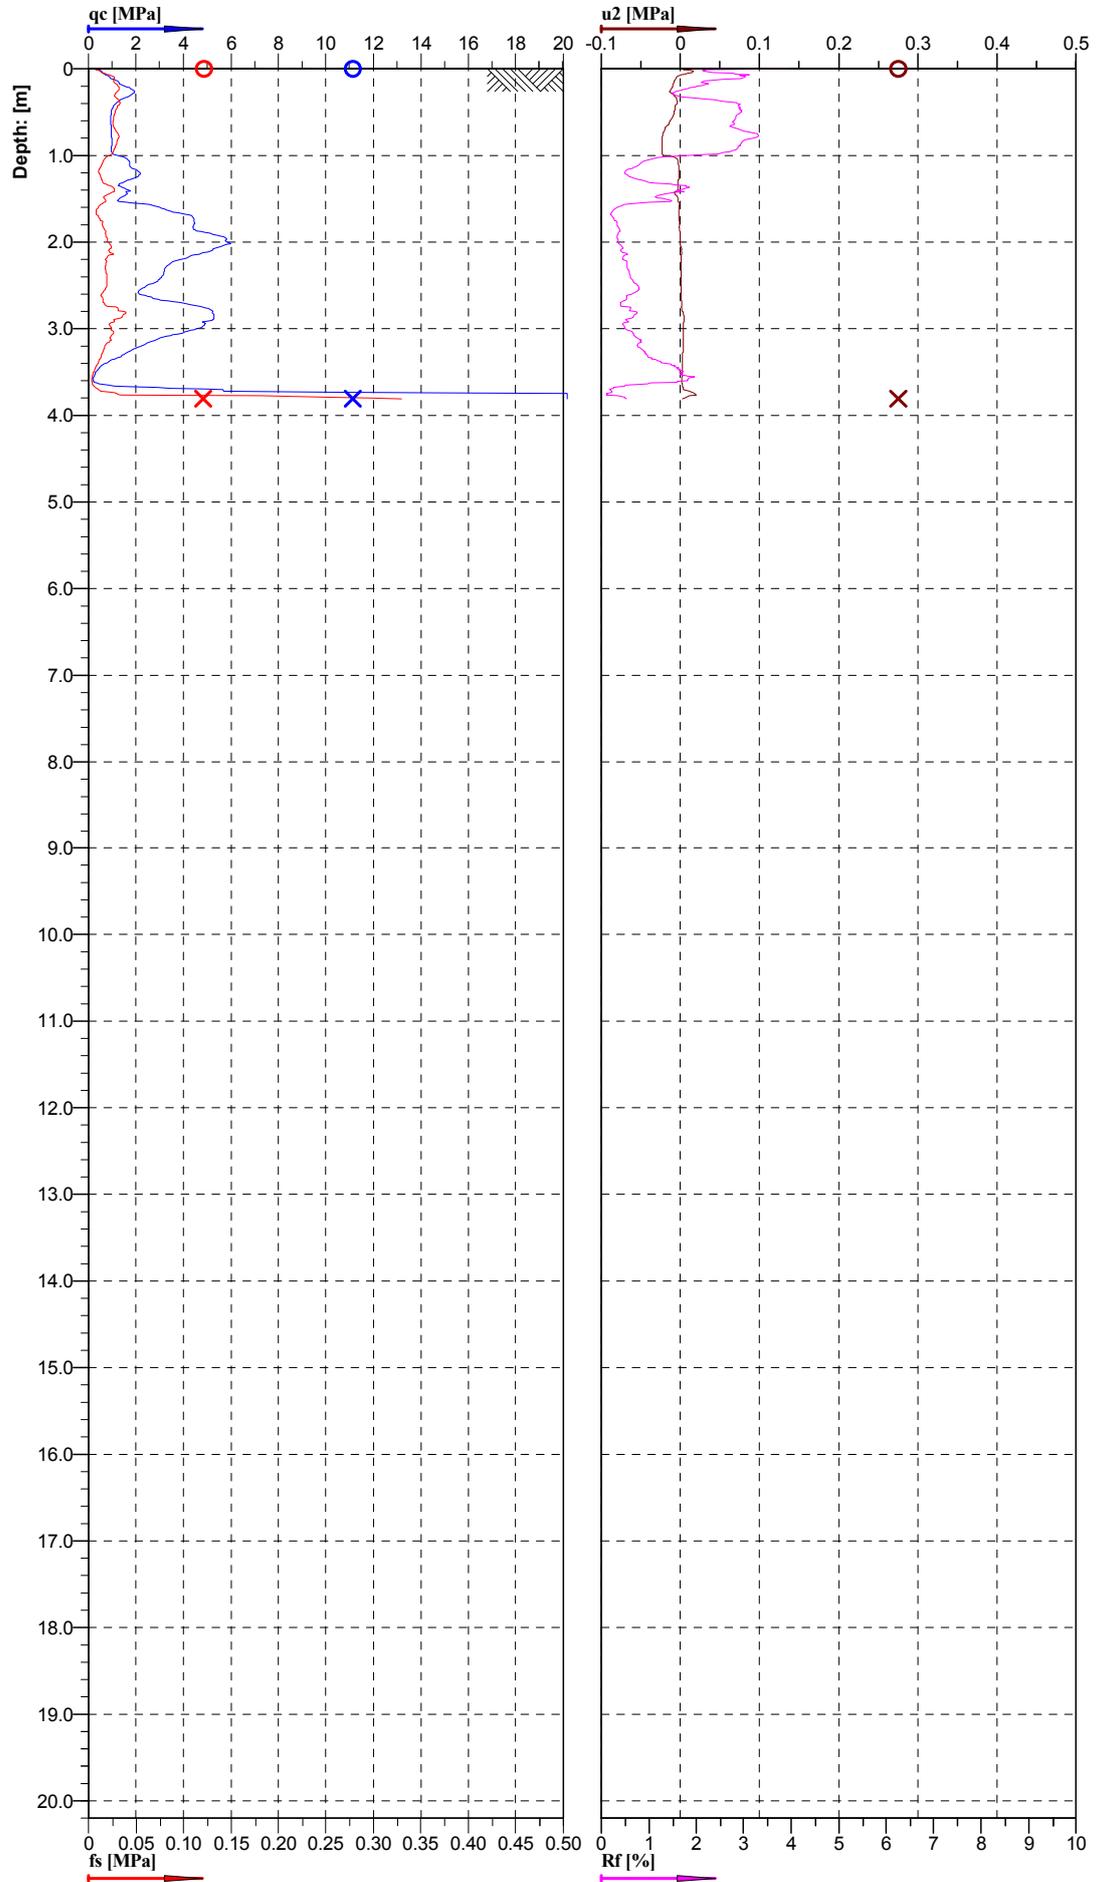
Location: PALMERSTON NORTH	Position: X: 0.00 m, Y: 0.00 m	Ground level: 0.00	Test No.: CPT122
Project ID:	Client: T&T	Date: 14/08/2018	Scale: 1 : 87
Project: HOKOWHITU		Page: 1/1	Fig.:
		File: hokowhituCPT122.cpt

- Silty clay to clay (4)
- Silty clay to clay (4)
- Sandy silt to clayey silt (6)
- Sand to silty sand (8)
- Silty sand to sandy silt (7)
- Sand to silty sand (8)
- Silty sand to sandy silt (7)
- Sensitive fine grained (1)
