Centennial Park, Palmerston North

Geotechnical Investigation and Liquefaction Assessment

Prepared for
Wallace Development Company Ltd

Prepared by
Tonkin & Taylor Ltd

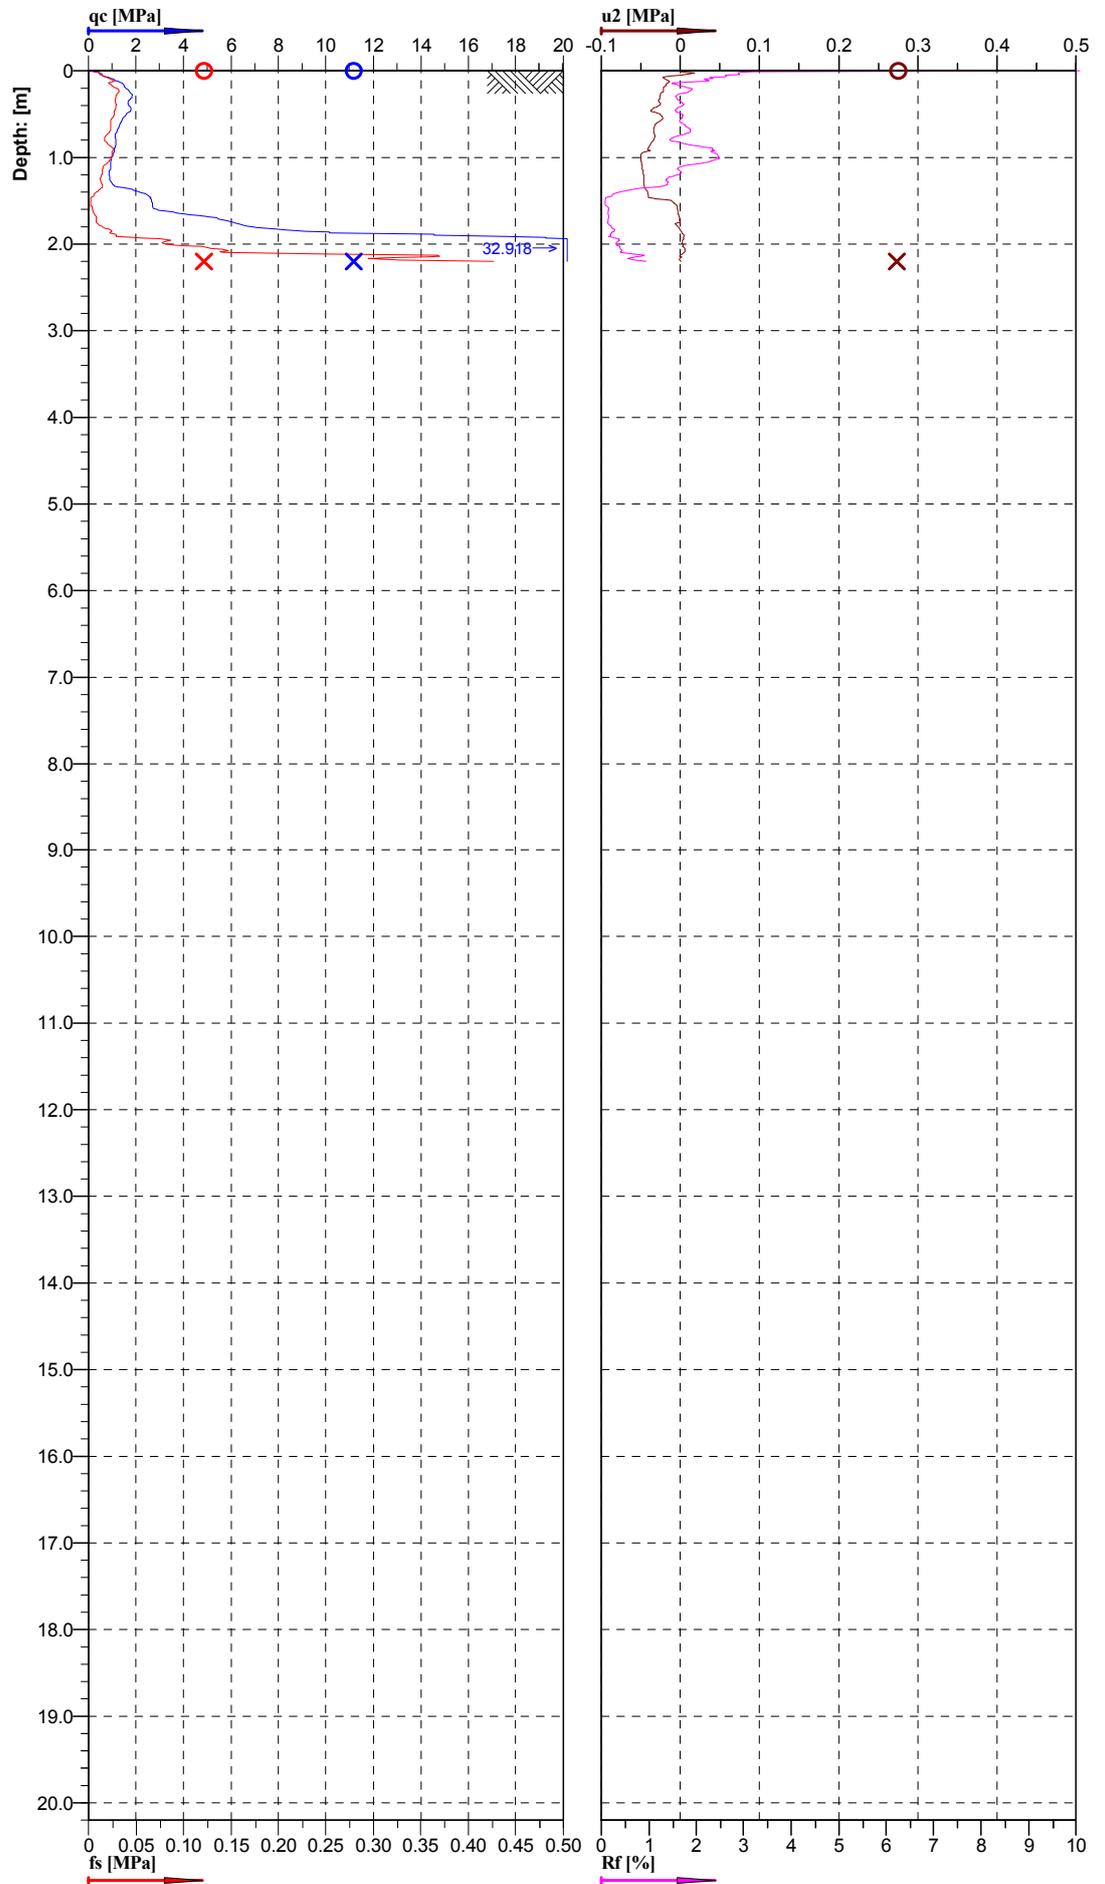
Location: PALMERSTON NORTH	Position: X: 0.00 m, Y: 0.00 m	Ground level: 0.00	Test No.: CPT123
Project ID:	Client: T&T	Date: 15/08/2018	Scale: 1 : 87
Project: HOKOWHITU		Page: 1/1	Fig.:
		File: hokowhituCPT123.cpt

- Sandy silt to clayey silt (6)
- Clayey silt to silty clay (5)
- Silty sand to sandy silt (7)
- Sand to silty sand (8)
- Gravely sand to sand (10)

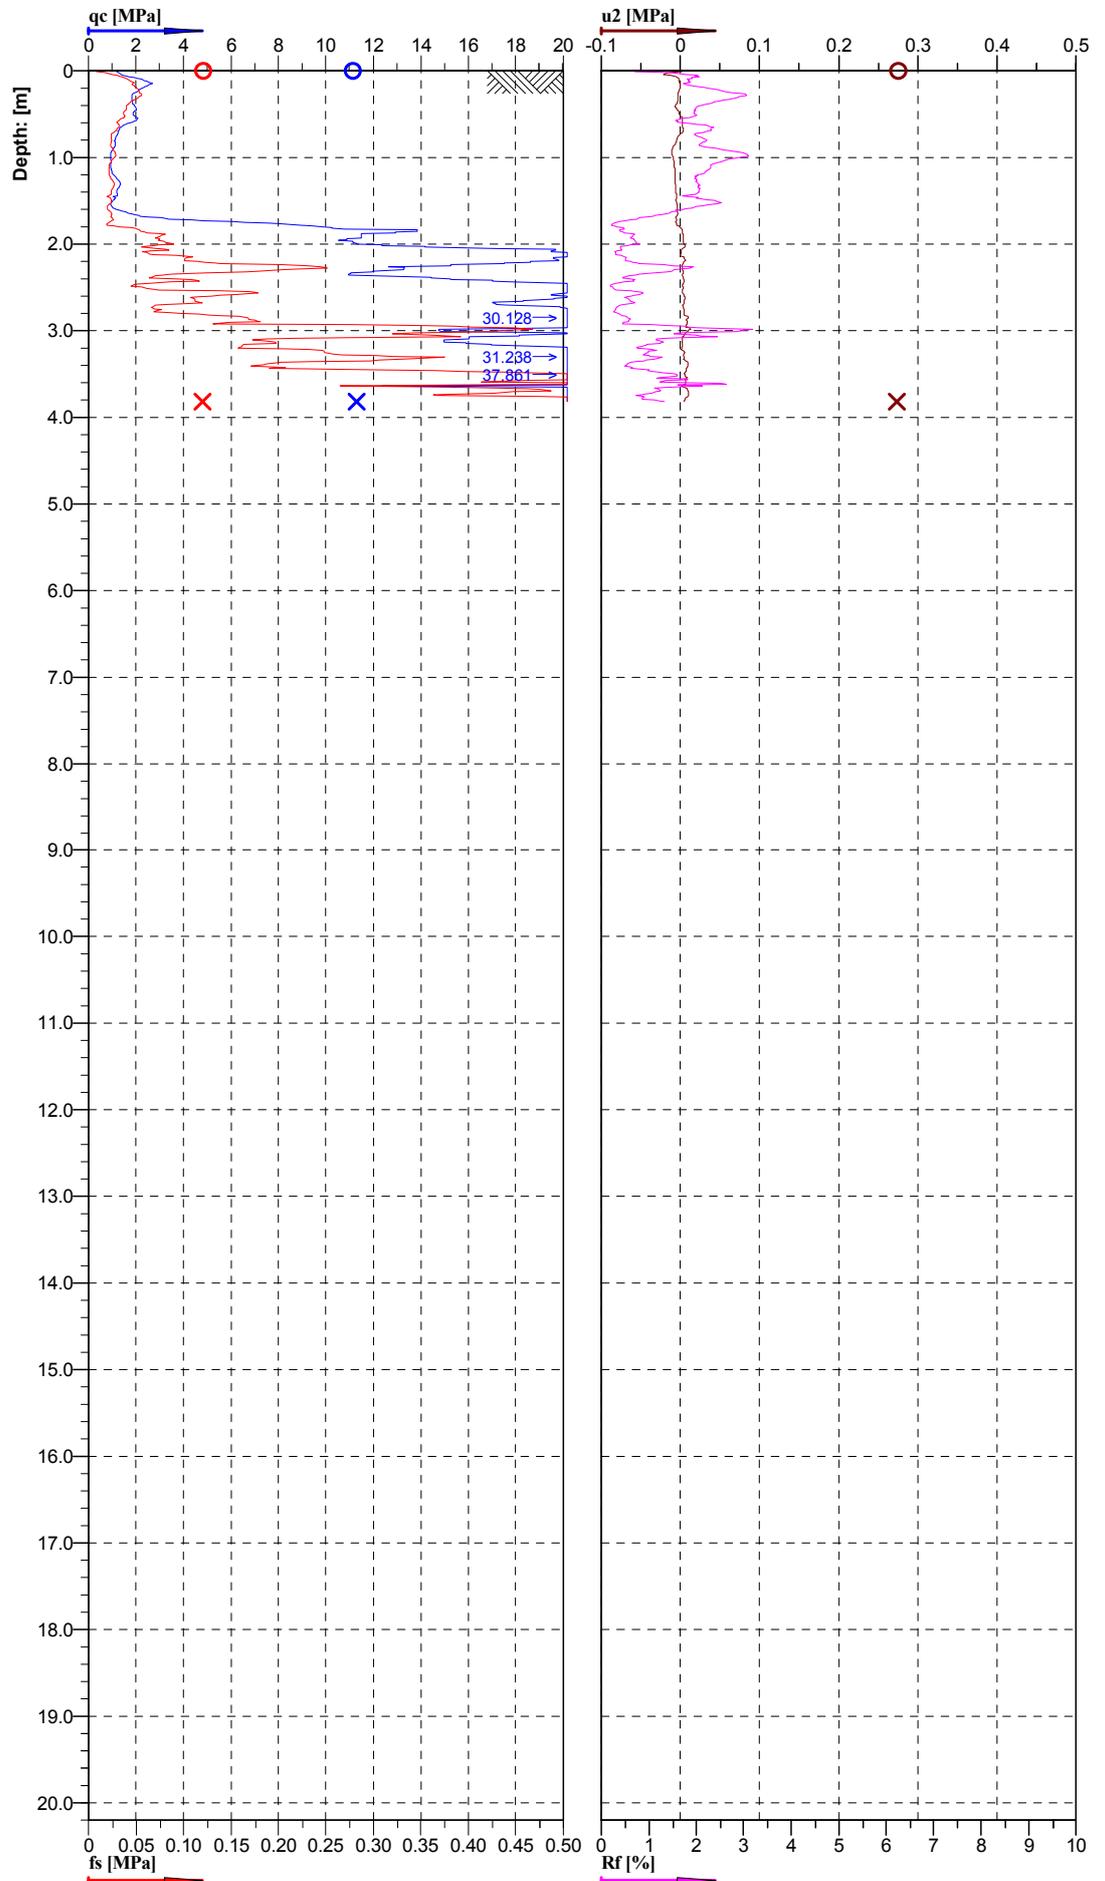
Location: PALMERSTON NORTH	Position: X: 0.00 m, Y: 0.00 m	Ground level: 0.00	Test No.: CPT124
Project ID:	Client: T&T	Date: 14/08/2018	Scale: 1 : 87
Project: HOKOWHITU		Page: 1/1	Fig.:
		File: hokowhituCPT124.cpt

- Clayey silt to silty clay (5)
- Sandy silt to clayey silt (6)
- Clayey silt to silty clay (5)
- Sand (9)
- Gravely sand to sand (10)
- Sand (9)

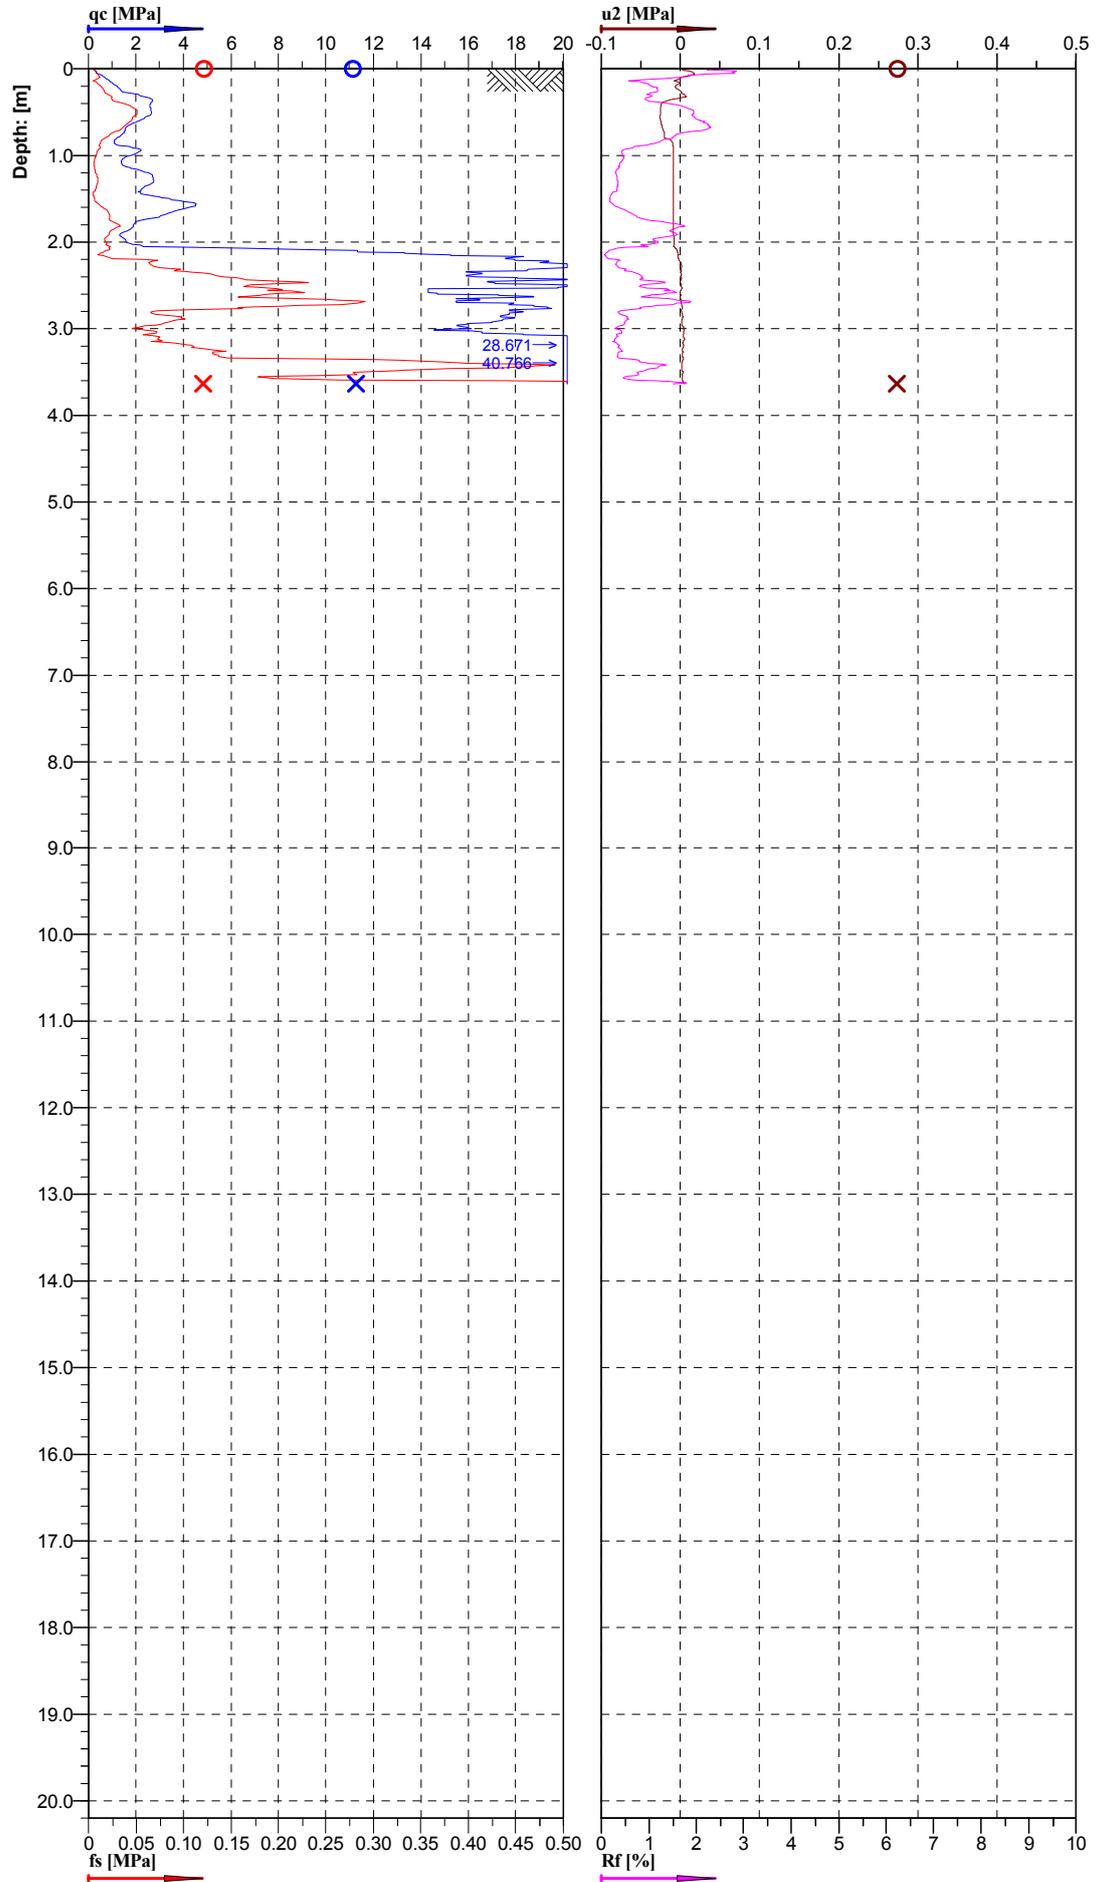
Location: PALMERSTON NORTH	Position: X: 0.00 m, Y: 0.00 m	Ground level: 0.00	Test No.: CPT125
Project ID:	Client: T&T	Date: 14/08/2018	Scale: 1 : 87
Project: HOKOWHITU		Page: 1/1	Fig.:
		File: hokowhituCPT125.cpt

- Clay (3)
- Sandy silt to clayey silt (6)
- Clayey silt to silty clay (5)
- Silty sand to sandy silt (7)
- Sandy silt to clayey silt (6)
- Sand (9)
- Sand to silty sand (8)
- Sand (9)
- Gravely sand to sand (10)

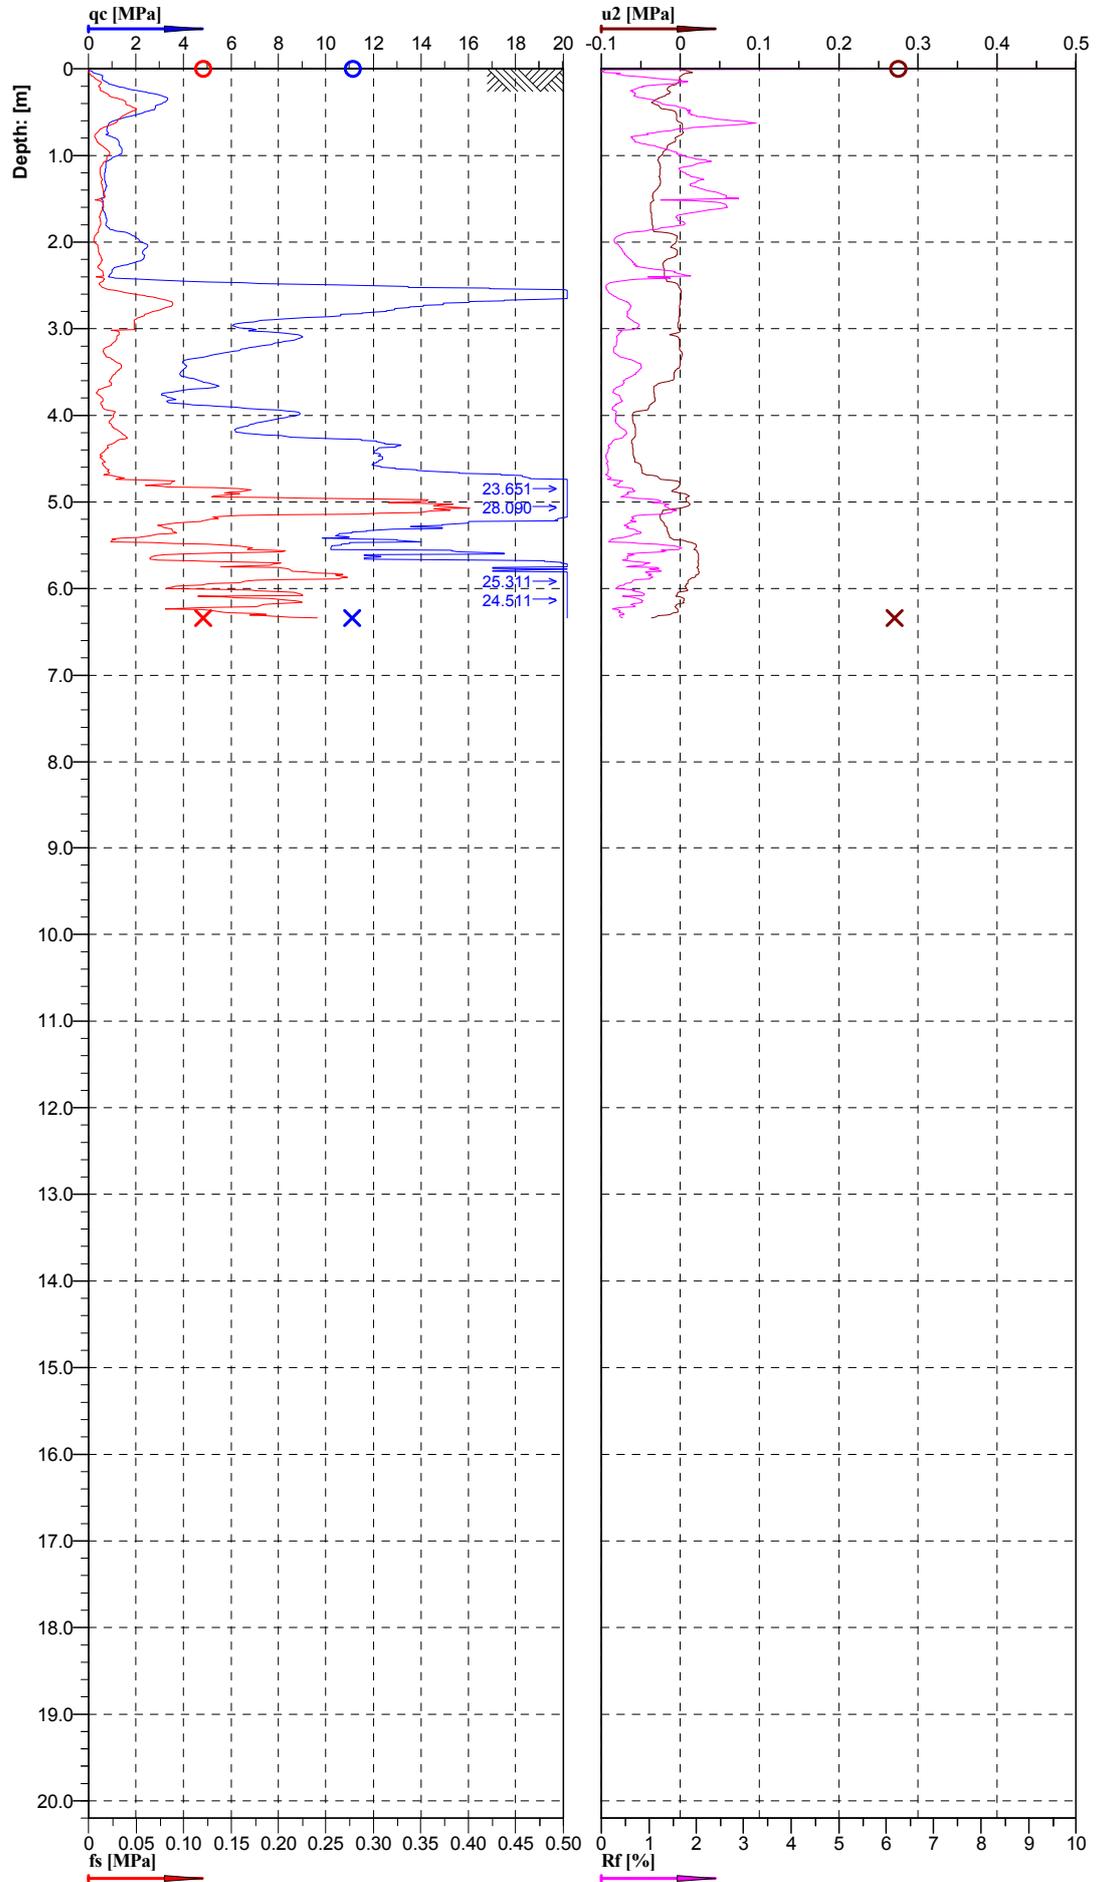
Location: PALMERSTON NORTH	Position: X: 0.00 m, Y: 0.00 m	Ground level: 0.00	Test No.: CPT126
Project ID:	Client: T&T	Date: 14/08/2018	Scale: 1 : 87
Project: HOKOWHITU		Page: 1/1	Fig.:
		File: hokowhituCPT126.cpt

- Sensitive fine grained (1)
- Silty sand to sandy silt (7)
- Sandy silt to clayey silt (6)
- Clayey silt to silty clay (5)
- Silty clay to clay (4)
- Clayey silt to silty clay (5)
- Silty sand to sandy silt (7)
- Clayey silt to silty clay (5)
- Sand (9)
- Sand to silty sand (8)
- Silty sand to sandy silt (7)
- Sand to silty sand (8)
- Sand (9)

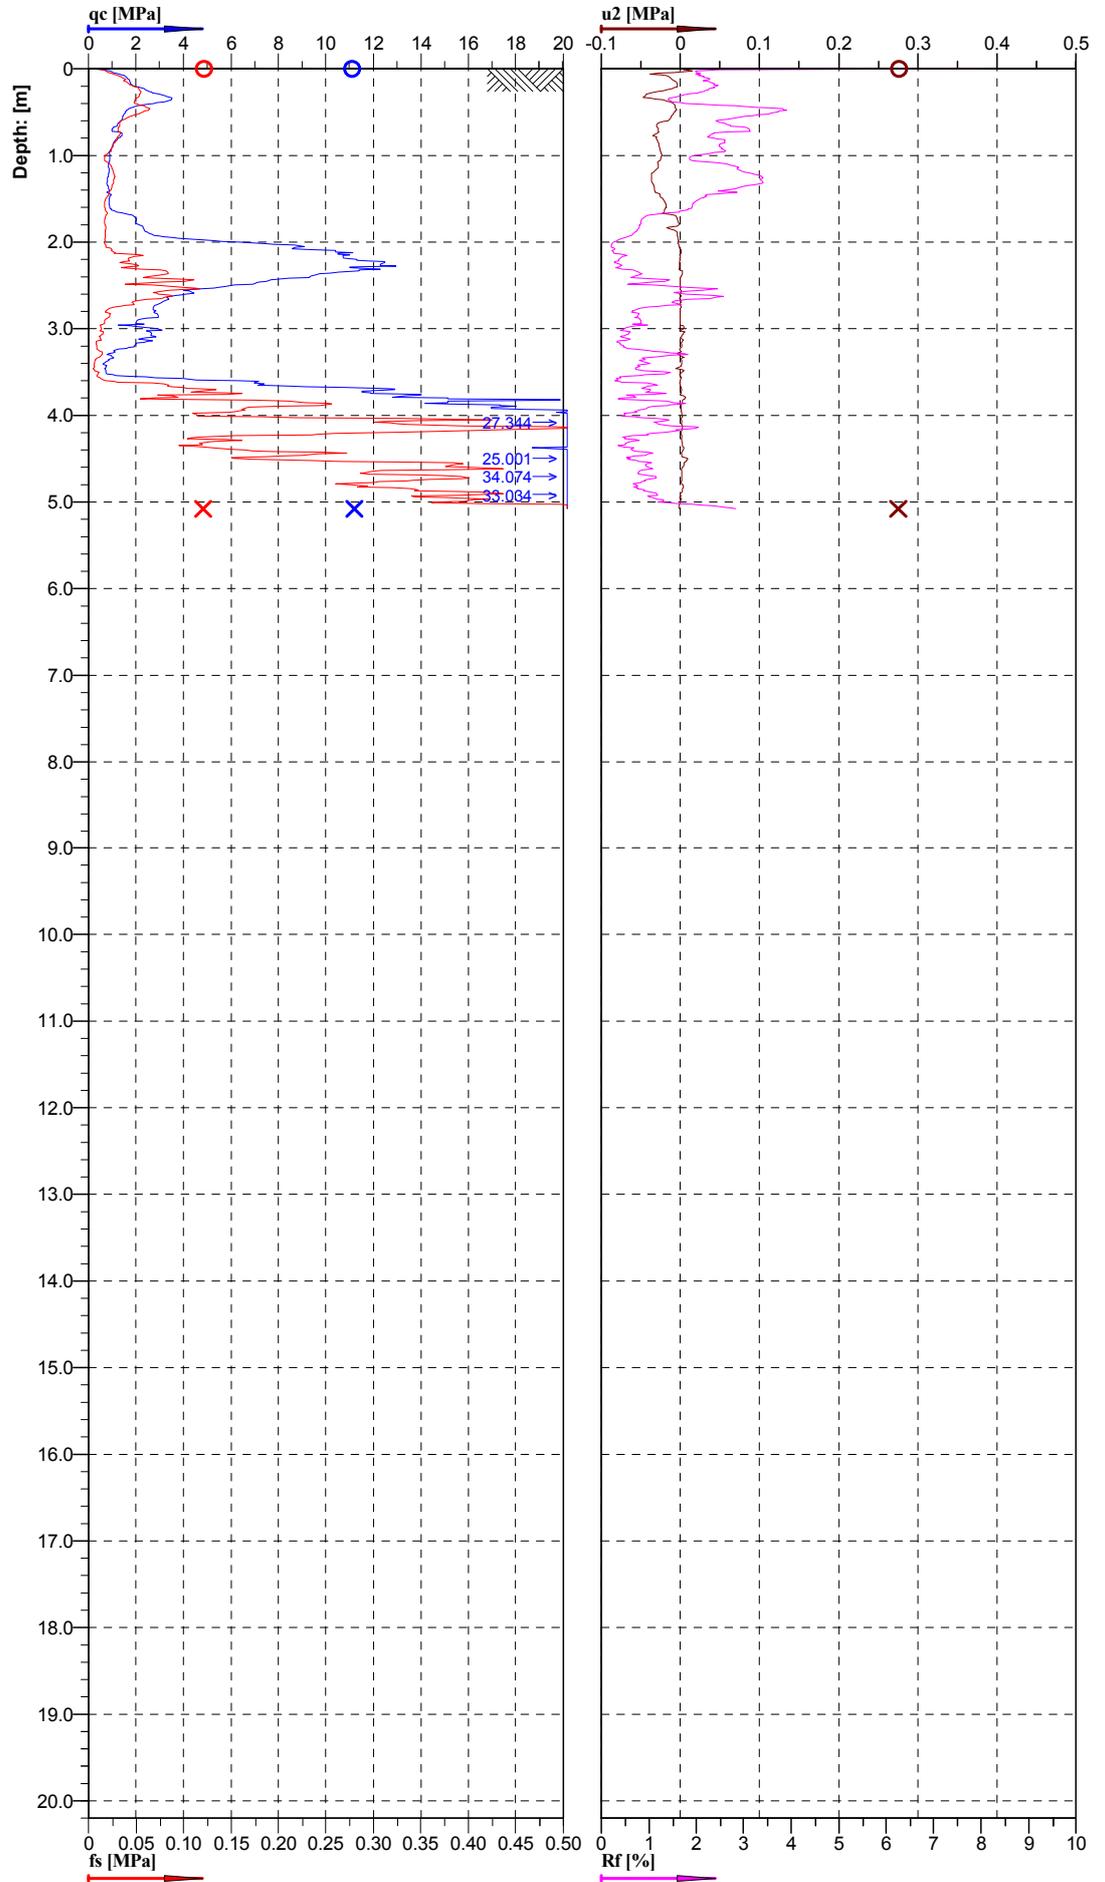
Location: PALMERSTON NORTH	Position: X: 0.00 m, Y: 0.00 m	Ground level: 0.00	Test No.: CPT128
Project ID:	Client: T&T	Date: 14/08/2018	Scale: 1 : 87
Project: HOKOWHITU		Page: 1/1	Fig.:
		File: hokowhituCPT128.cpt

- Clayey silt to silty clay (5)
- Silty clay to clay (4)
- Clayey silt to silty clay (5)
- Silty sand to sandy silt (7)
- Sand (9)
- Sandy silt to clayey silt (6)
- Silty sand to sandy silt (7)
- Sensitive fine grained (1)
- Sand to silty sand (8)
- Sand (9)

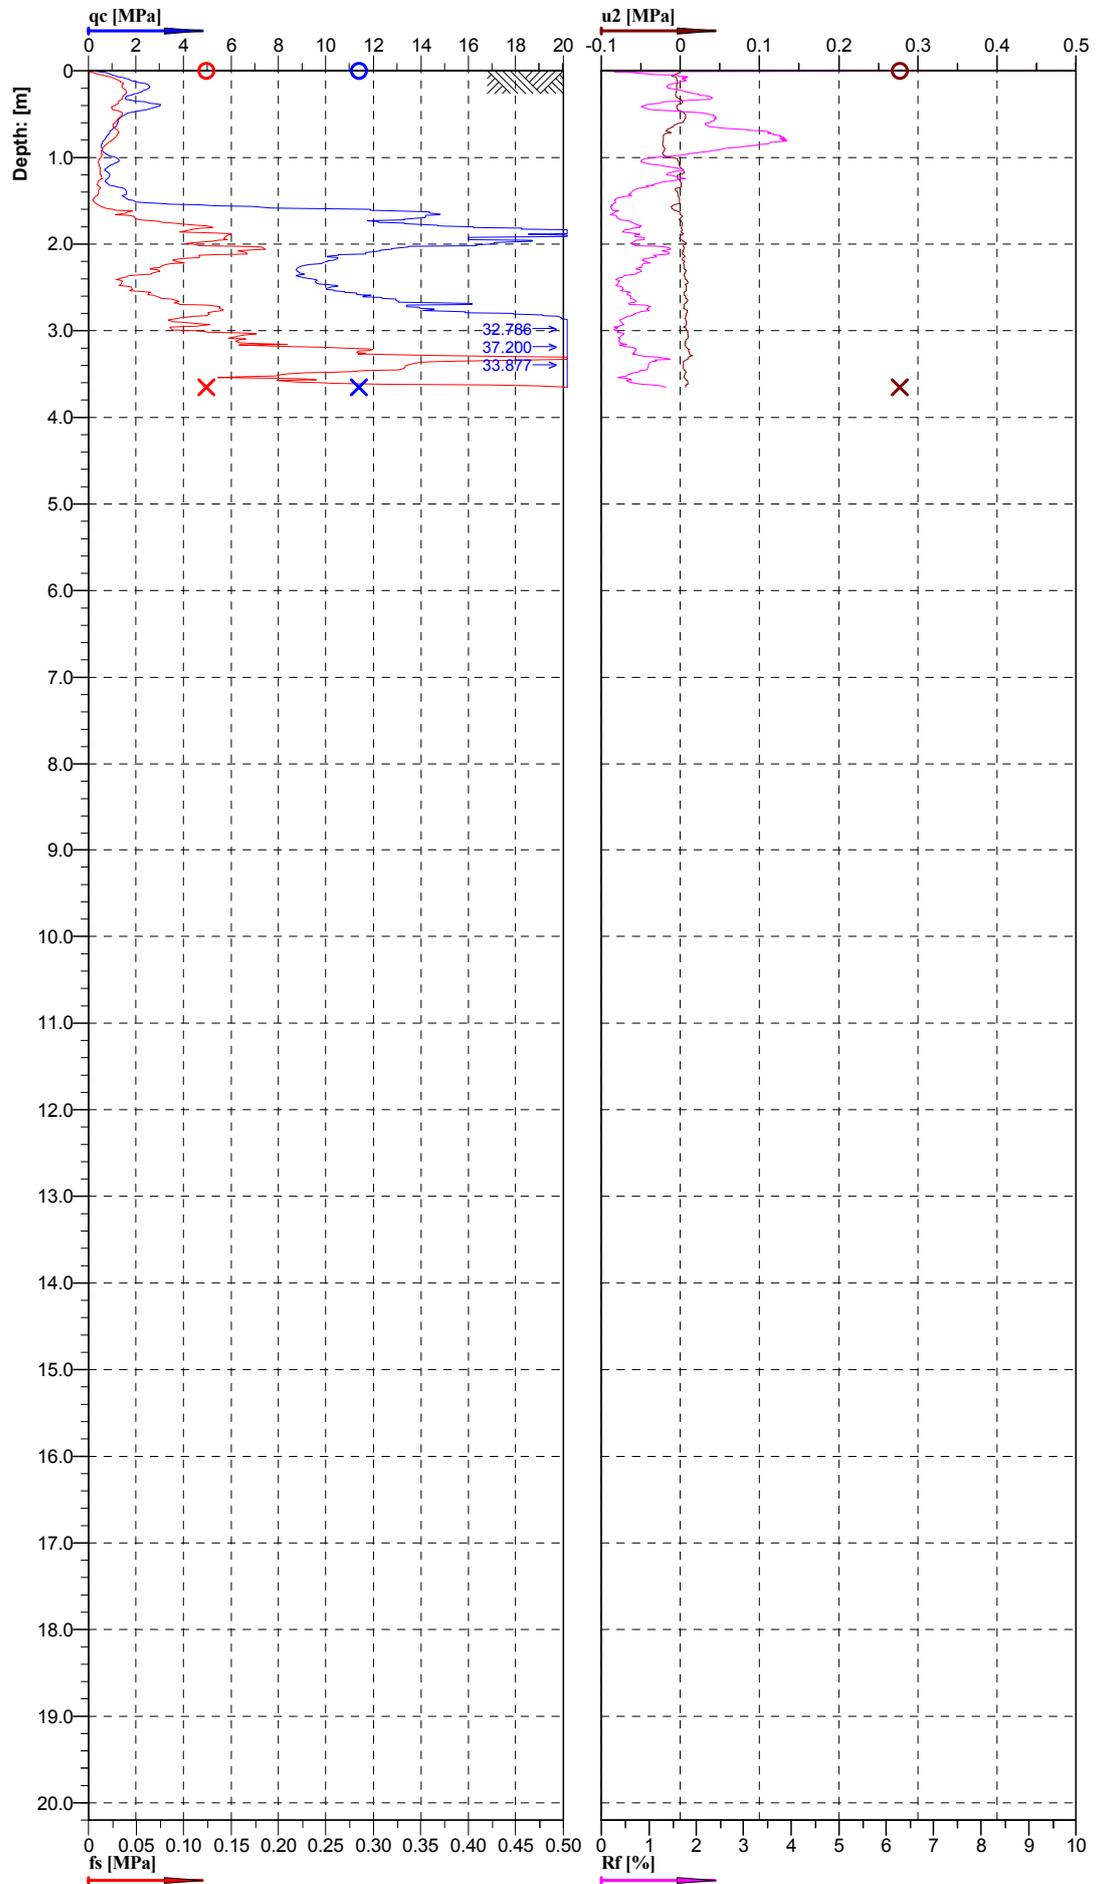
Location: PALMERSTON NORTH	Position: X: 0.00 m, Y: 0.00 m	Ground level: 0.00	Test No.: CPT129
Project ID:	Client: T&T	Date: 13/08/2018	Scale: 1 : 87
Project: HOKOWHITU		Page: 1/1	Fig.:
		File: hokowhituCPT129.cpt

- Sandy silt to clayey silt (6)
- Clayey silt to silty clay (5)
- Clay (3)
- Clayey silt to silty clay (5)
- Sand (9)
- Sand to silty sand (8)
- Sand (9)
- Gravely sand to sand (10)

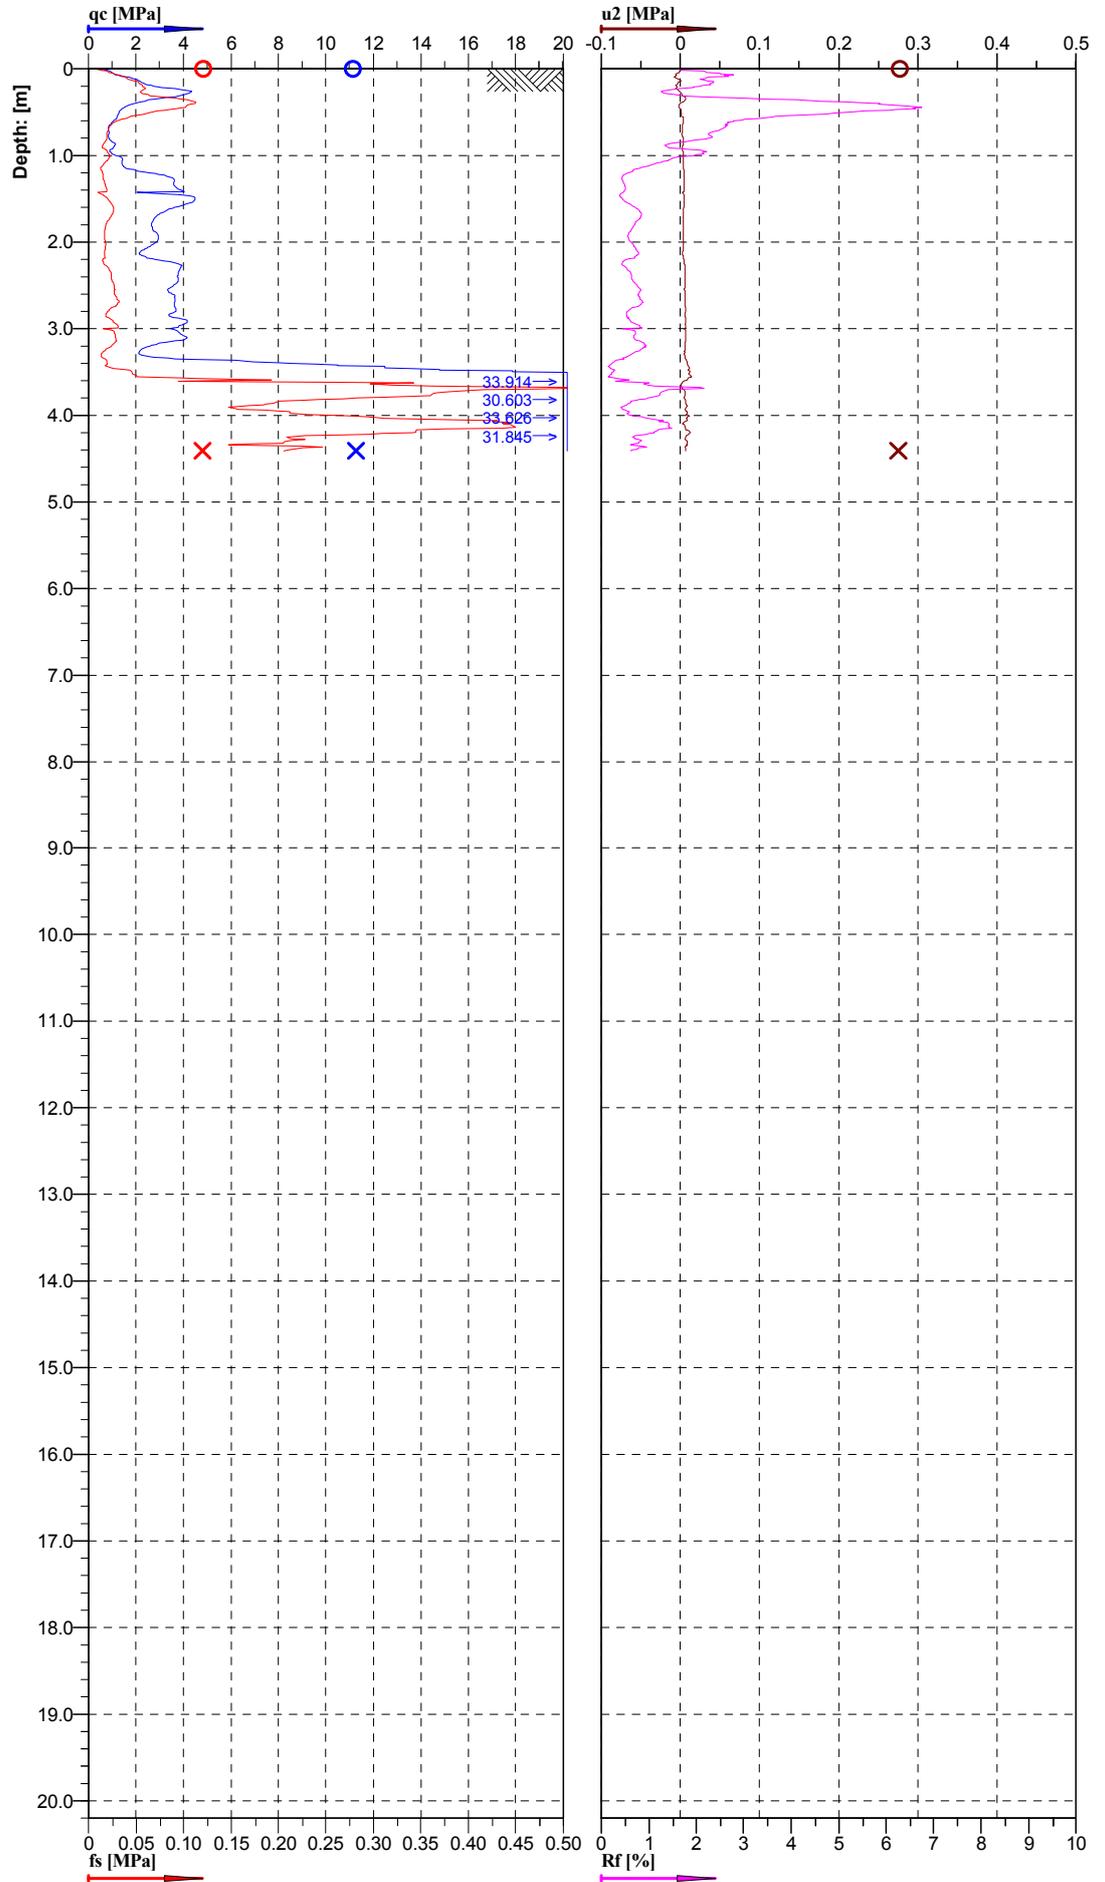
Classification by Robertson 1986

- Clayey silt to silty clay (5)
- Clay (3)
- Clayey silt to silty clay (5)
- Silty sand to sandy silt (7)
- Sand (9)

Cone No: 4494
 Tip area [cm²]: 10
 Sleeve area [cm²]: 150

Location: PALMERSTON NORTH	Position: X: 0.00 m, Y: 0.00 m	Ground level: 0.00	Test No.: CPT130
Project ID:	Client: T&T	Date: 13/08/2018	Scale: 1 : 87
Project: HOKOWHITU		Page: 1/1	Fig.:
		File: hokowhитуCPT130.cpt

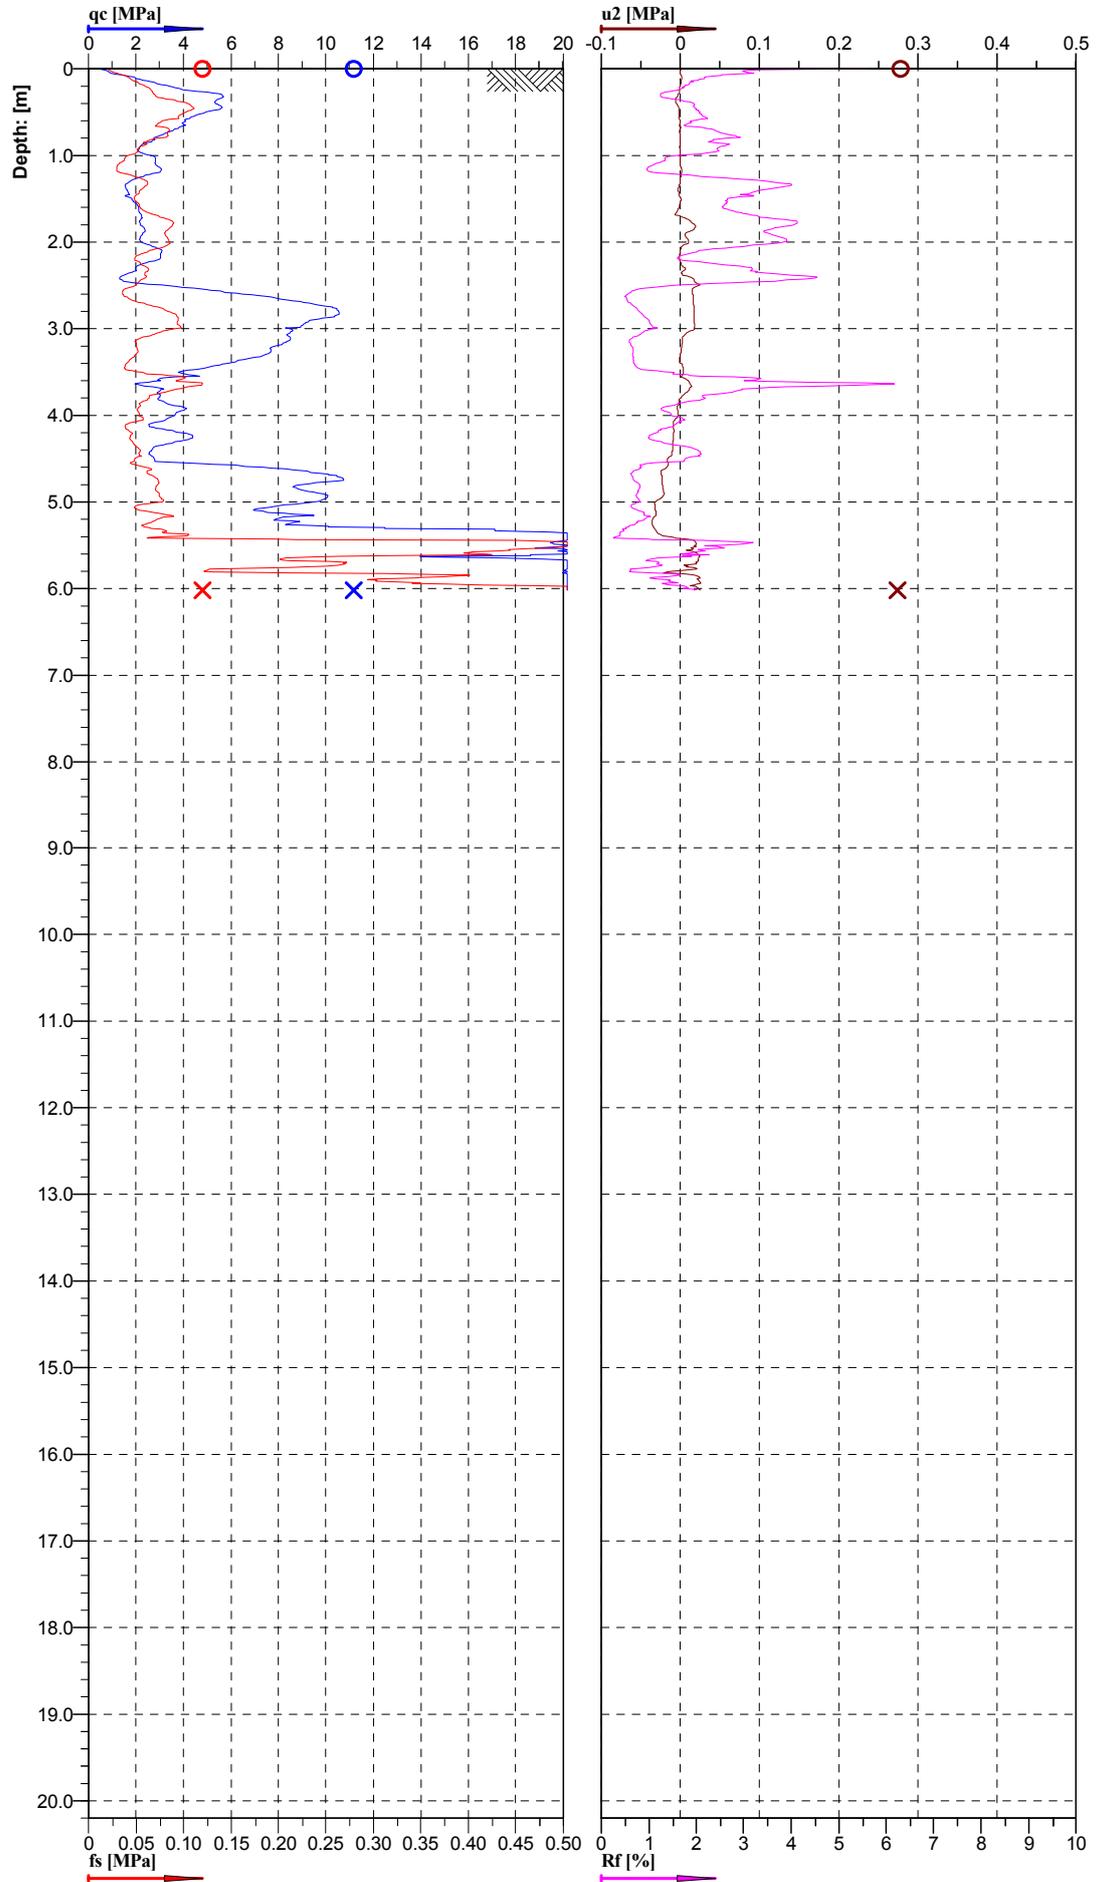
Classification by Robertson 1986

- Silty clay to clay (4)
- Silty sand to sandy silt (7)
- Sandy silt to clayey silt (6)
- Clayey silt to silty clay (5)
- Silty clay to clay (4)
- Sandy silt to clayey silt (6)
- Sand to silty sand (8)
- Sandy silt to clayey silt (6)
- Sand to silty sand (8)
- Silty sand to sandy silt (7)
- Sand (9)

Cone No: 4494
 Tip area [cm²]: 10
 Sleeve area [cm²]: 150

Location: PALMERSTON NORTH	Position: X: 0.00 m, Y: 0.00 m	Ground level: 0.00	Test No.: CPT132
Project ID:	Client: T&T	Date: 13/08/2018	Scale: 1 : 87
Project: HOKOWHITU		Page: 1/1	Fig.:
		File: hokowhituCPT132.cpt

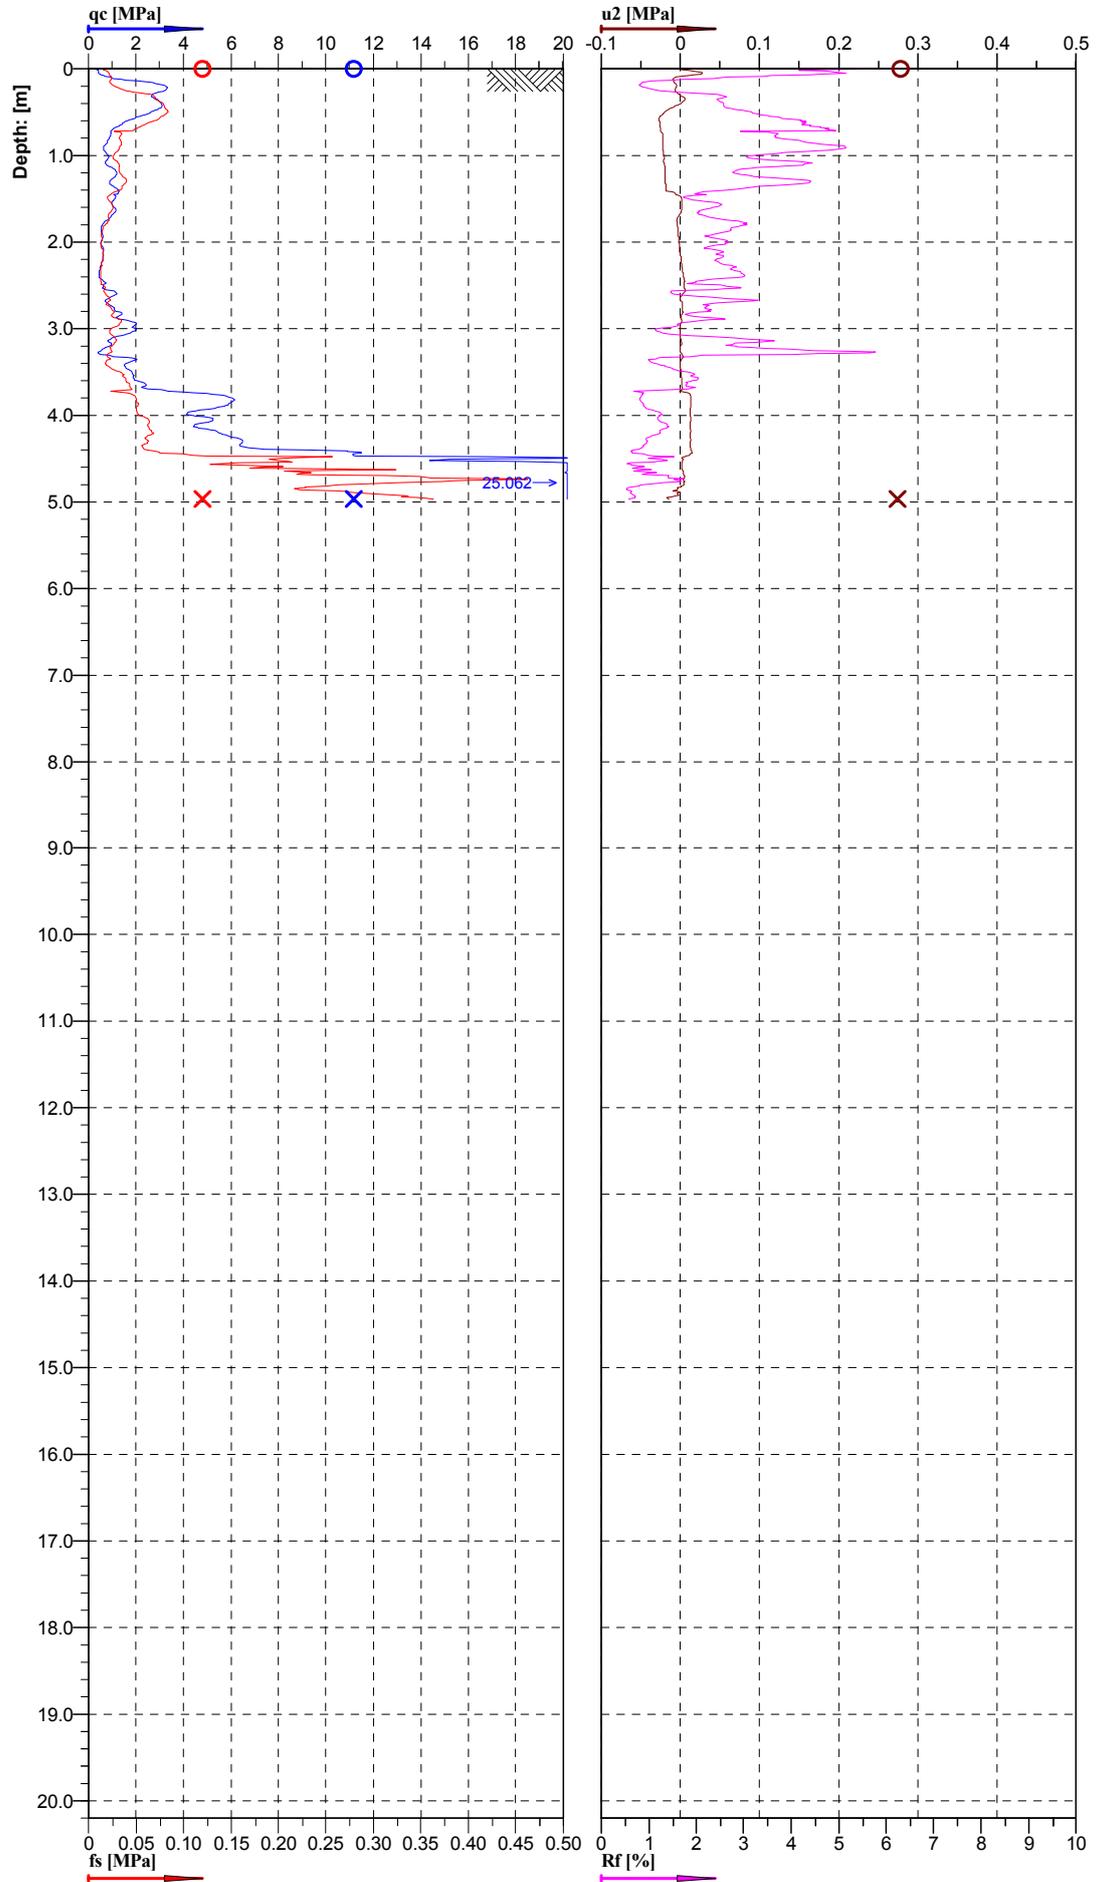
Classification by Robertson 1986

- Clay (3)
- Sandy silt to clayey silt (6)
- Clay (3)
- Clayey silt to silty clay (5)
- Silty clay to clay (4)
- Clayey silt to silty clay (5)
- Clay (3)
- Sandy silt to clayey silt (6)
- Silty sand to sandy silt (7)
- Sand (9)

Cone No: 4494
 Tip area [cm²]: 10
 Sleeve area [cm²]: 150

Location: PALMERSTON NORTH	Position: X: 0.00 m, Y: 0.00 m	Ground level: 0.00	Test No.: CPT133
Project ID:	Client: T&T	Date: 13/08/2018	Scale: 1 : 87
Project: HOKOWHITU		Page: 1/1	Fig.:
		File: hokowhituCPT133.cpt

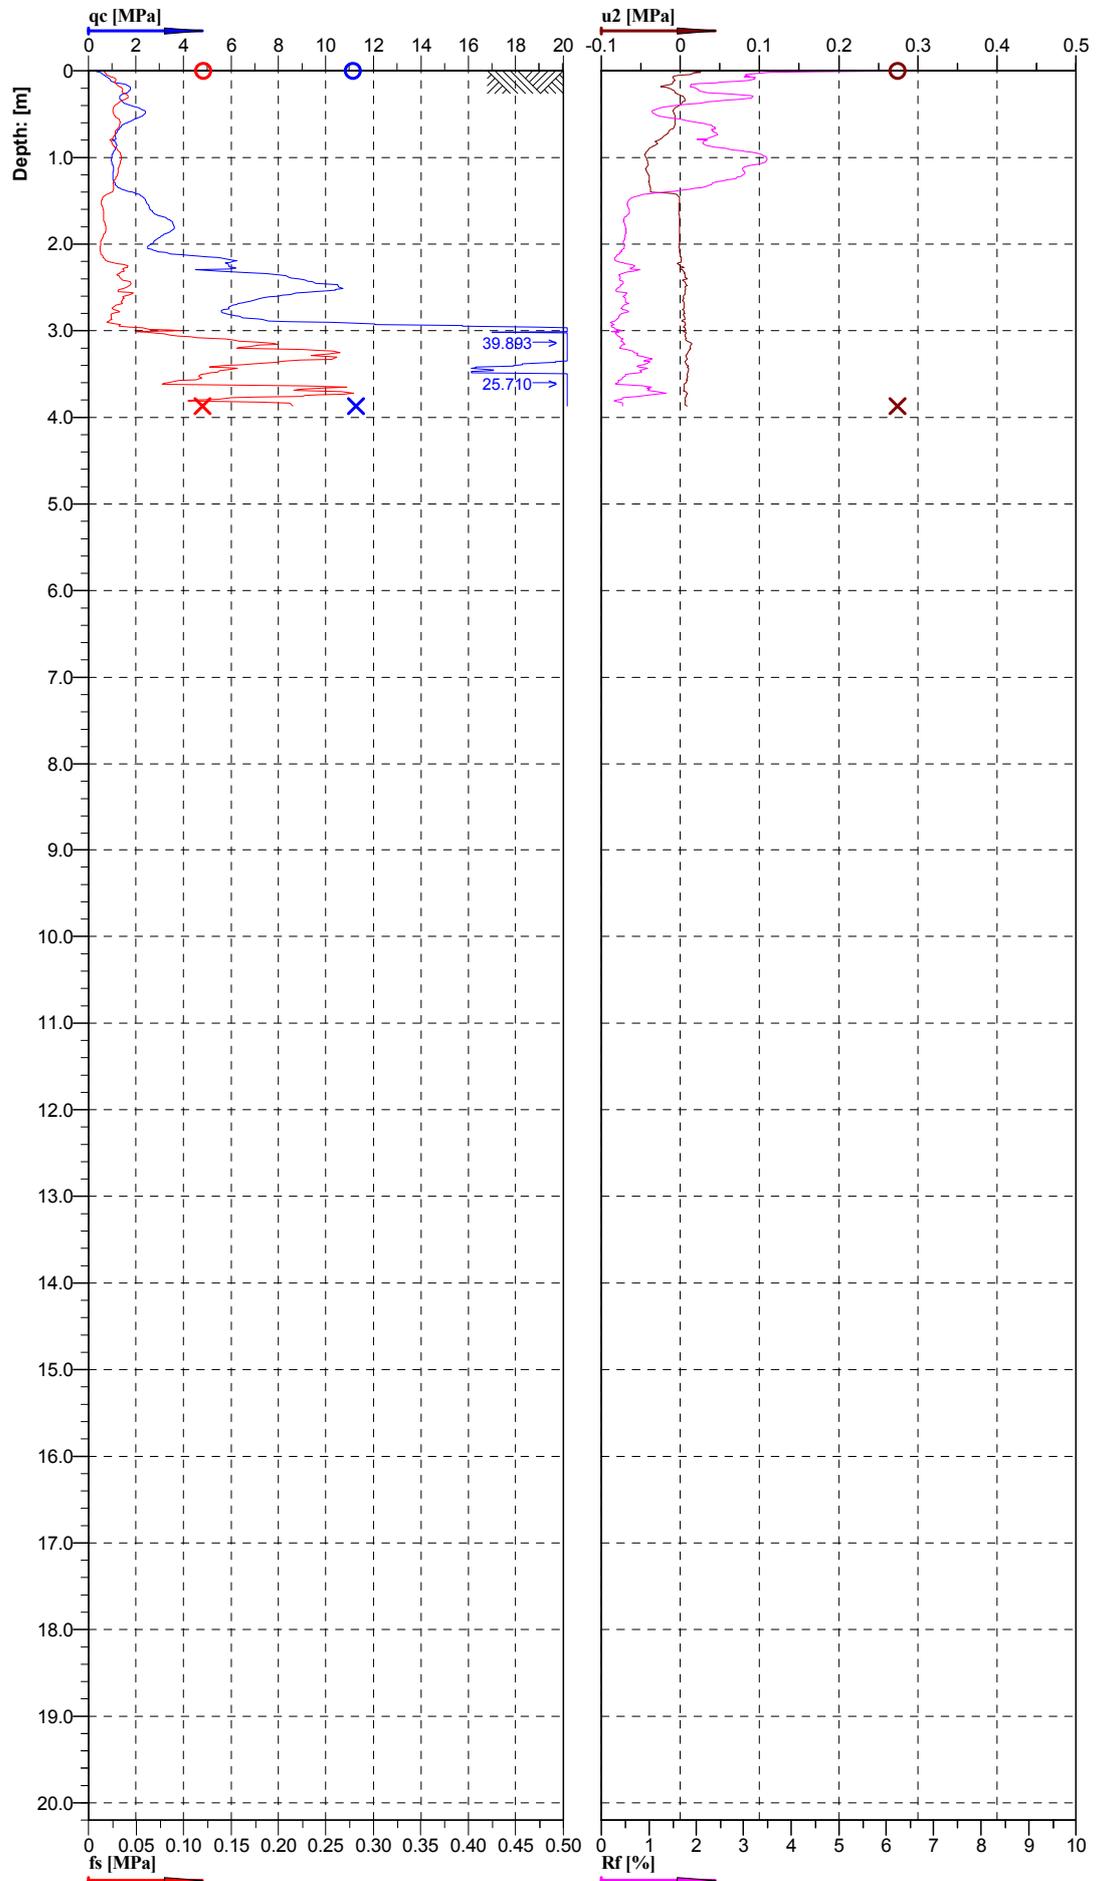
Classification by Robertson 1986

- Clay (3)
- Sandy silt to clayey silt (6)
- Clayey silt to silty clay (5)
- Silty clay to clay (4)
- Silty sand to sandy silt (7)
- Sand to silty sand (8)
- Sand (9)
- Sand to silty sand (8)
- Gravely sand to sand (10)
- Sand (9)

Cone No: 4494
 Tip area [cm²]: 10
 Sleeve area [cm²]: 150

Location: PALMERSTON NORTH	Position: X: 0.00 m, Y: 0.00 m	Ground level: 0.00	Test No.: CPT134
Project ID:	Client: T&T	Date: 14/08/2018	Scale: 1 : 87
Project: HOKOWHITU		Page: 1/1	Fig.:
		File: hokowhituCPT134.cpt
