Centennial Park, Palmerston North

Geotechnical Investigation and Liquefaction Assessment

Prepared for
Wallace Development Company Ltd

Prepared by
Tonkin & Taylor Ltd

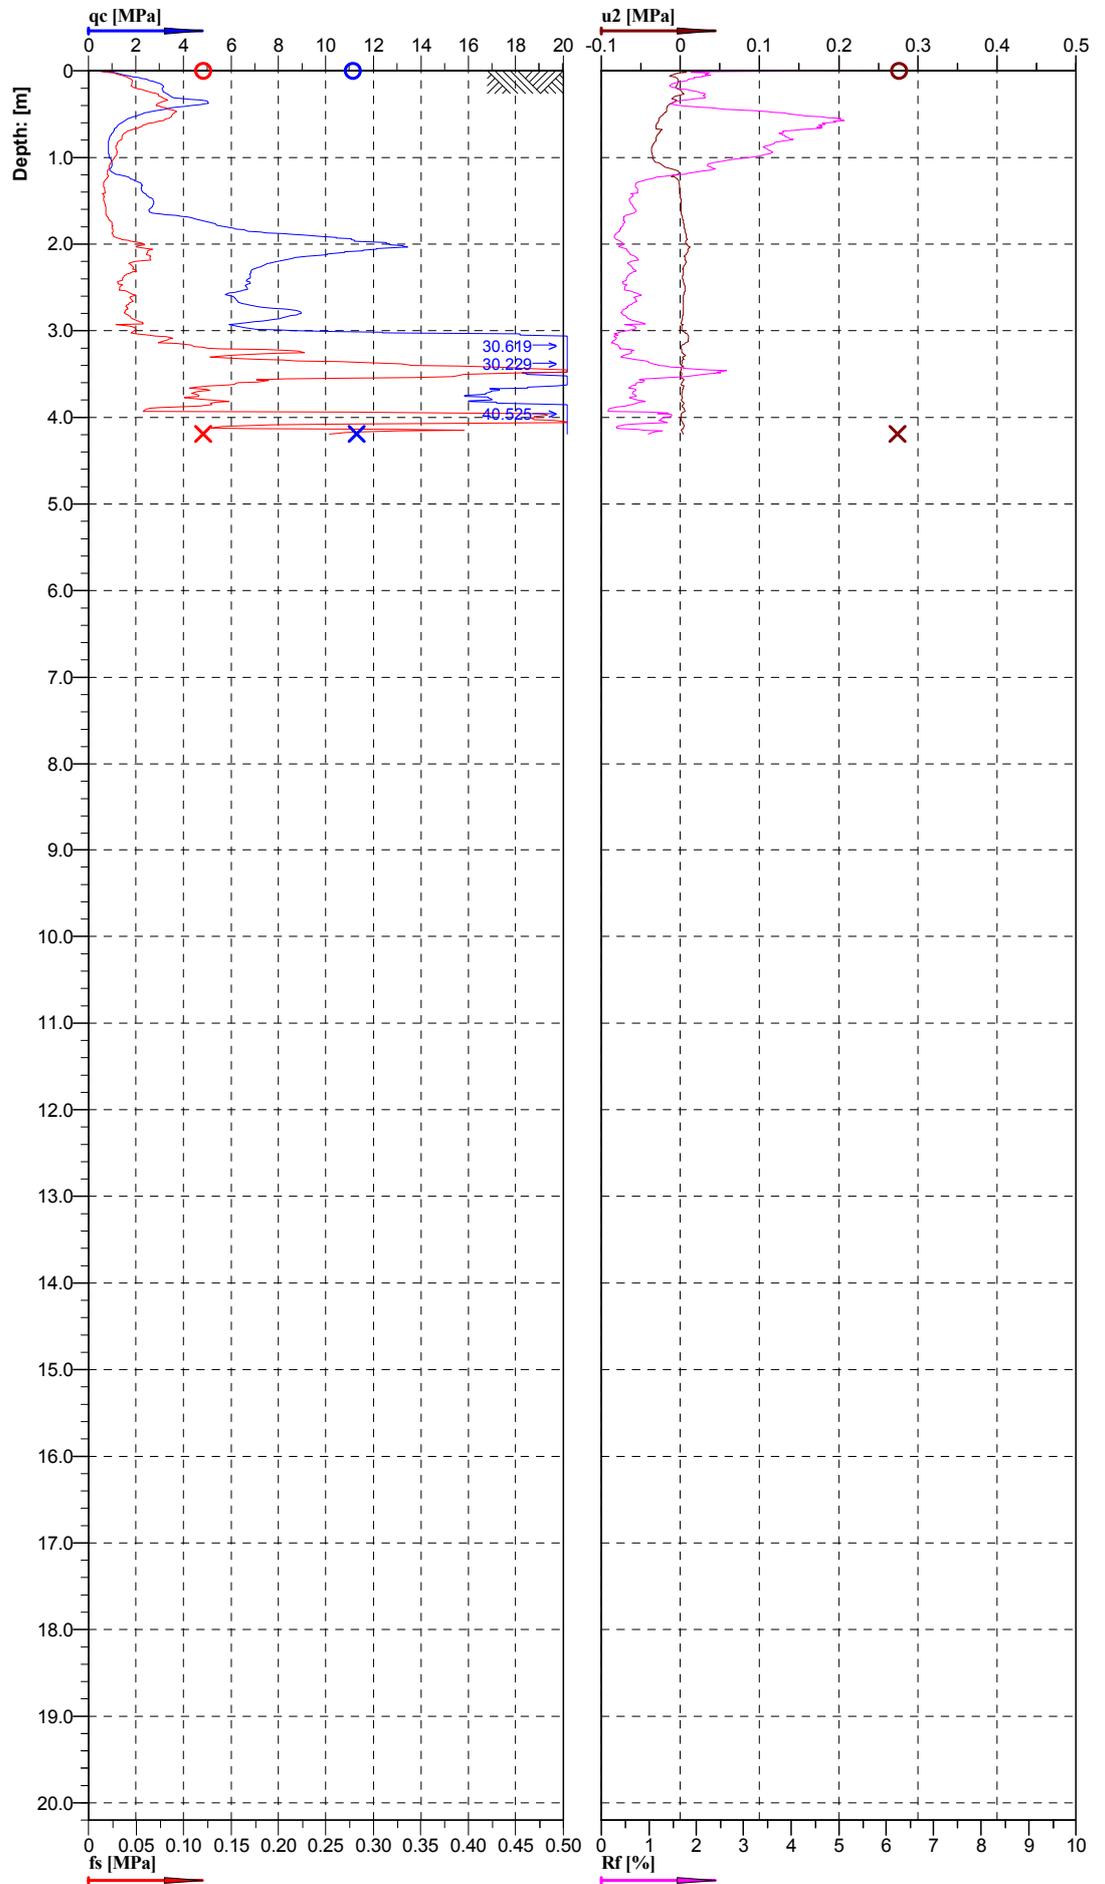
**Classification by
Robertson 1986**

- Sandy silt to clayey silt (6)
- Clay (3)
- Clayey silt to silty clay (5)
- Silty sand to sandy silt (7)
- Sand to silty sand (8)
- Sand (9)
- Sand to silty sand (8)
- Gravely sand to sand (10)
- Sand (9)
- Gravely sand to sand (10)

Cone No: 4494
Tip area [cm²]: 10
Sleeve area [cm²]: 150

Location: PALMERSTON NORTH	Position: X: 0.00 m, Y: 0.00 m	Ground level: 0.00	Test No.: CPT135
Project ID:	Client: T&T	Date: 14/08/2018	Scale: 1 : 87
Project: HOKOWHITU		Page: 1/1	Fig.:
		File: hokowhituCPT135.cpt

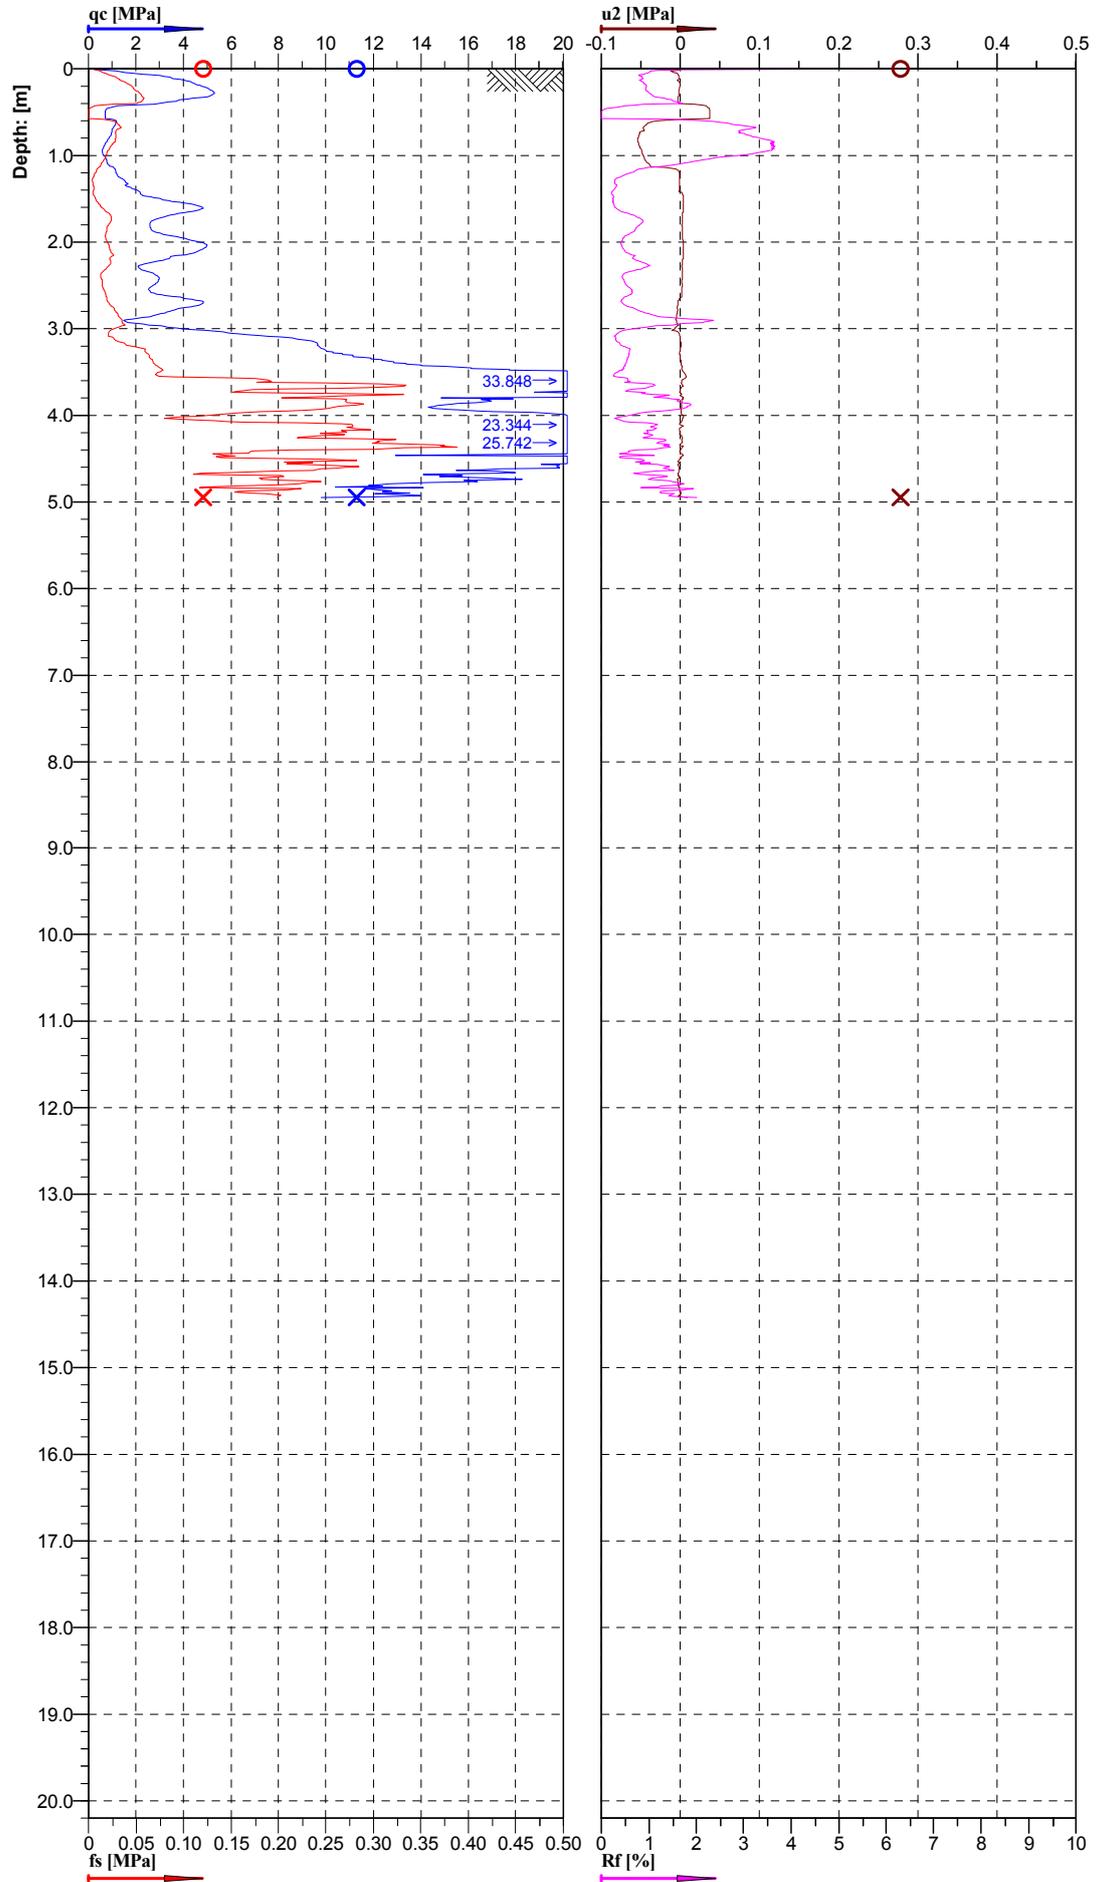
Classification by Robertson 1986

- Silty sand to sandy silt (7)
- Sensitive fine grained (1)
- Clay (3)
- Sandy silt to clayey silt (6)
- Silty sand to sandy silt (7)
- Sand (9)
- Sand to silty sand (8)

Cone No: 4494
 Tip area [cm²]: 10
 Sleeve area [cm²]: 150

Location: PALMERSTON NORTH	Position: X: 0.00 m, Y: 0.00 m	Ground level: 0.00	Test No.: CPT136
Project ID:	Client: T&T	Date: 13/08/2018	Scale: 1 : 87
Project: HOKOWHITU		Page: 1/1	Fig.:
		File: hokowhituCPT136.cpt

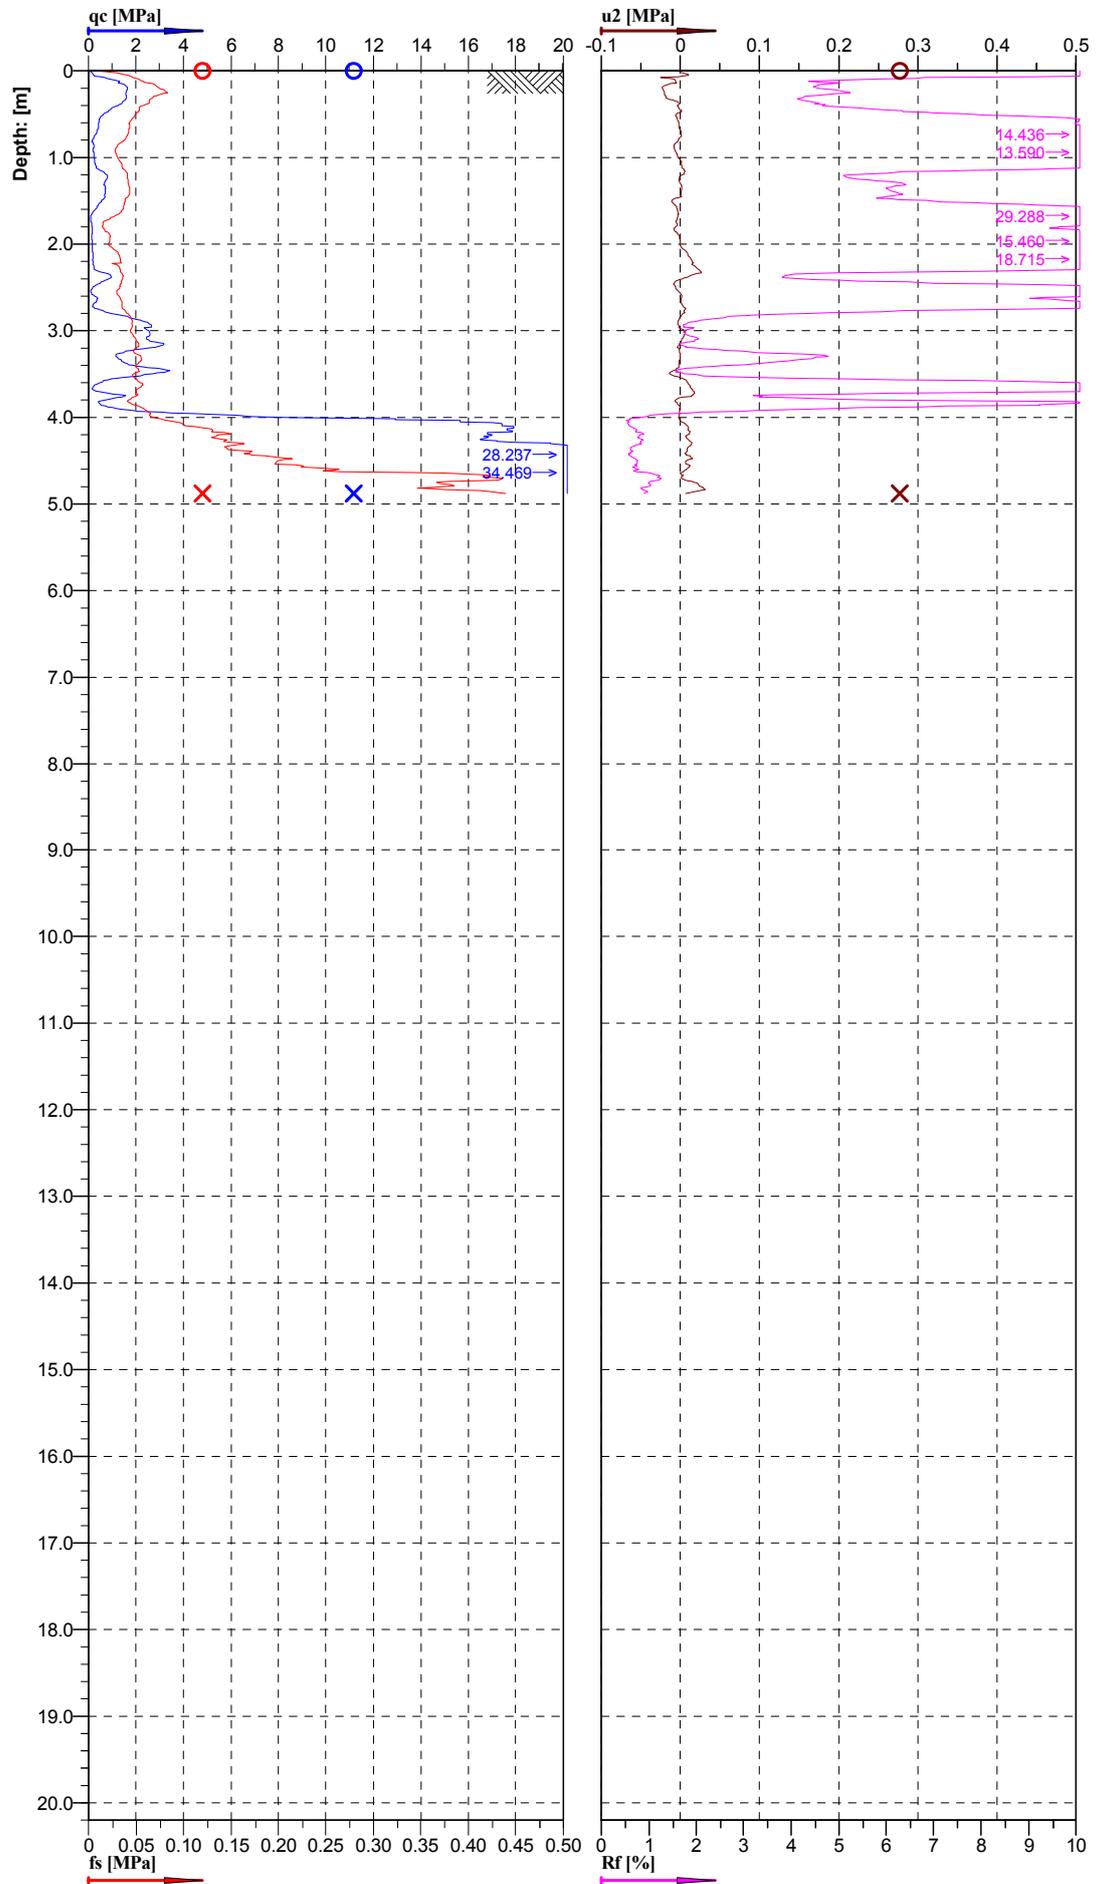
Classification by Robertson 1986

- Clay (3)
- Organic material (2)
- Clay (3)
- Organic material (2)
- Sandy silt to clayey silt (6)
- Clay (3)
- Sand (9)

Cone No: 4494
 Tip area [cm²]: 10
 Sleeve area [cm²]: 150

Location: PALMERSTON NORTH	Position: X: 0.00 m, Y: 0.00 m	Ground level: 0.00	Test No.: CPT137
Project ID:	Client: T&T	Date: 13/08/2018	Scale: 1 : 87
Project: HOKOWHITU		Page: 1/1	Fig.:
		File: hokowhитуCPT137.cpt

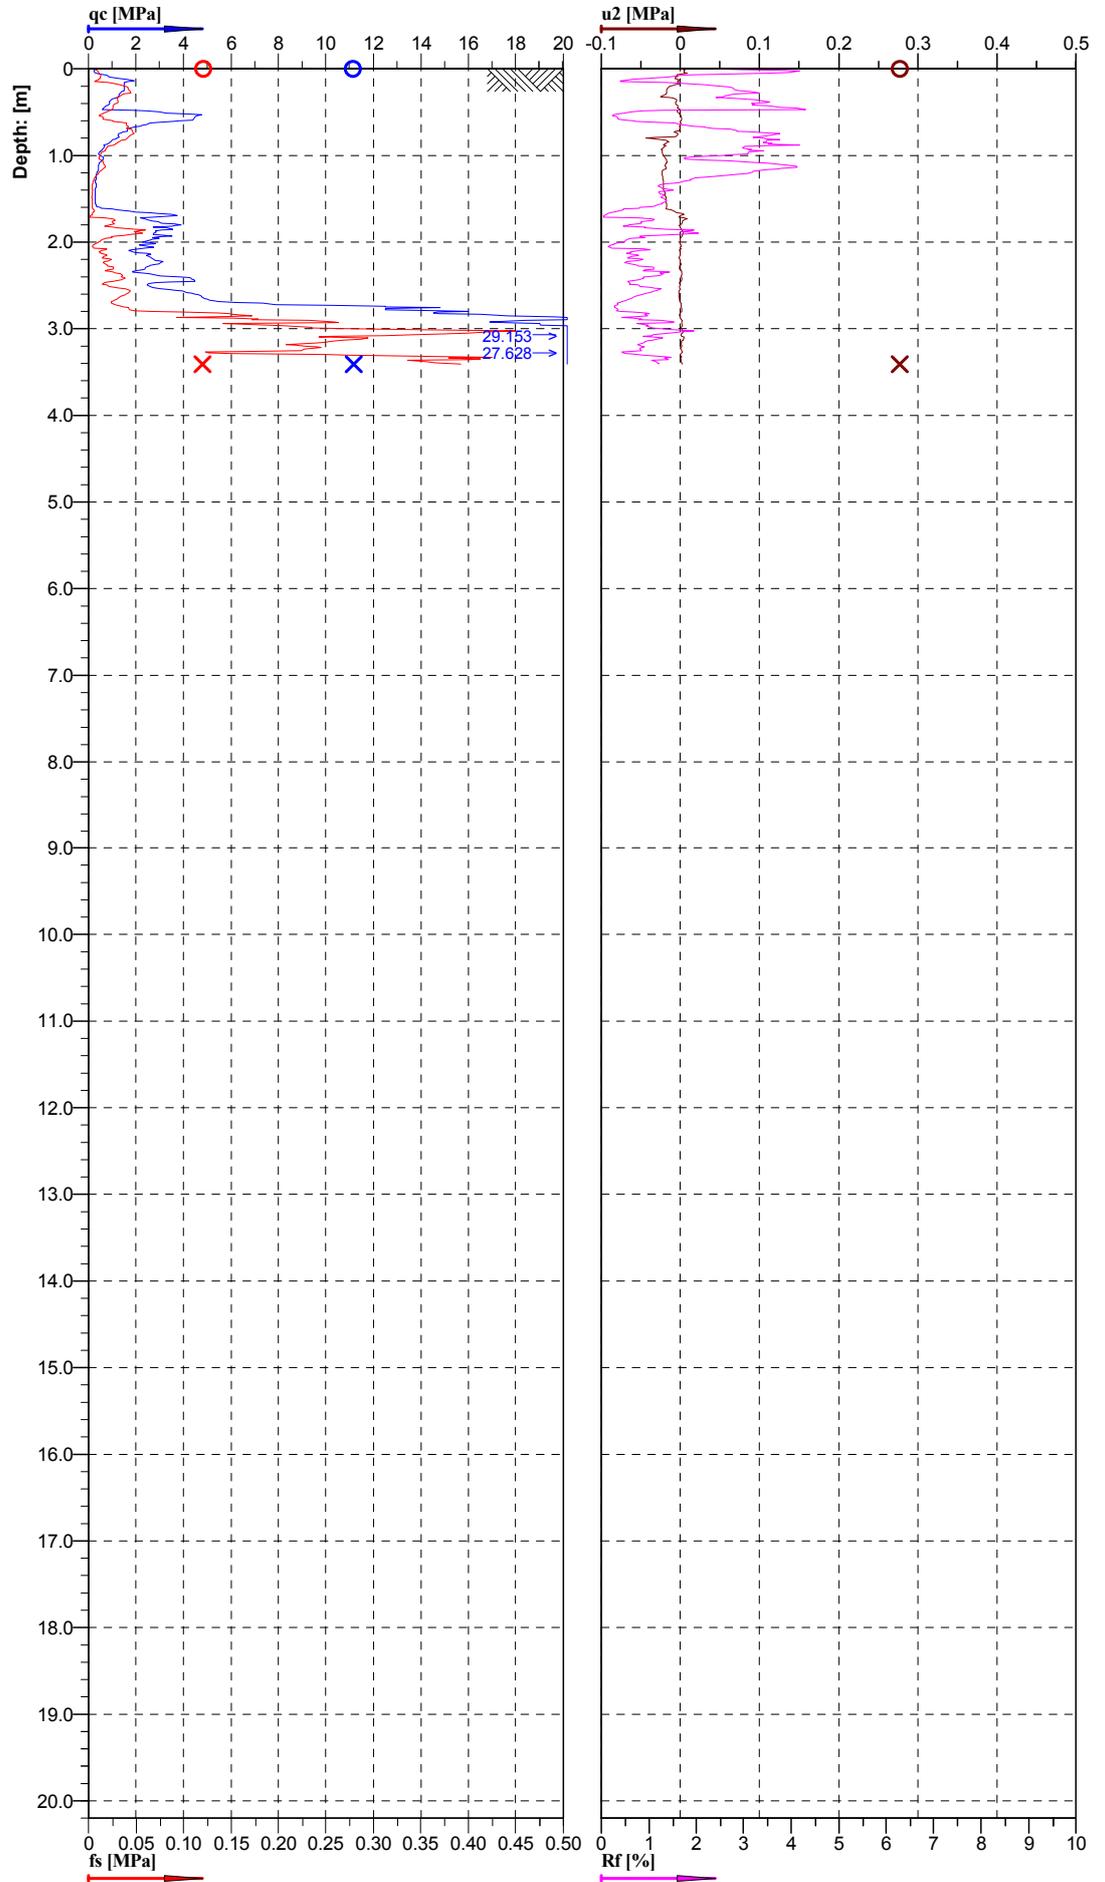
Classification by Robertson 1986

- Clayey silt to silty clay (5)
- Sand to silty sand (8)
- Clay (3)
- Sensitive fine grained (1)
- Silty sand to sandy silt (7)
- Sand (9)

Cone No: 4494
 Tip area [cm²]: 10
 Sleeve area [cm²]: 150

Location: PALMERSTON NORTH	Position: X: 0.00 m, Y: 0.00 m	Ground level: 0.00	Test No.: CPT138
Project ID:	Client: T&T	Date: 13/08/2018	Scale: 1 : 87
Project: HOKOWHITU		Page: 1/1	Fig.:
		File: hokowhituCPT138.cpt

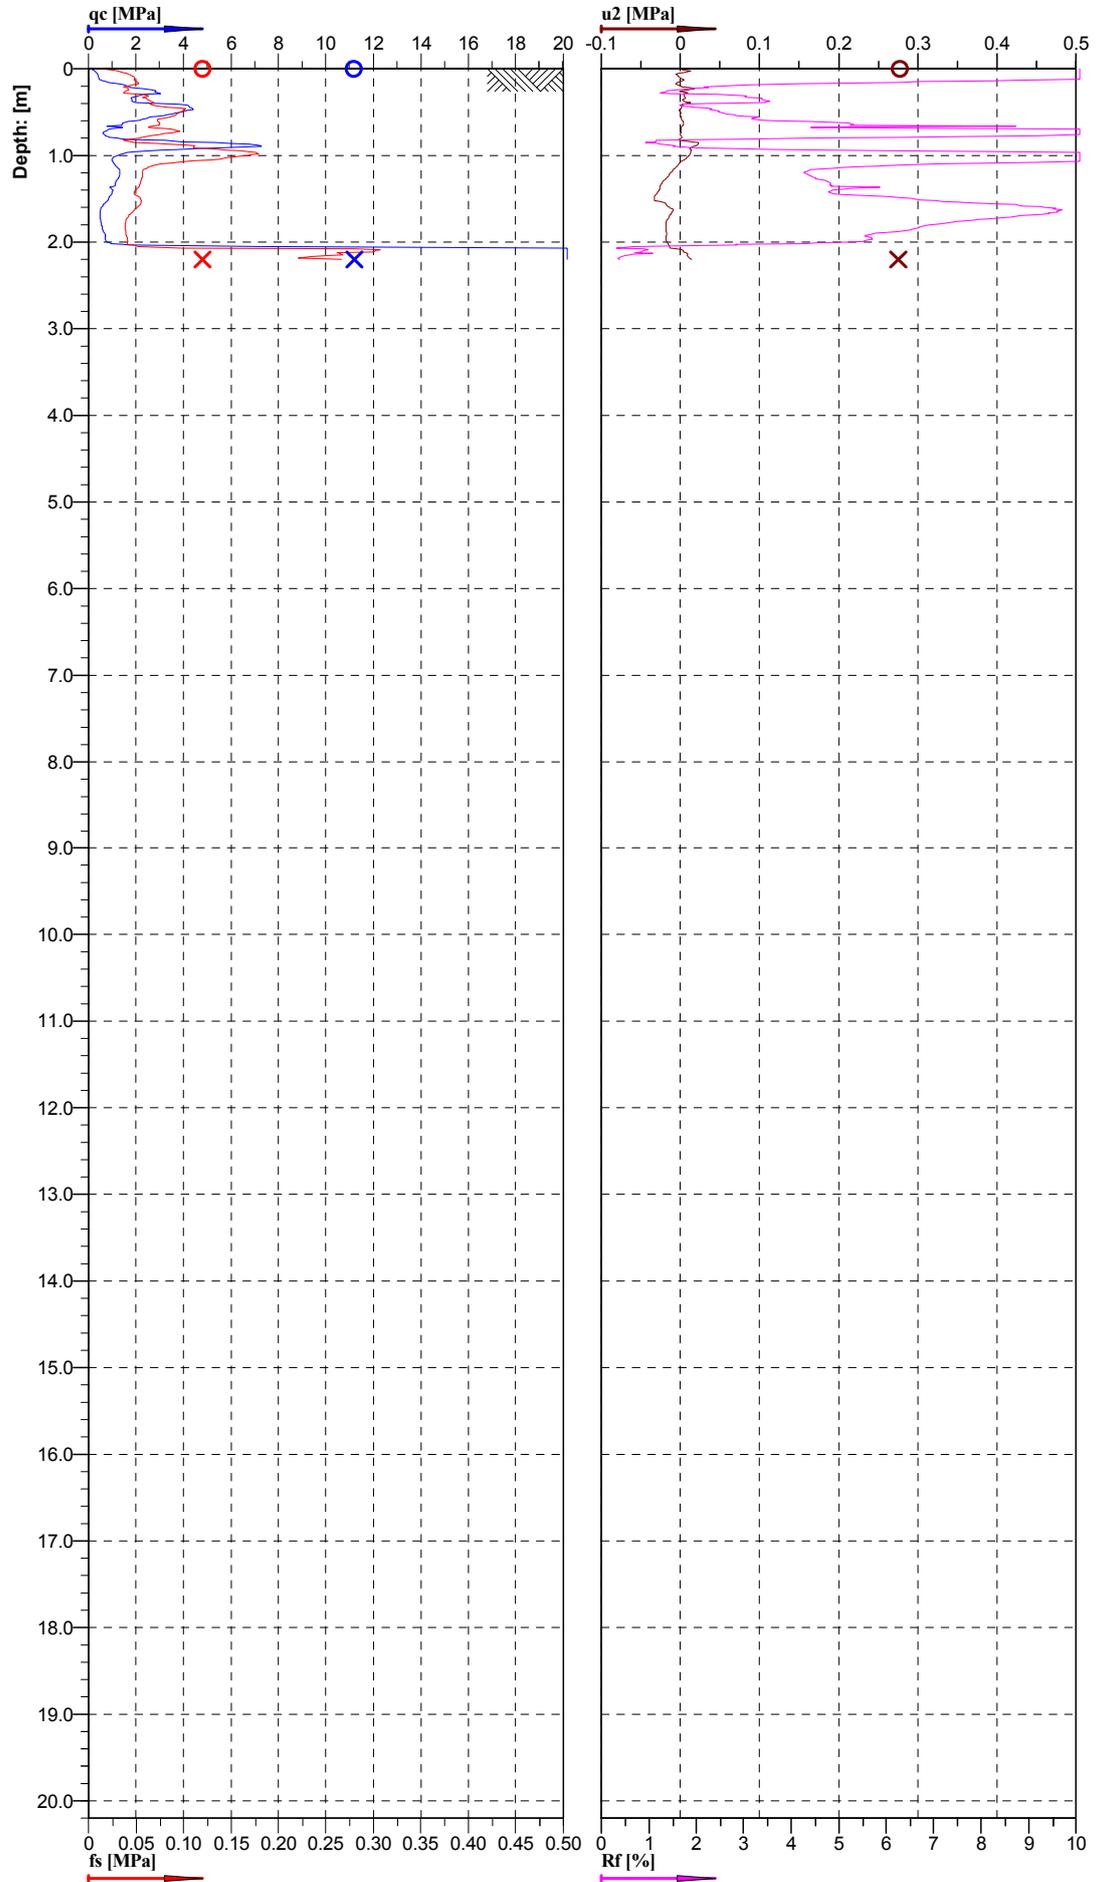
**Classification by
Robertson 1986**

- Organic material (2)
- Clayey silt to silty clay (5)
- Clay (3)

Cone No: 4494
Tip area [cm²]: 10
Sleeve area [cm²]: 150

Location: PALMERSTON NORTH	Position: X: 0.00 m, Y: 0.00 m	Ground level: 0.00	Test No.: CPT139
Project ID:	Client: T&T	Date: 13/08/2018	Scale: 1 : 87
Project: HOKOWHITU		Page: 1/1	Fig.:
		File: hokowhituCPT139.cpt

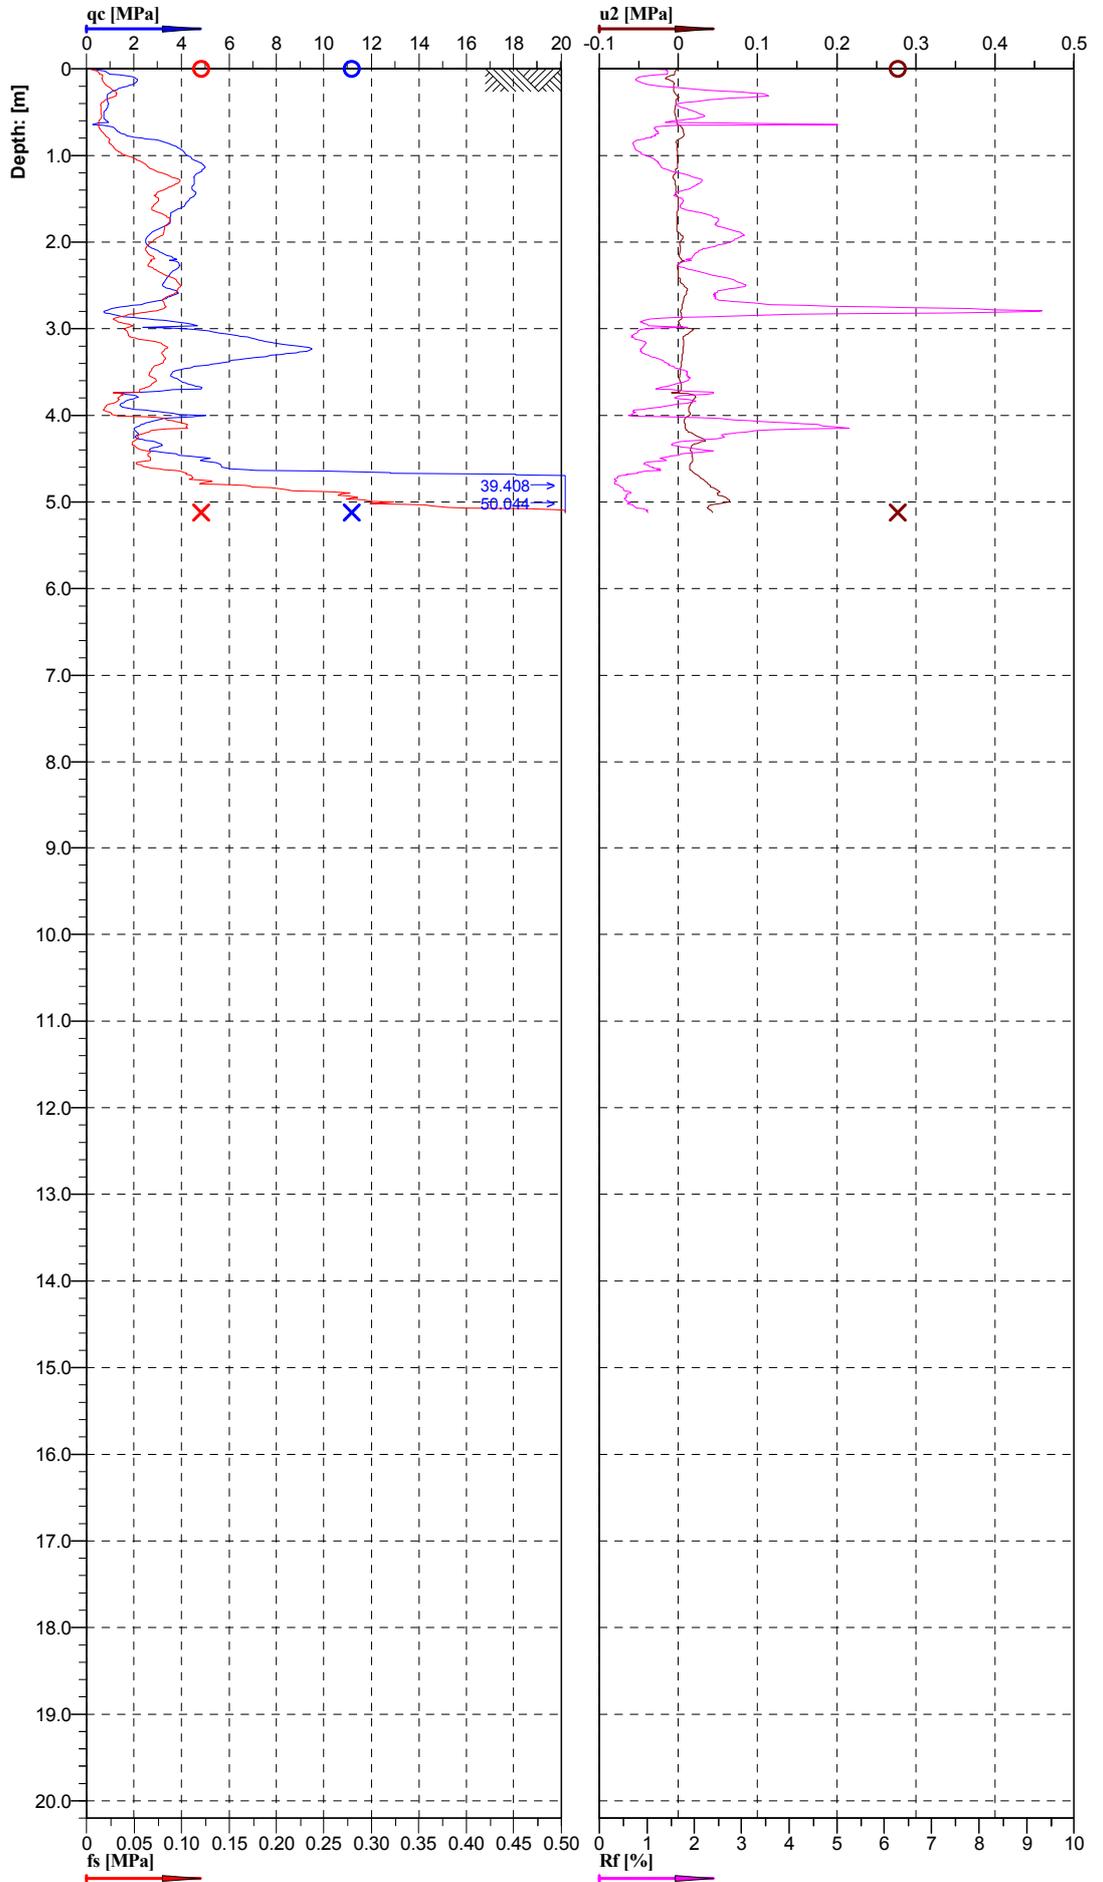
Classification by Robertson 1986

- Silty clay to clay (4)
- Clayey silt to silty clay (5)
- Silty sand to sandy silt (7)
- Sandy silt to clayey silt (6)
- Sand to silty sand (8)
- Silty sand to sandy silt (7)
- Gravely sand to sand (10)

Cone No: 4494
 Tip area [cm²]: 10
 Sleeve area [cm²]: 150

Location: PALMERSTON NORTH	Position: X: 0.00 m, Y: 0.00 m	Ground level: 0.00	Test No.: CPT140
Project ID:	Client: T&T	Date: 13/08/2018	Scale: 1 : 87
Project: HOKOWHITU		Page: 1/1	Fig.:
		File: hokowhituCPT140.cpt

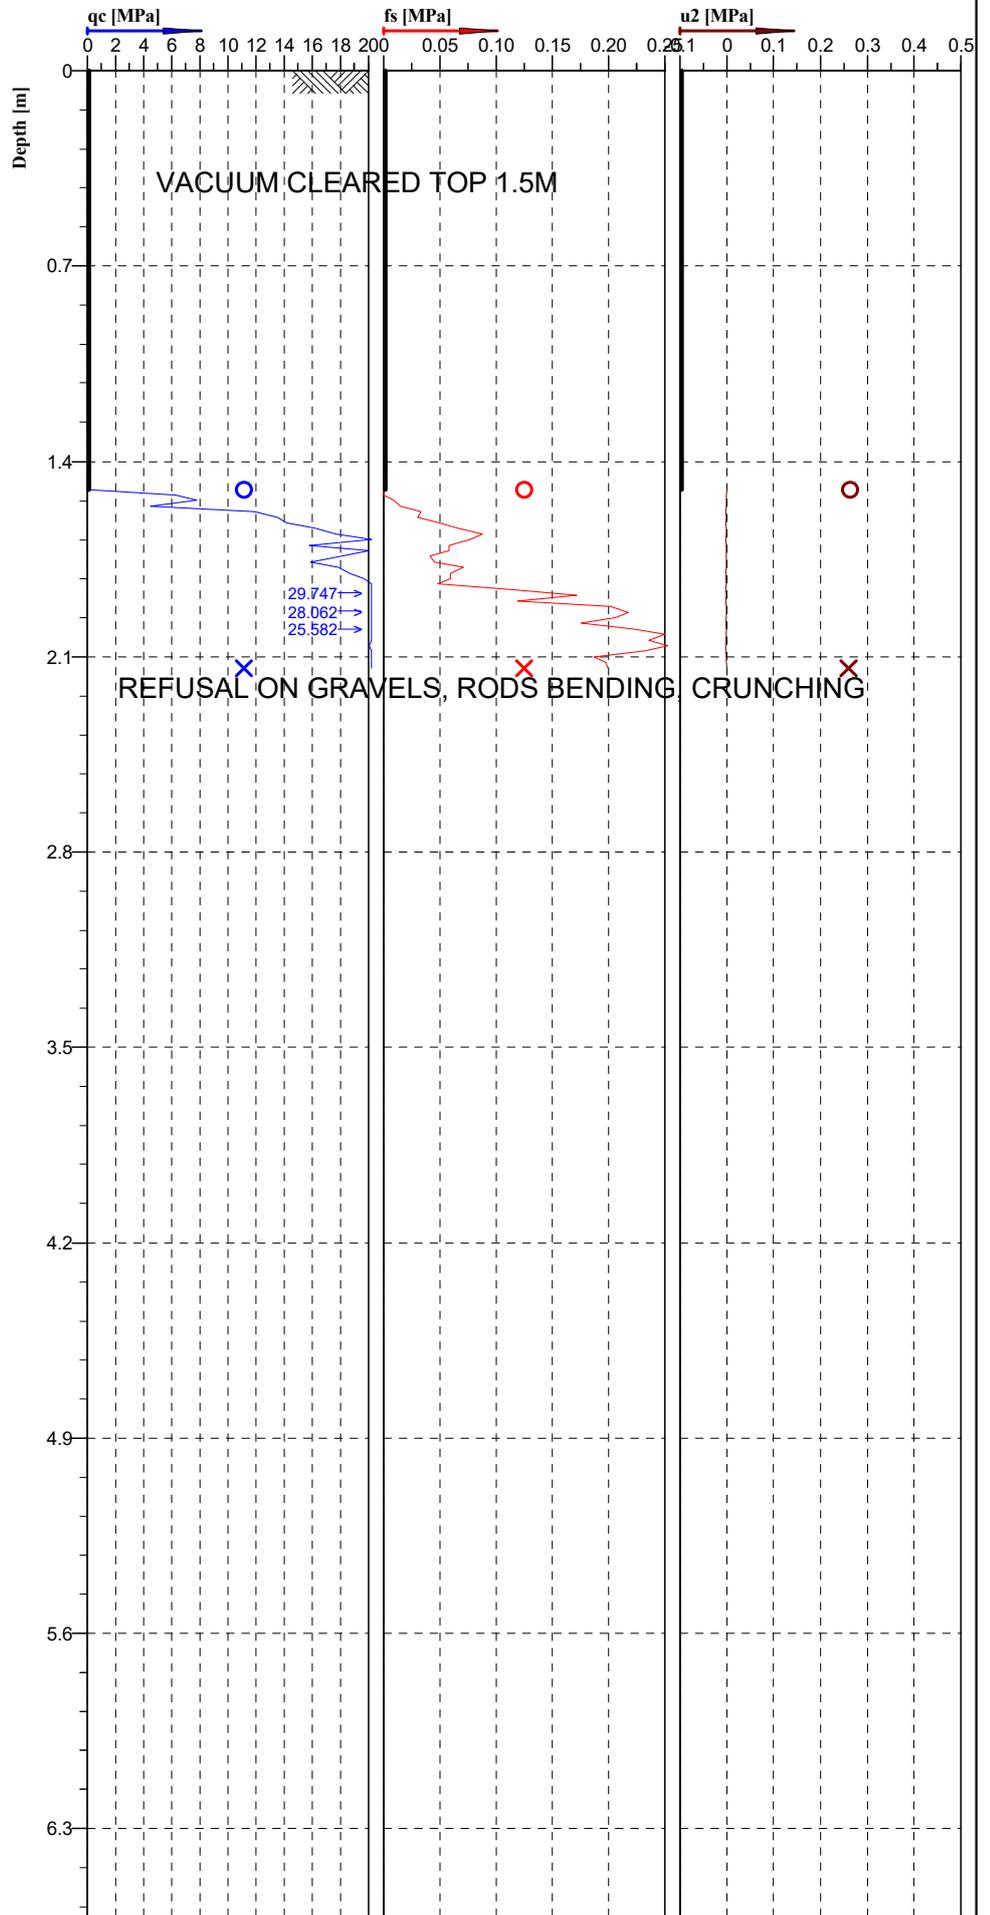
Sand to silty sand (8)

Sand (9)

Location: PALMERSTON NORTH	Position: X: 0.00 m, Y: 0.00 m	Ground level: 0.00	Test no: 01
Project ID: 85442.004	Client: TONKIN & TAYLOR LTD	Date: 20/07/2016	Scale: 1 : 27
Project: HOROWHITU CAMPUS		Page: 1/1	Fig:
S 40°22.137 E 175°37.857		File: CPT-H-01.CPT

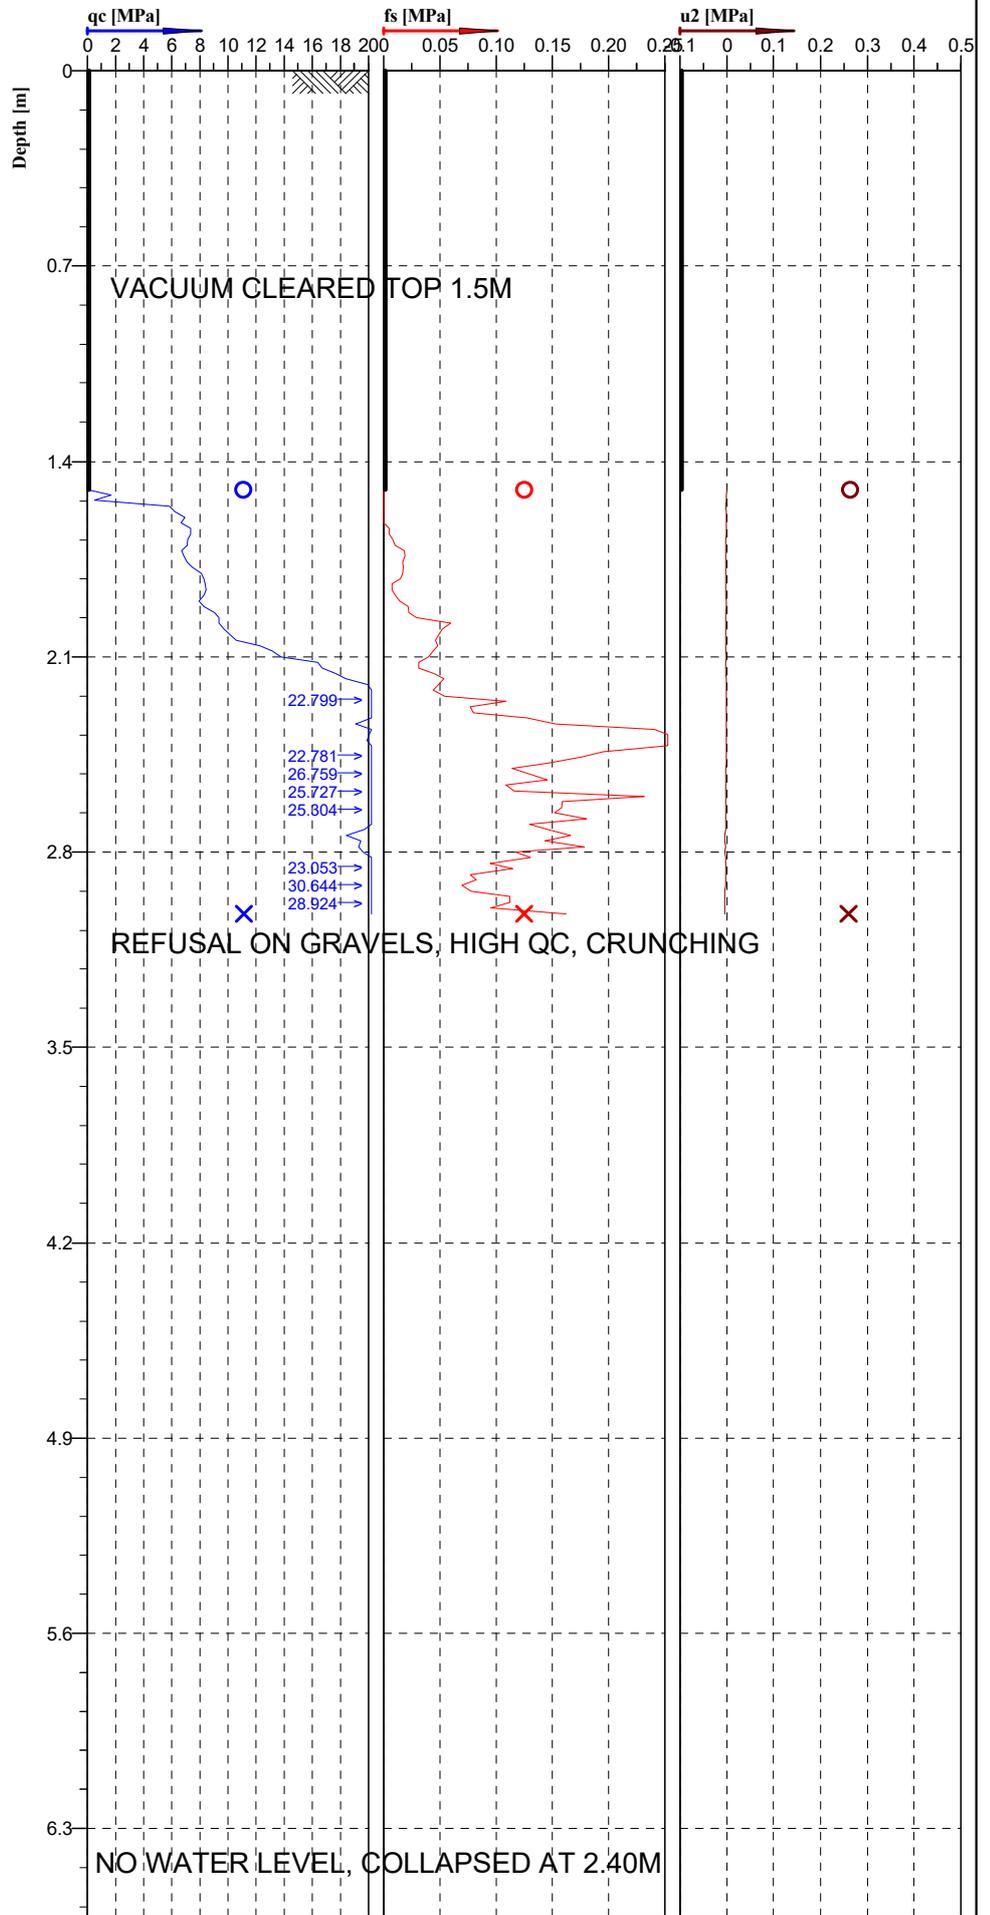
Cone No: 4696
Tip area [cm²]: 10
Sleeve area [cm²]: 150

Location: PALMERSTON NORTH	Position: X: 0.00 m, Y: 0.00 m	Ground level: 0.00	Test no: 02
Project ID: 85442.004	Client: TONKIN & TAYLOR LTD	Date: 20/07/2016	Scale: 1 : 27
Project: HOROWHITU CAMPUS		Page: 1/1	Fig:
S 40°22.110 E 175°37.754		File: CPT-H-02.CPT

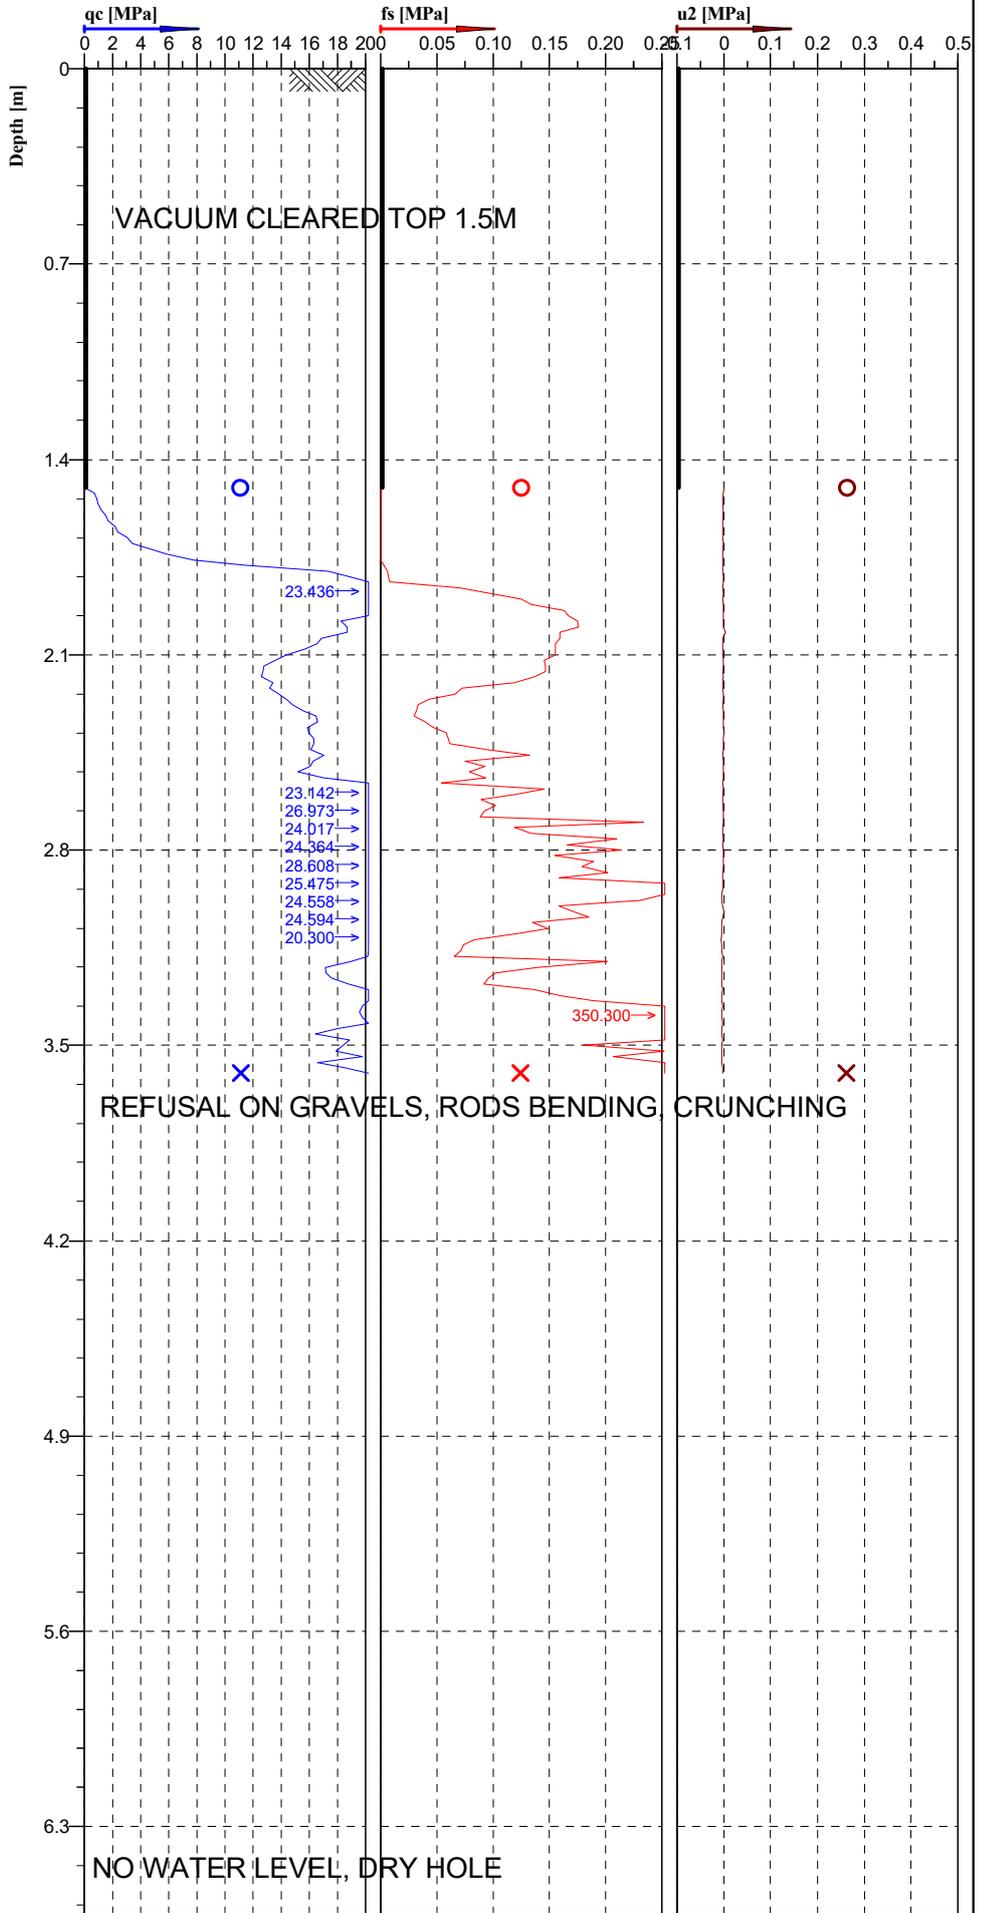
Cone No: 4696
Tip area [cm²]: 10
Sleeve area [cm²]: 150

Location: PALMERSTON NORTH	Position: X: 0.00 m, Y: 0.00 m	Ground level: 0.00	Test no: 04
Project ID: 85442.004	Client: TONKIN & TAYLOR LTD	Date: 20/07/2016	Scale: 1 : 27
Project: HOROWHITU CAMPUS		Page: 1/1	Fig: 1 : 27
S 40°22.168 E 175°37.774		File: CPT-H-04.CPT

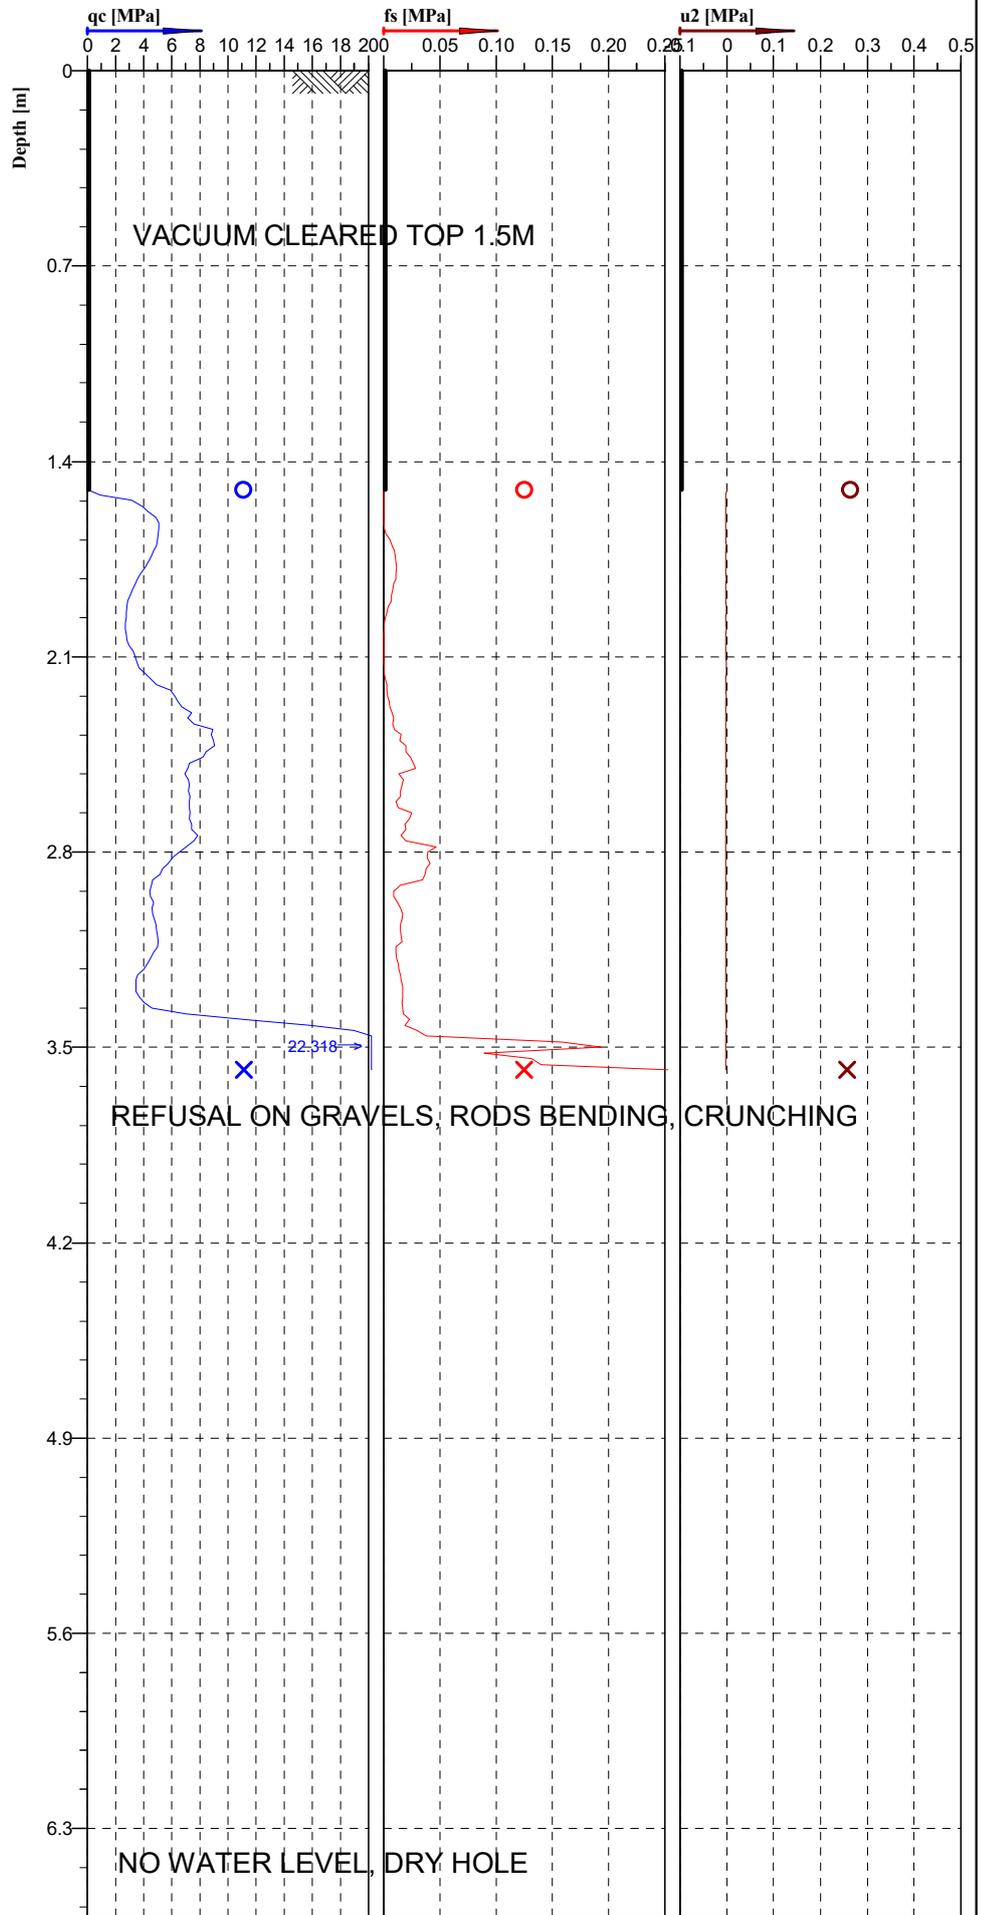
Sand to silty sand (8)

Sand (9)

Location: PALMERSTON NORTH	Position: X: 0.00 m, Y: 0.00 m	Ground level: 0.00	Test no: 05
Project ID: 85442.004	Client: TONKIN & TAYLOR LTD	Date: 20/07/2016	Scale: 1 : 27
Project: HOROWHITU CAMPUS		Page: 1/1	Fig:
S 40°22.267 E 175°37.903		File: CPT-H-05.CPT

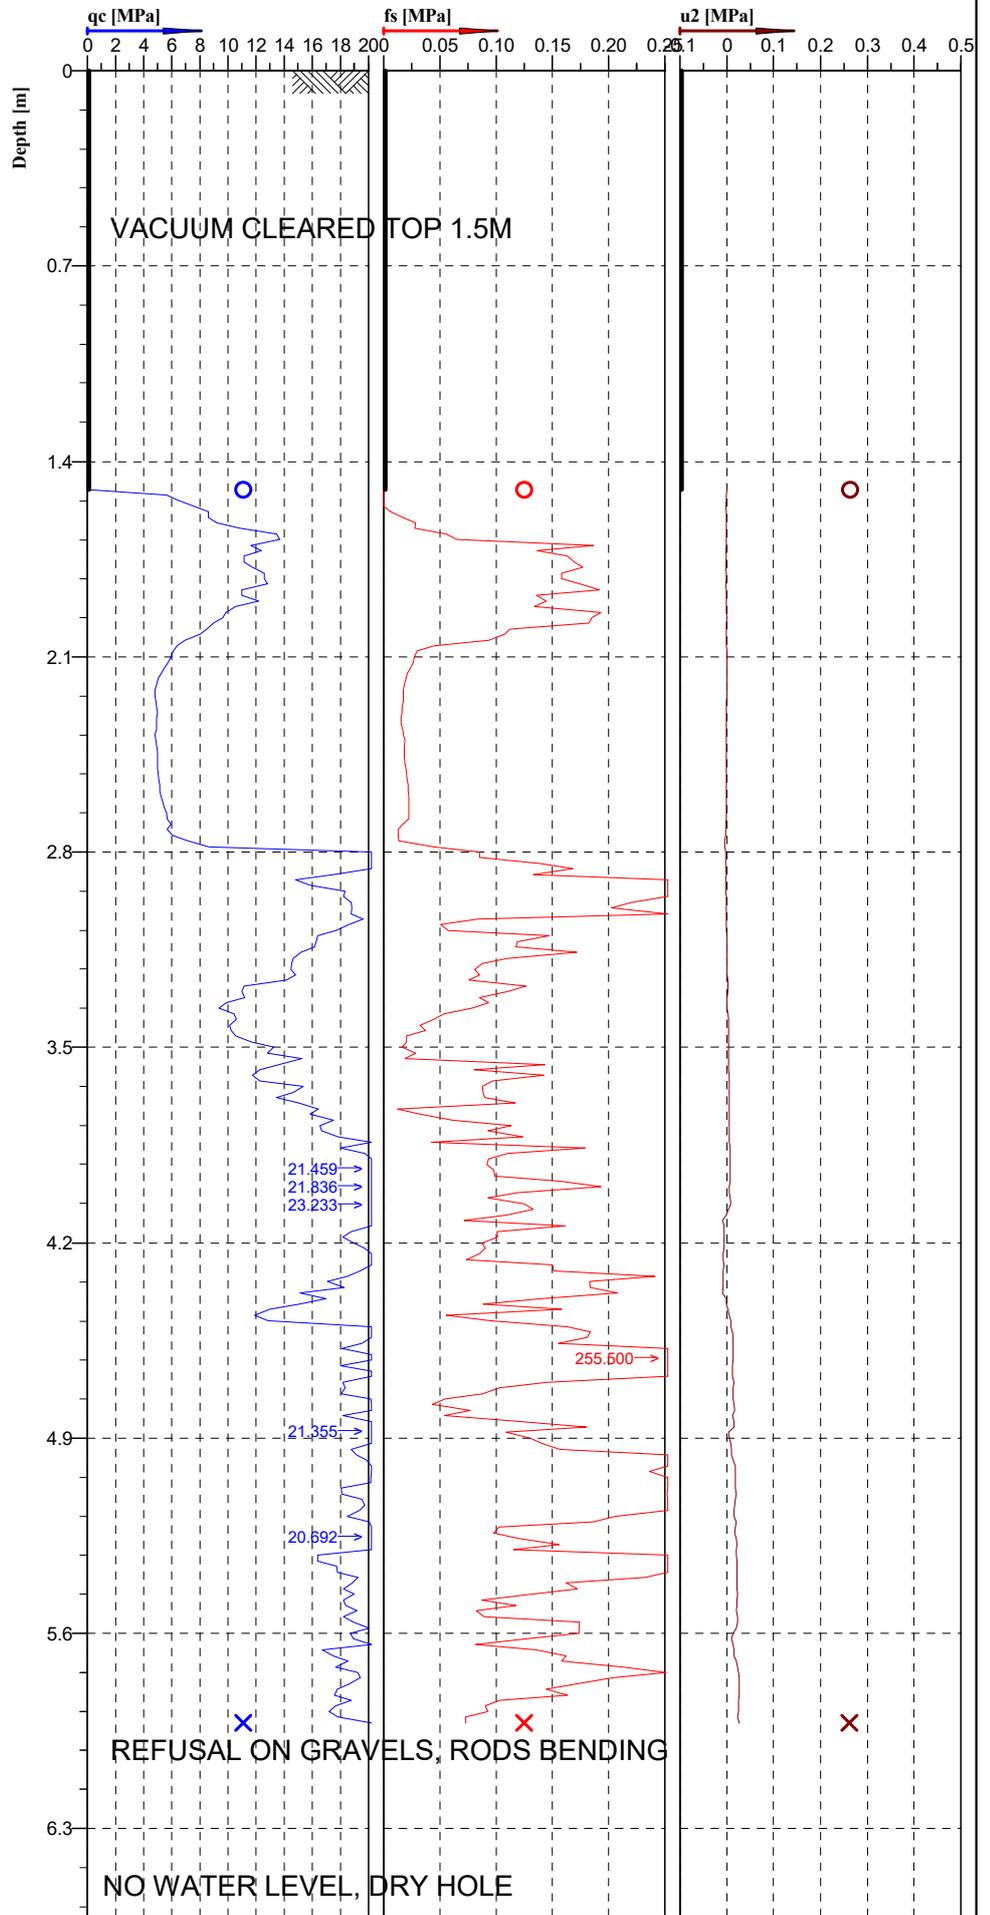
Cone No: 4696
Tip area [cm²]: 10
Sleeve area [cm²]: 150

Location: PALMERSTON NORTH	Position: X: 0.00 m, Y: 0.00 m	Ground level: 0.00	Test no: 06
Project ID: 85442.004	Client: TONKIN & TAYLOR LTD	Date: 20/07/2016	Scale: 1 : 27
Project: HOROWHITU CAMPUS		Page: 1/1	Fig: 1
S 40°22.220 E 175°37.797		File: CPT-H-06.CPT
