Centennial Park, Palmerston North

Geotechnical Investigation and Liquefaction Assessment

Prepared for
Wallace Development Company Ltd

Prepared by
Tonkin & Taylor Ltd

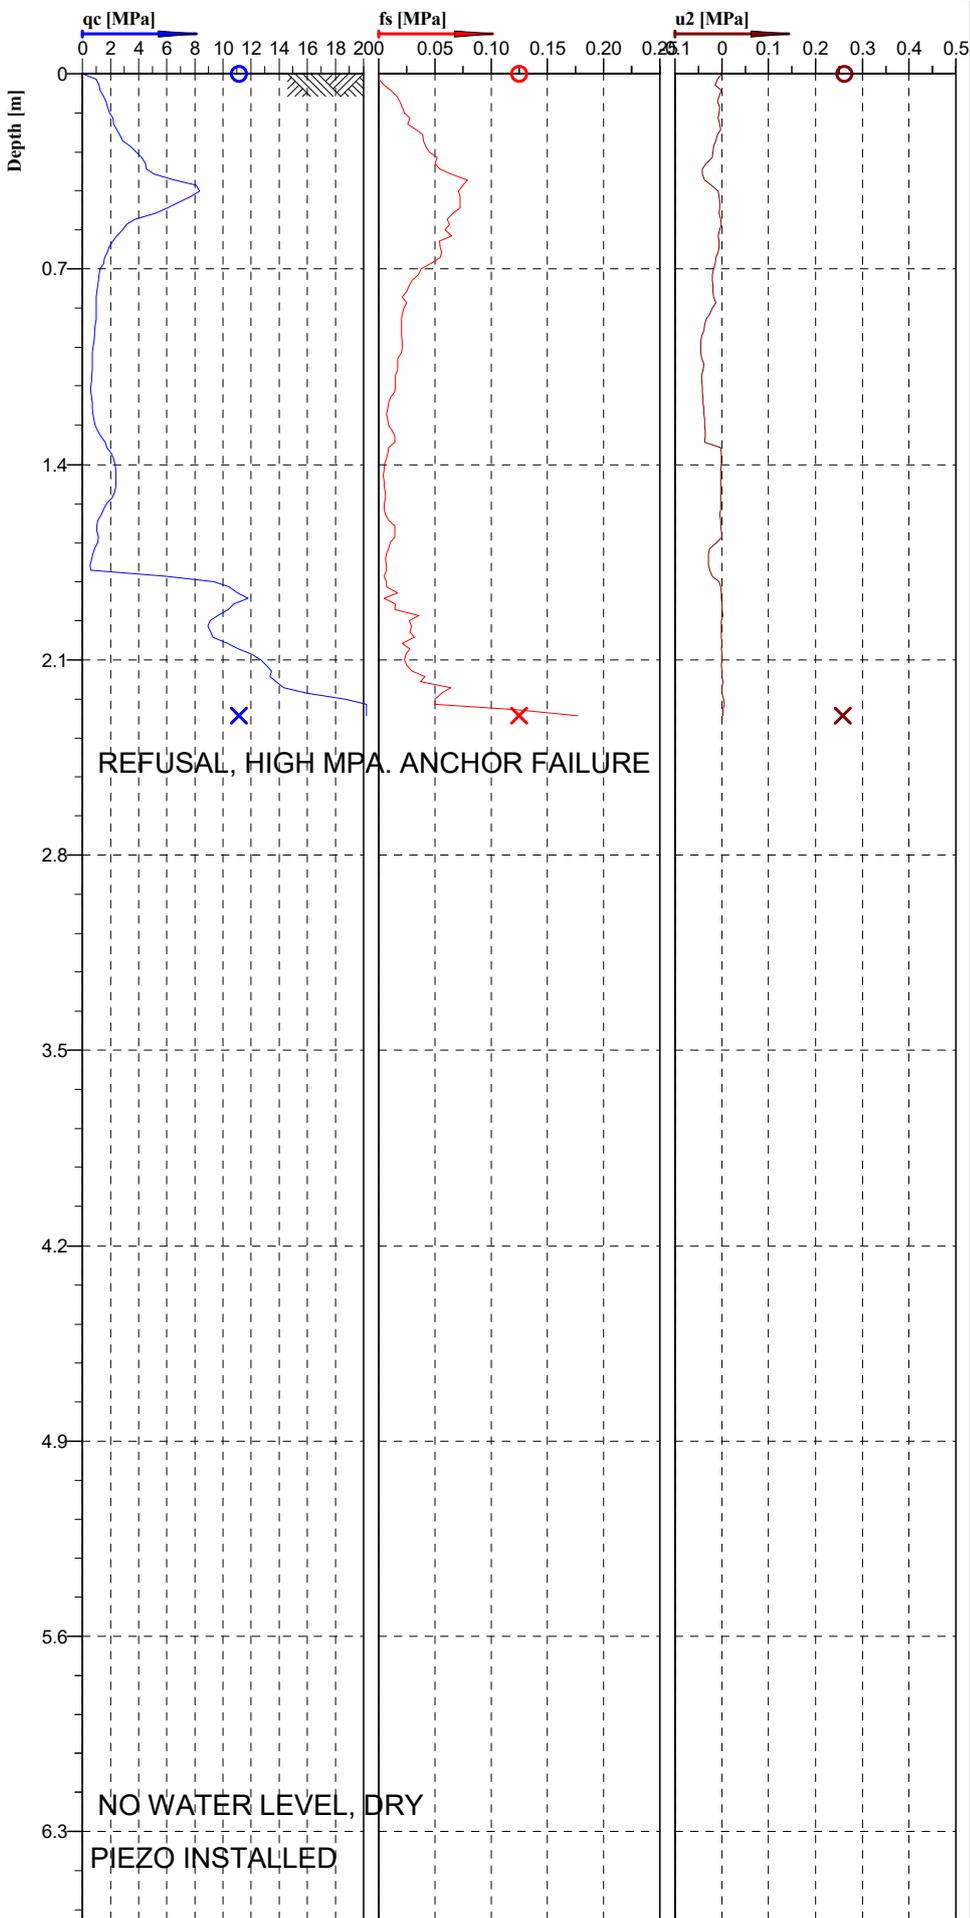
Cone No: 4696
Tip area [cm²]: 10
Sleeve area [cm²]: 150

Location: PALMERSTON NORTH	Position: X: 0.00 m, Y: 0.00 m	Ground level: 0.00	Test no: 07
Project ID: 85442.004	Client: TONKIN & TAYLOR LTD	Date: 19/07/2016	Scale: 1 : 27
Project: HOROWHITU CAMPUS		Page: 1/1	Fig:
S 40°22.312 E 175°37.887		File: CPT-H-07.cpd

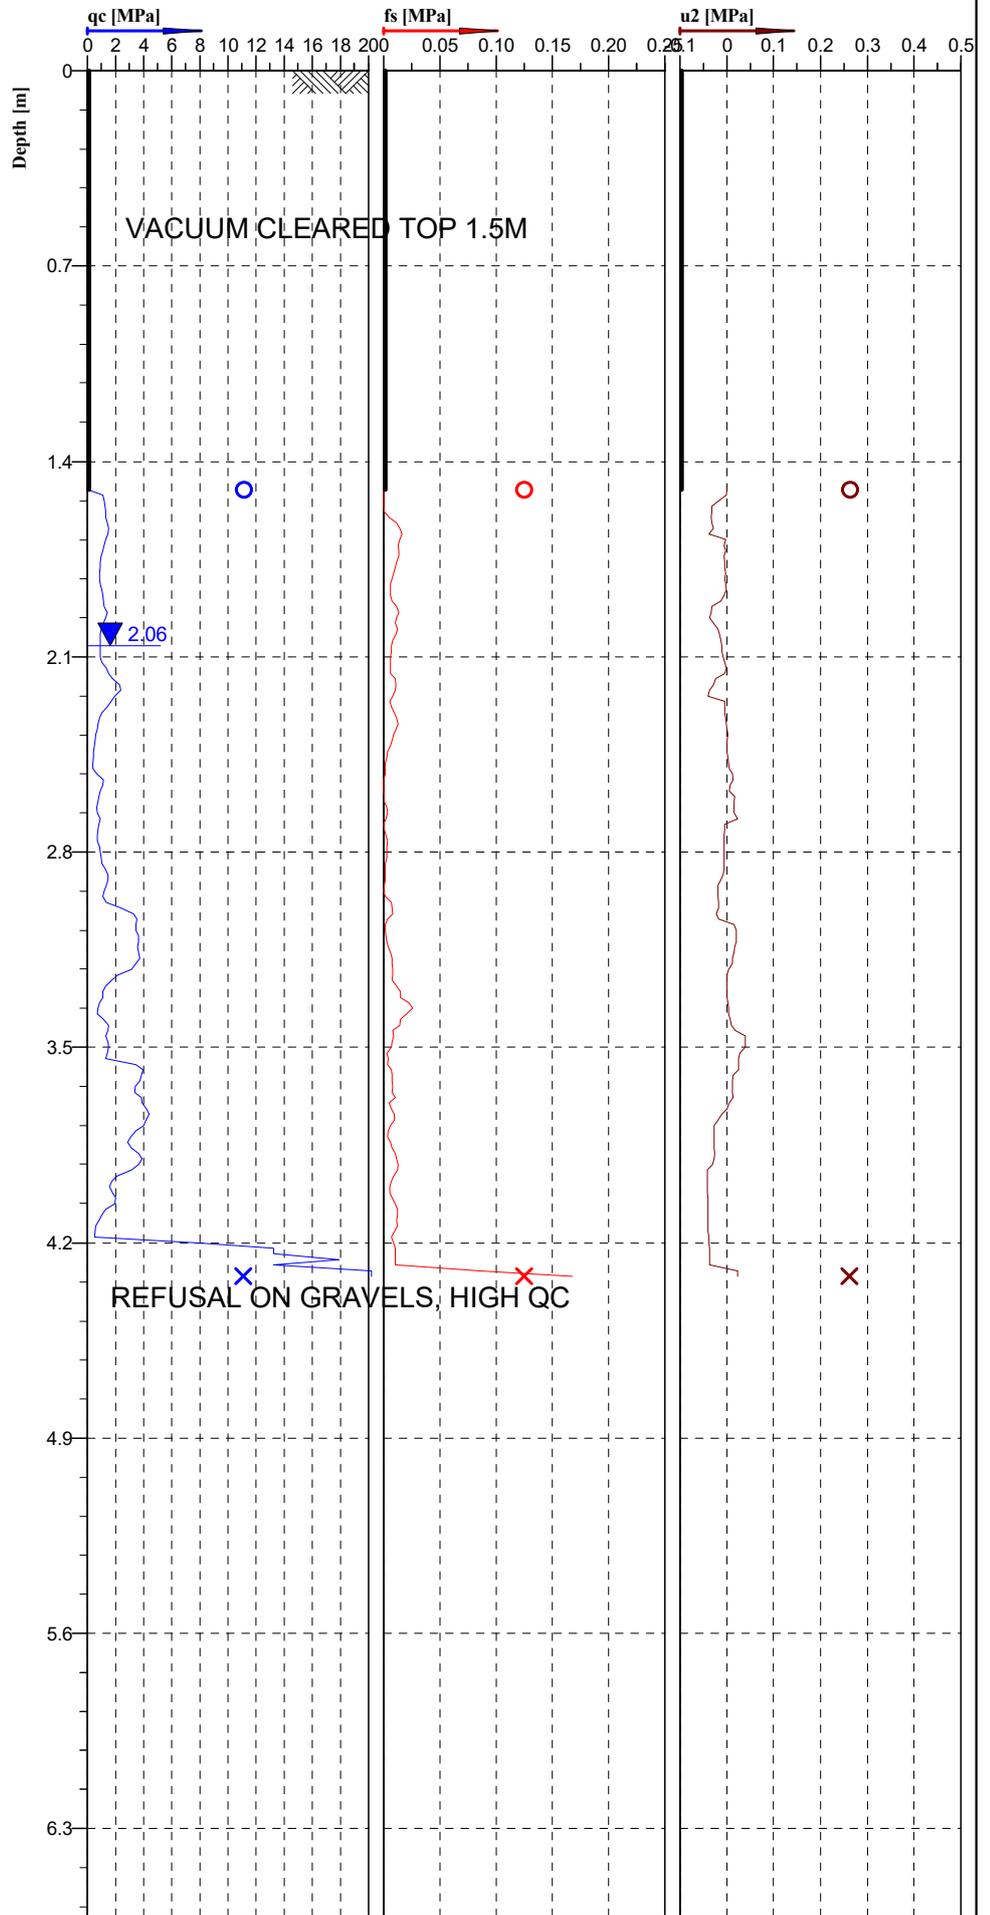
Cone No: 4696
Tip area [cm²]: 10
Sleeve area [cm²]: 150

Location: PALMERSTON NORTH	Position: X: 0.00 m, Y: 0.00 m	Ground level: 0.00	Test no: 08
Project ID: 85442.004	Client: TONKIN & TAYLOR LTD	Date: 20/07/2016	Scale: 1 : 27
Project: HOROWHITU CAMPUS		Page: 1/1	Fig:
S 40°22.298 E 175°37.801		File: CPT-H-08.CPT

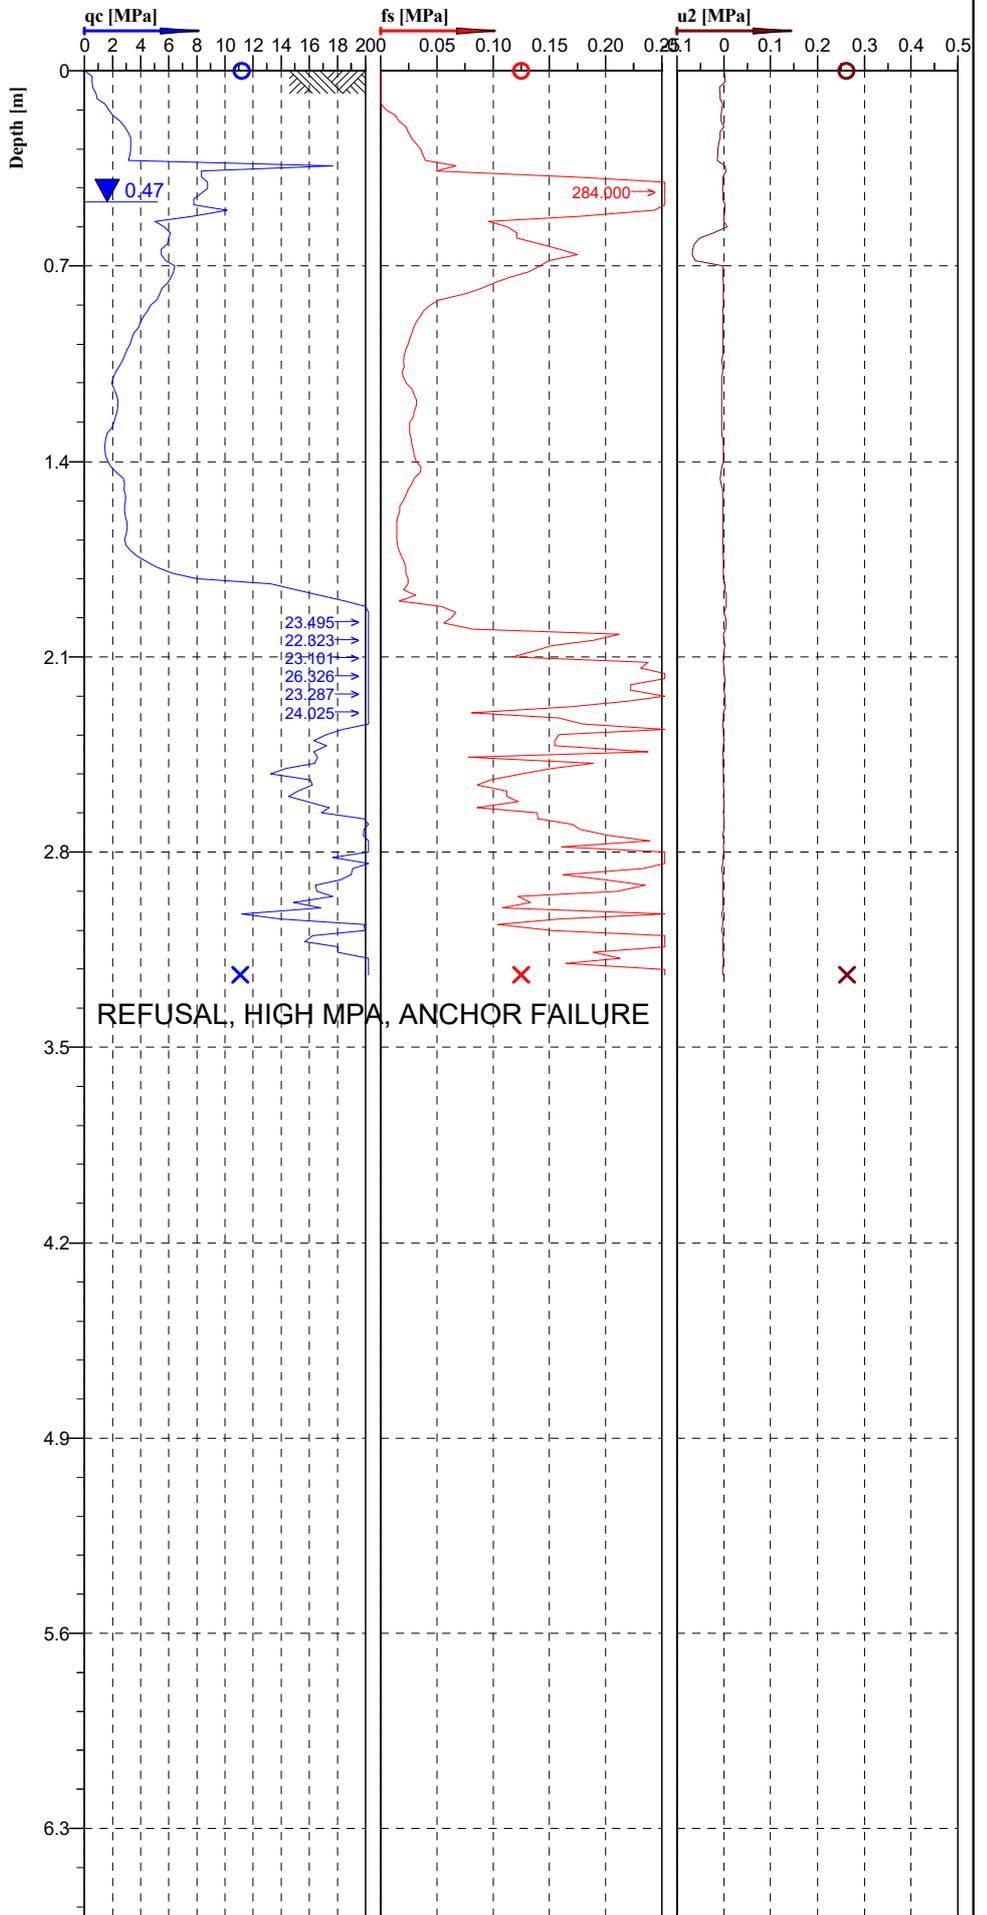
Cone No: 4696
Tip area [cm²]: 10
Sleeve area [cm²]: 150

Location: PALMERSTON NORTH	Position: X: 0.00 m, Y: 0.00 m	Ground level: 0.00	Test no: 09
Project ID: 85442.004	Client: TONKIN & TAYLOR LTD	Date: 19/07/2016	Scale: 1 : 27
Project: HOROWHITU CAMPUS		Page: 1/1	Fig:
S 40°22.364 E 175°37.848		File: CPT-H-09.cpd

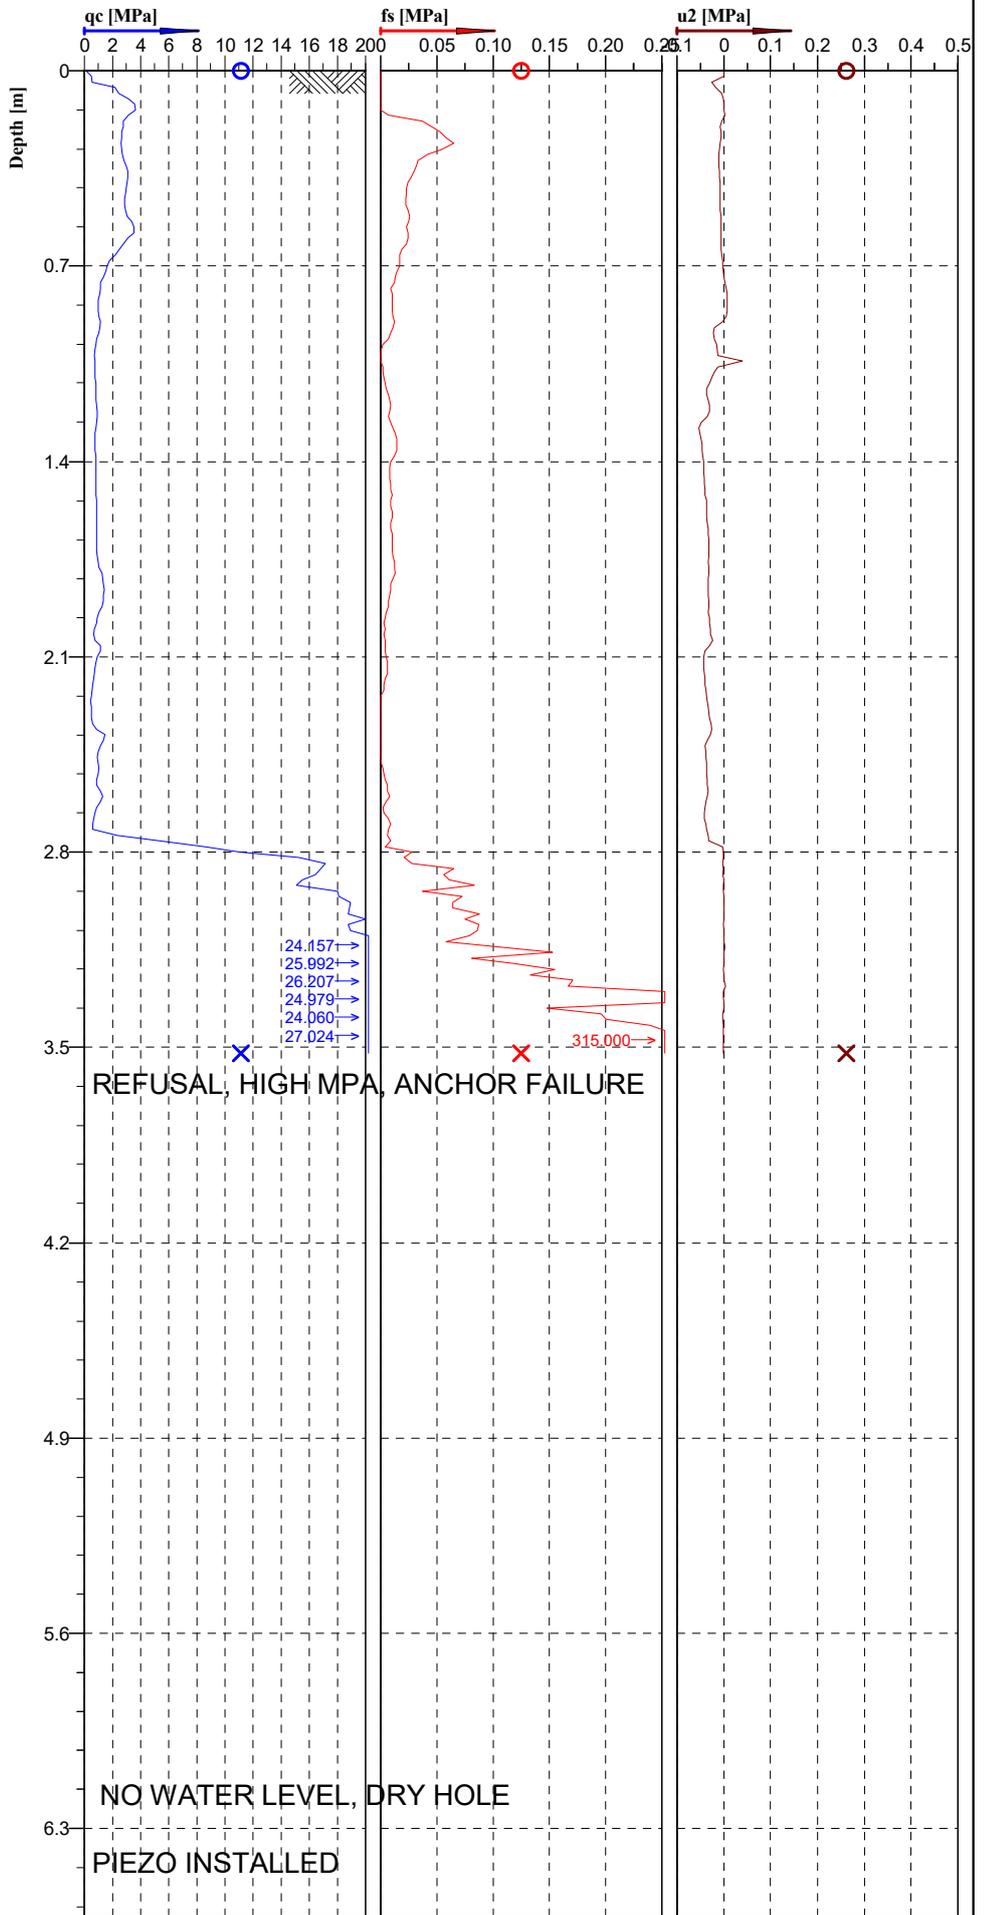
Cone No: 4696
Tip area [cm²]: 10
Sleeve area [cm²]: 150

Location: PALMERSTON NORTH	Position: X: 0.00 m, Y: 0.00 m	Ground level: 0.00	Test no: 10
Project ID: 85442.004	Client: TONKIN & TAYLOR LTD	Date: 19/07/2016	Scale: 1 : 27
Project: HOROWHITU CAMPUS		Page: 1/1	Fig:
S 40°22.351 E 175°37.776		File: CPT-H-10.cpd

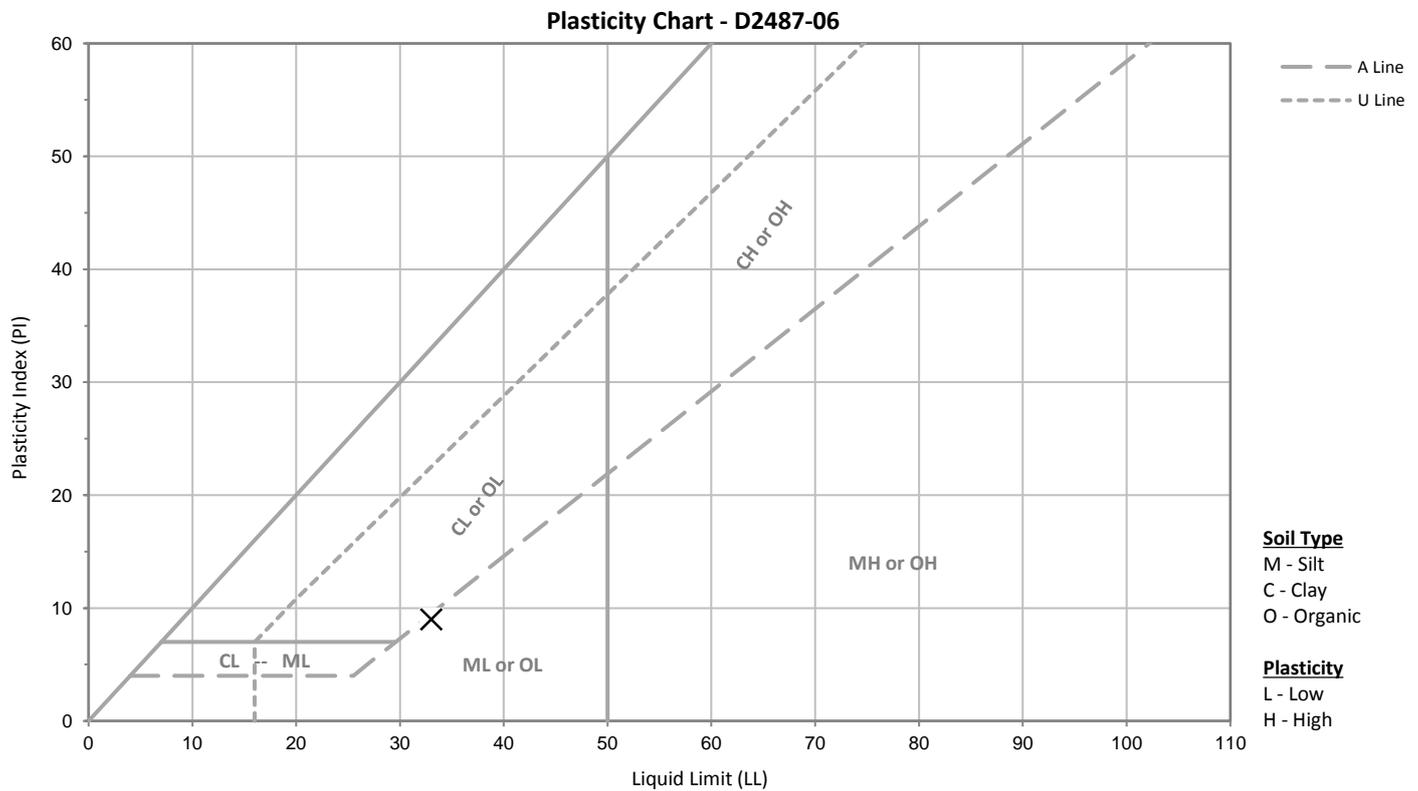
LOCATION	ID	H2		
	Description	Hokowhitu Campus		
	Data	N/A		
SAMPLE	Geotechnics ID	GEOT201608012	Date Received	29/07/2016
	Reference	1	Depth	1.00m
	Description	SILT with minor sand, grey. Moist, low-plasticity. Sand is fine.		
SPECIMEN	Reference	2	Depth	N/A
	Description	N/A

Plastic Limit **24**

Plasticity Index **9**

TEST REMARKS

- The material used for testing was natural, whole soil.
- The liquid limit was done with a manual device. The plastic limit sample was hand rolled. A metal grooving tool was used.
- The maximum grain size was approximately <2mm.

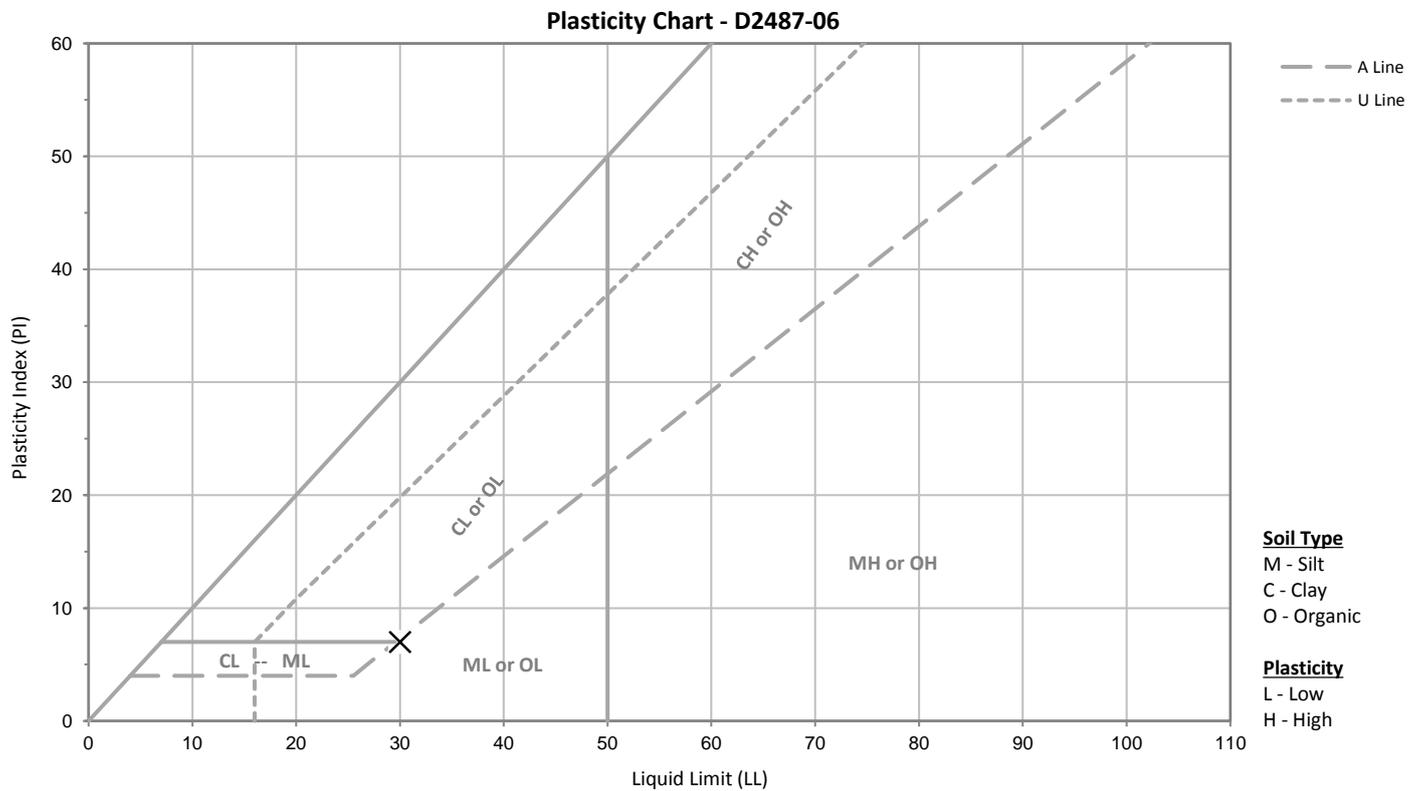
LOCATION	ID	H2		
	Description	Hokowhitu Campus		
	Data	N/A		
SAMPLE	Geotechnics ID	GEOT201608013	Date Received	29/07/2016
	Reference	1.9	Depth	1.90m
	Description	SILT with minor sand, grey. Moist, low-plasticity. Sand is fine.		
SPECIMEN	Reference	2	Depth	N/A
	Description	N/A

Plastic Limit **23**

Plasticity Index **7**

TEST REMARKS

- The material used for testing was natural, whole soil.
- The liquid limit was done with a manual device. The plastic limit sample was hand rolled. A metal grooving tool was used.
- The maximum grain size was approximately <2mm.

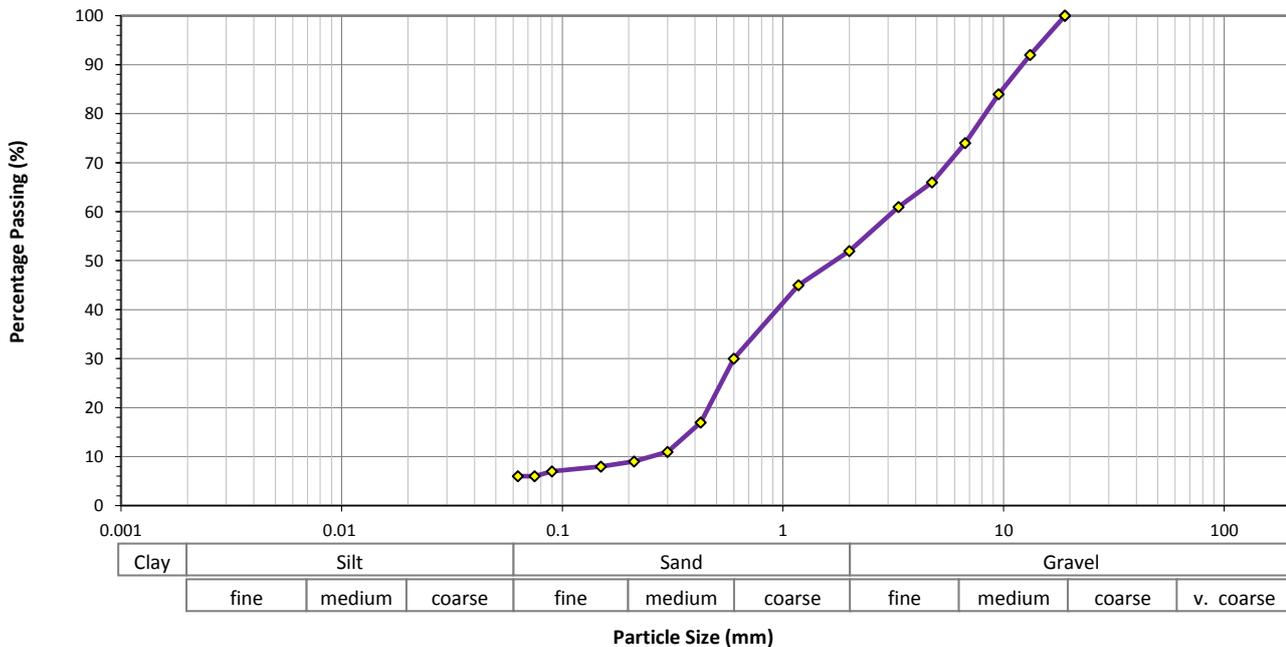
LOCATION	ID	H2		
	Description	Hokowhitu Campus		
	Data	N/A		
SAMPLE	Geotechnics ID	GEOT201608014	Date Received	29/07/2016
	Reference	2.3	Depth	2.30m
	Description	Sandy fine to medium GRAVEL with minor silt, grey. Moist, subrounded to rounded. Sand is fine to coarse.		
SPECIMEN	Reference	2	Depth	N/A
	Description	N/A

TEST RESULTS

Clay	Silt			Sand			Gravel			
	fine	medium	coarse	fine	medium	coarse	fine	medium	coarse	v. coarse

Sieve Size (mm)	Percentage Passing (%)						
150	-	26.5	-	4.75	66	0.300	11
100	-	19.0	100	3.35	61	0.212	9
75.0	-	16.0	-	2.00	52	0.150	8
63.0	-	13.2	92	1.18	45	0.090	7
53.0	-	9.50	84	0.600	30	0.075	6
37.5	-	6.70	74	0.425	17	0.063	6

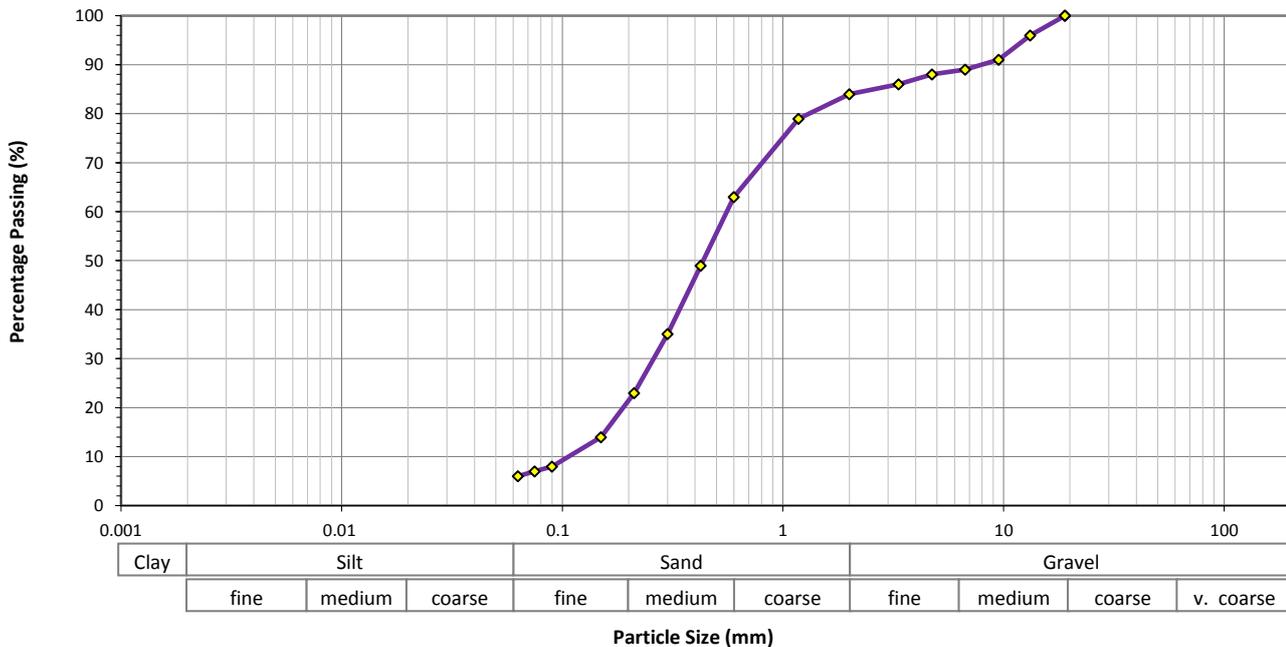
LOCATION	ID	H1		
	Description	Hokowhitu Campus		
	Data	N/A		
SAMPLE	Geotechnics ID	GEOT201608011	Date Received	29/07/2016
	Reference	3.3	Depth	3.30m
	Description	Fine to coarse SAND with some gravel and minor silt, grey. Moist. Gravel is fine to medium, subrounded to rounded.		
	SPECIMEN	Reference	2	Depth
	Description	N/A

TEST RESULTS

Sieve Size (mm)	Percentage Passing (%)						
150	-	26.5	-	4.75	88	0.300	35
100	-	19.0	100	3.35	86	0.212	23
75.0	-	16.0	-	2.00	84	0.150	14
63.0	-	13.2	96	1.18	79	0.090	8
53.0	-	9.50	91	0.600	63	0.075	7
37.5	-	6.70	89	0.425	49	0.063	6
